# SERVICE CAMPAIGN BULLETIN

SUBJECT:			No: <b>SC-14-004</b>
<b>LANCER PASSENGER AIR BAG INFLATOR – SPECIAL SERVICE CAMPAIGN</b>			DATE: <b>October, 2014</b>
			MODEL: <b>2004-05 Lancer</b>
CIRCULATE TO:	<input checked="" type="checkbox"/> GENERAL MANAGER	<input checked="" type="checkbox"/> PARTS MANAGER	<input checked="" type="checkbox"/> TECHNICIAN
<input checked="" type="checkbox"/> SERVICE ADVISOR	<input checked="" type="checkbox"/> SERVICE MANAGER	<input checked="" type="checkbox"/> WARRANTY PROCESSOR	<input checked="" type="checkbox"/> SALES MANAGER

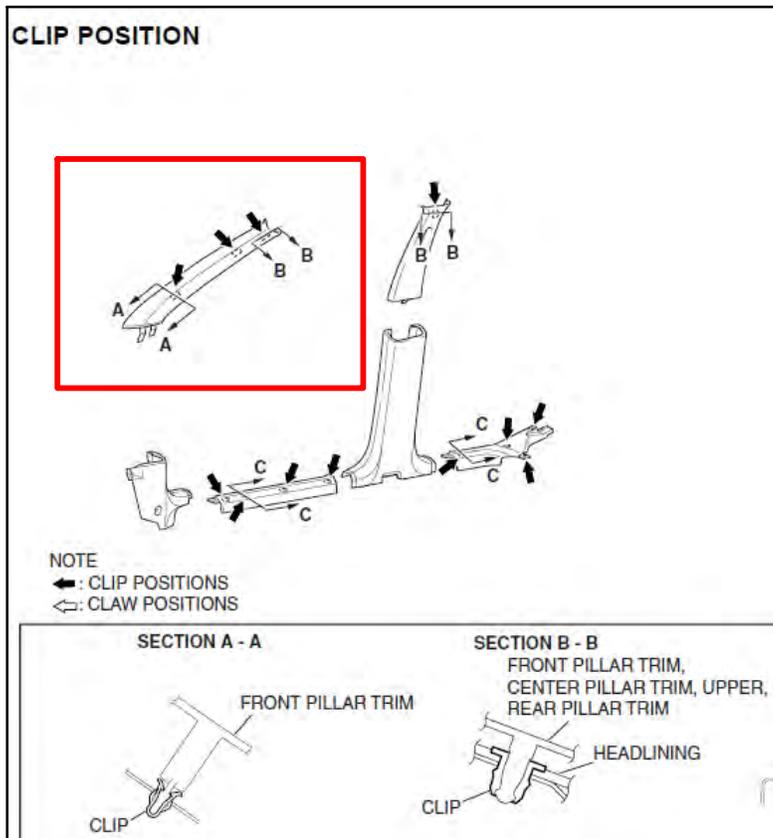
2. Remove the front left and right A-pillar trim.

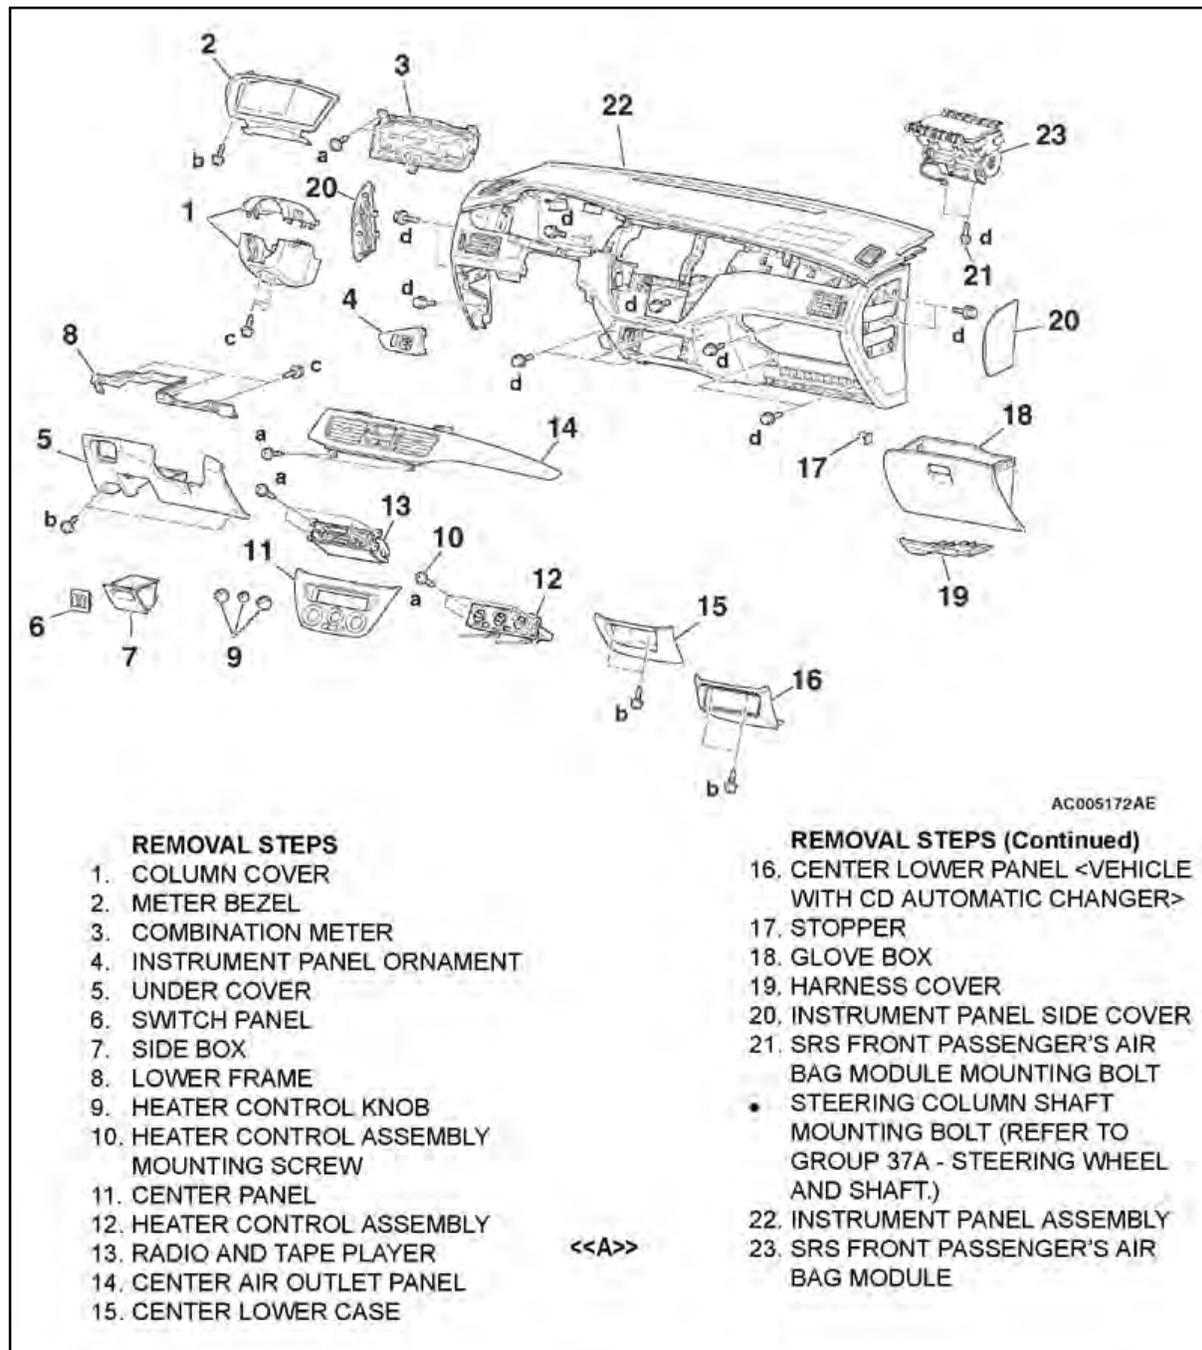
3. Remove the instrument panel.

#### REMOVAL STEPS

1. COLUMN COVER
2. METER BEZEL
3. COMBINATION METER
4. INSTRUMENT PANEL ORNAMENT
5. UNDER COVER
6. SWITCH PANEL
7. SIDE BOX
8. LOWER FRAME
9. HEATER CONTROL KNOB
10. HEATER CONTROL ASSEMBLY MOUNTING SCREW
11. CENTER PANEL
12. HEATER CONTROL ASSEMBLY
13. RADIO AND TAPE PLAYER
14. CENTER AIR OUTLET PANEL
15. CENTER LOWER CASE

#### REMOVAL STEPS (Continued)

16. CENTER LOWER PANEL <VEHICLE WITH CD AUTOMATIC CHANGER>
17. STOPPER
18. GLOVE BOX
19. HARNESS COVER
20. INSTRUMENT PANEL SIDE COVER
21. SRS FRONT PASSENGER'S AIR BAG MODULE MOUNTING BOLT
  - STEERING COLUMN SHAFT MOUNTING BOLT (REFER TO GROUP 37A - STEERING WHEEL AND SHAFT.)
22. INSTRUMENT PANEL ASSEMBLY
23. SRS FRONT PASSENGER'S AIR BAG MODULE

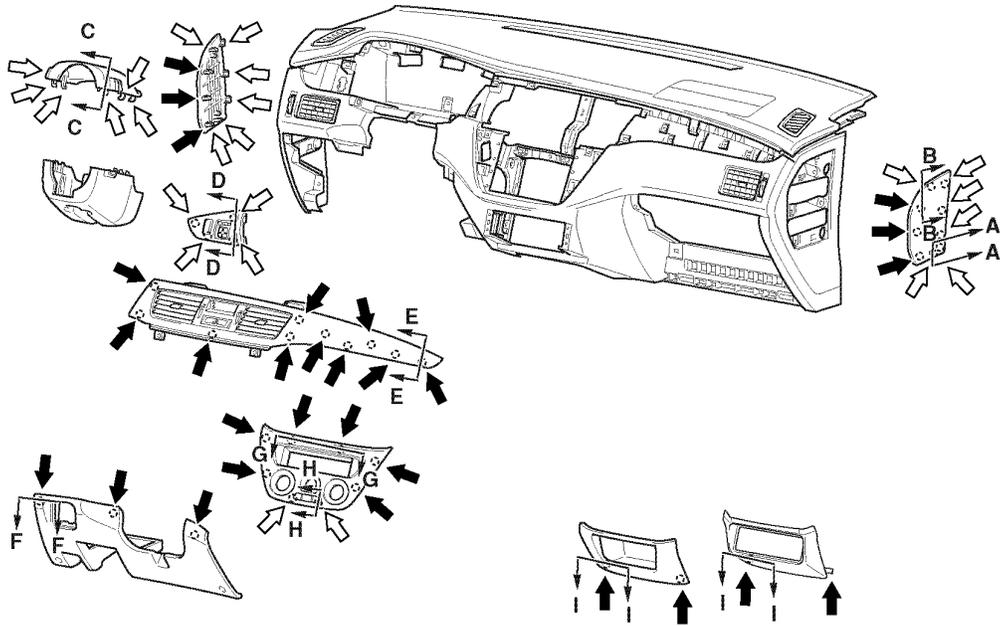
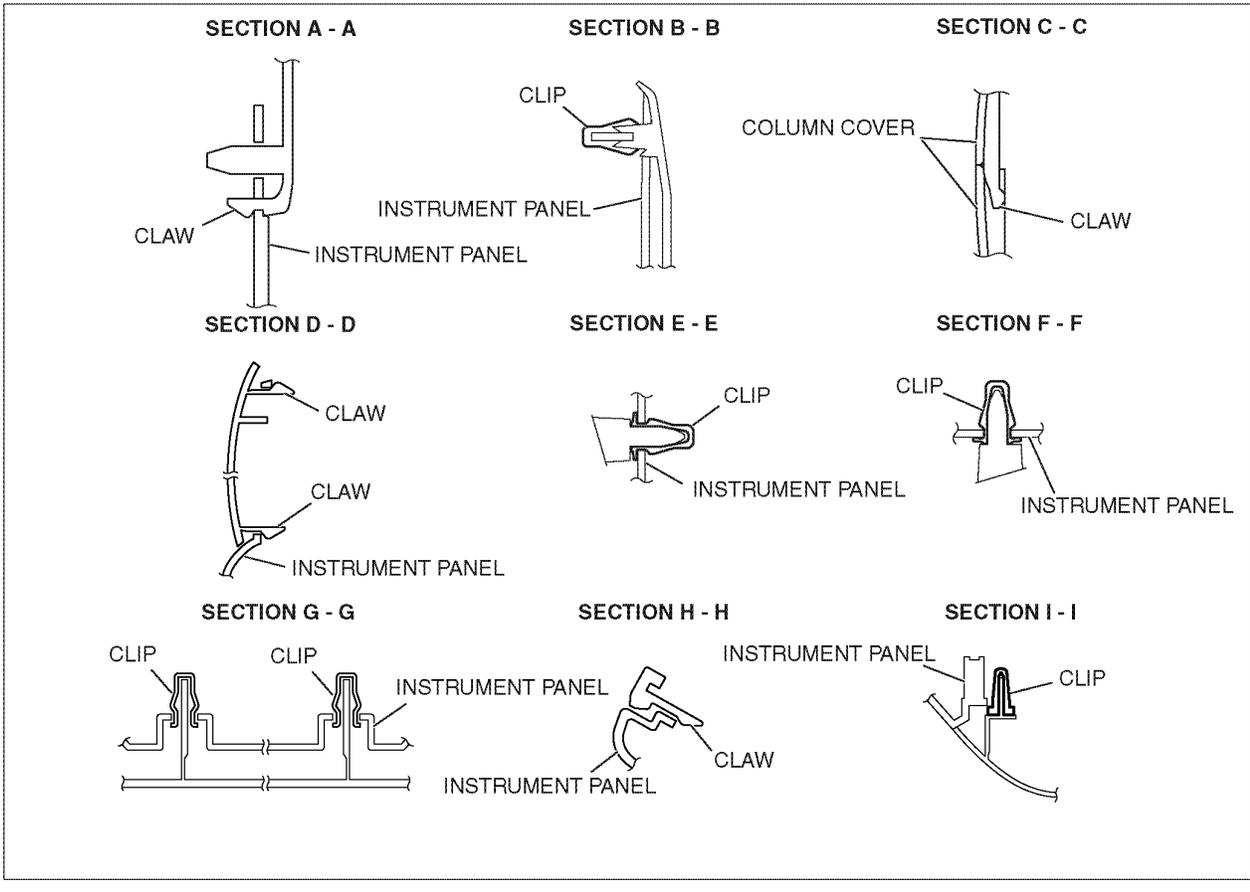
### CLIP AND CLAW POSITION

NOTE  
 (1) : CLIP POSITIONS  
 (2) : CLAW POSITIONS

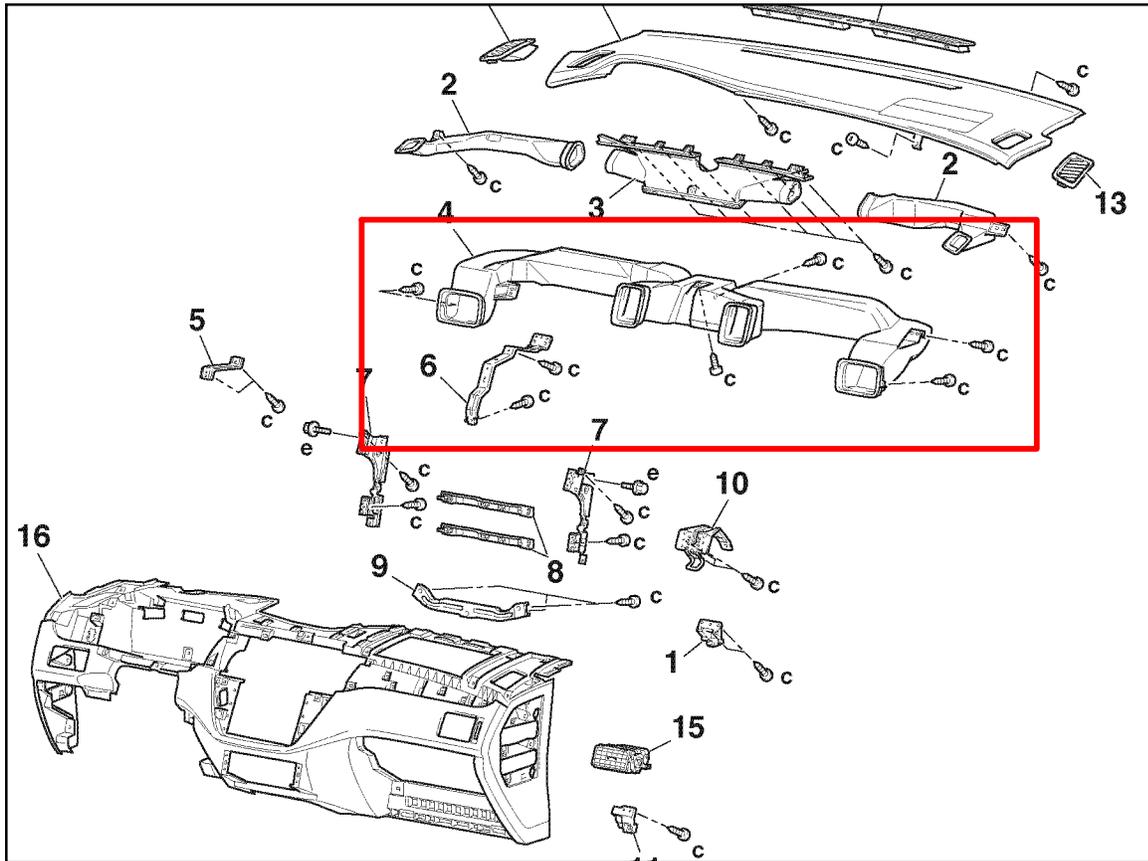
4. Remove the distribution duct from the instrument panel.

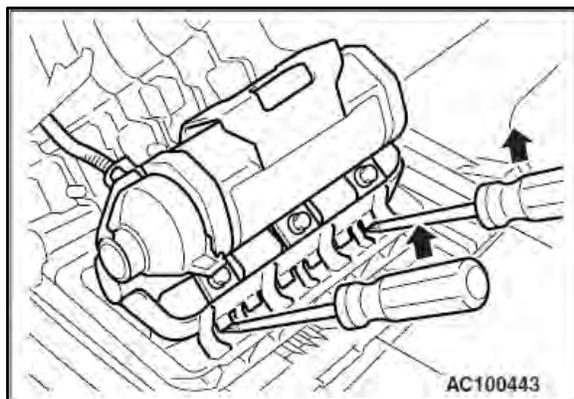
5. The passenger side air bag module is secured to the instrument panel in a flexible plastic enclosure. Insert a flat head screwdriver and disengage the mounting hooks to dislodge the module from the enclosure.

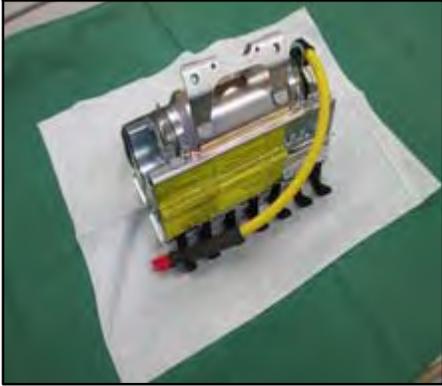
1. Place the air bag module on a clean work bench covered with a new, clean cloth/sheet with the air bag facing down.

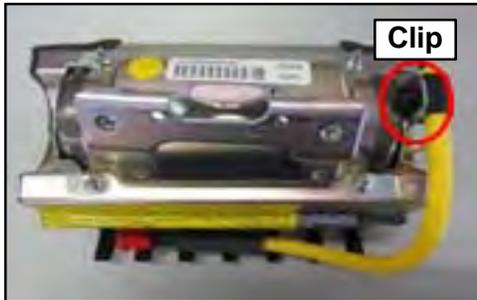
2. Use pliers to remove the wiring clip from the bracket.

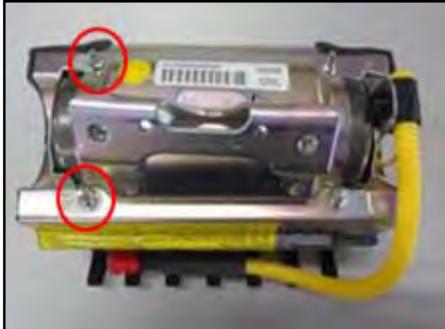
3. Remove and discard the circled nuts (gold finish).

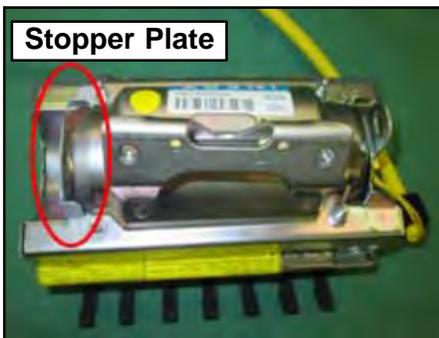
4. Remove the stopper plate.

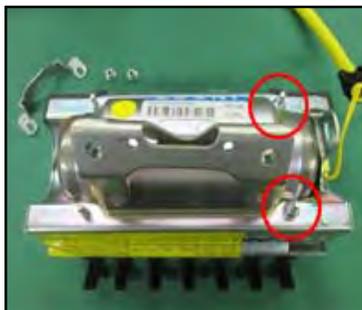
5. **Loosen, but do not remove,** the circled nuts (gold finish).

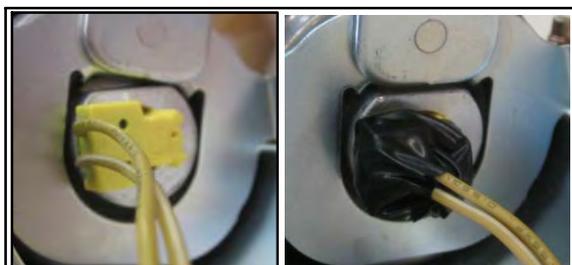
6. Apply protective tape around the wires near the base of the connector to protect the wire during inflator removal.

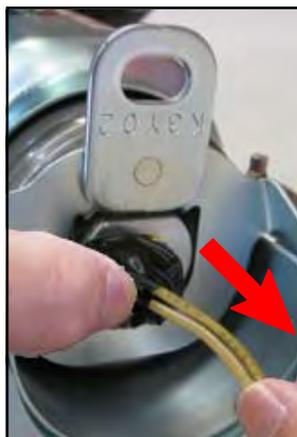
7. Gently pull and straighten the wires so they are in line with the inflator. This will prevent the wire from contacting the edges of the inflator housing during removal.

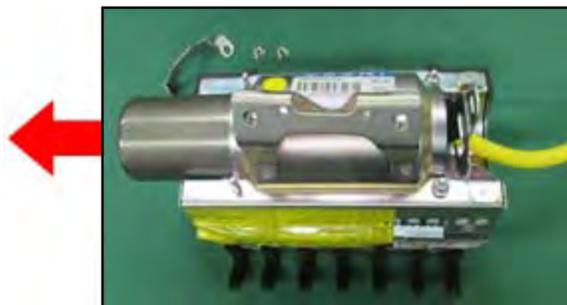
8. Gently push the inflator with your finger in the indicated direction while gently pulling (straightening) the wire to remove the inflator.

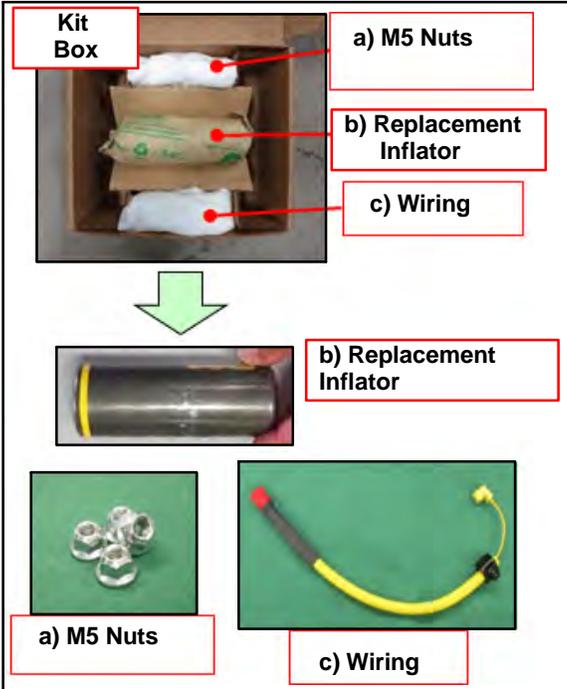
9. Unpackage the air bag inflator kit, remove and verify the contents:
  - a. (4) Replacement nuts – M5 (silver finish)
  - b. (1) Replacement inflator with yellow taping
  - c. (1) Replacement wiring harness
10. Package the old inflator with wiring harness into the box. Ensure the items are correctly wrapped with the old wrapping to protect from damage during shipping.

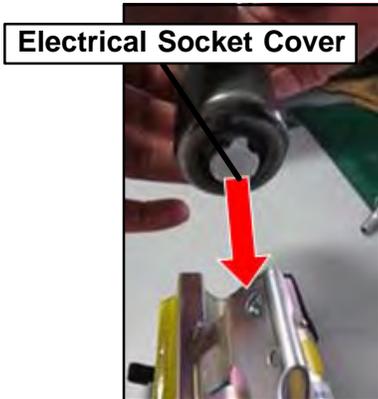
11. Insert the the replacement inflator into the housing as shown, with the electrical socket cover end (opposite of the yellow identification tape) going in first.

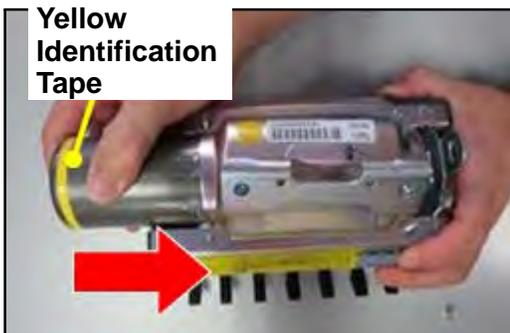
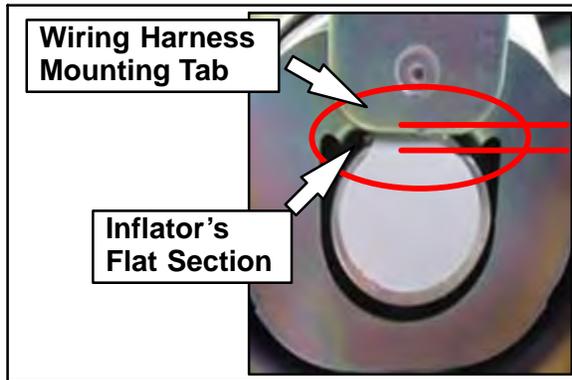
12. Rotate the inflator so the flat section is parallel with the wiring harness mounting tab.

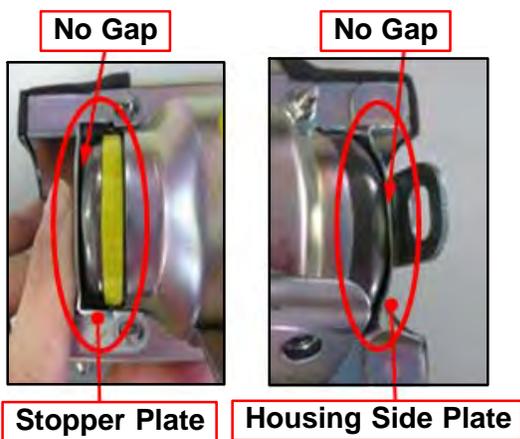
13. Reinstall the stopper plate.

14. Ensure the inflator is seated correctly in the housing and there are no gaps on either end.

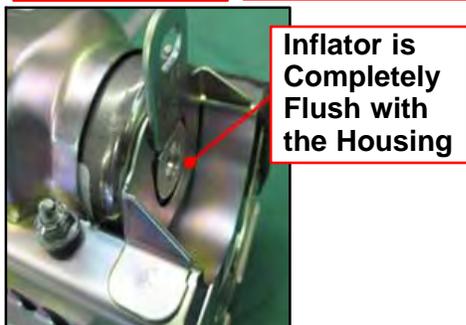
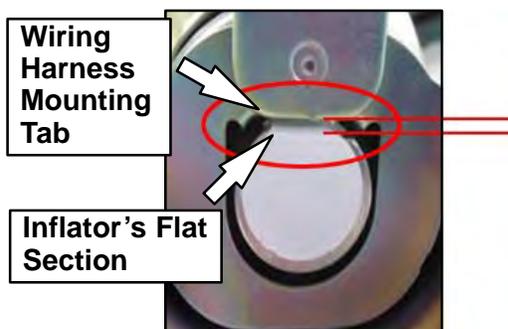
15. Confirm the inflator's flat section is still parallel with the wiring harness mounting tab. If not, rotate the inflator until it is parallel.

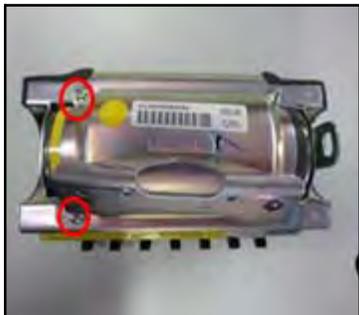
16. Install (2) new nuts (silver finish) in the circled area. Do not tighten all the way.

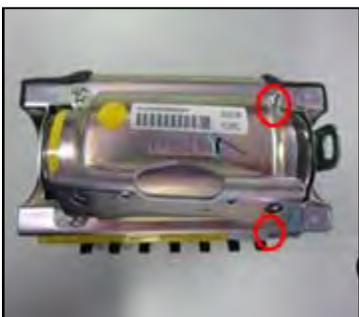
17. Remove and discard the (2) old nuts (gold finish) loosened from step 5 and replace them with (2) new nuts (silver finish).

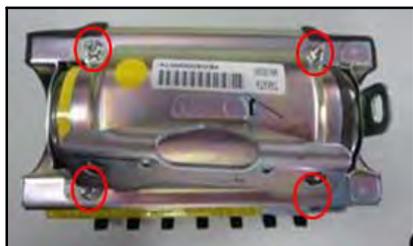
18. Torque all (4) nuts to  $34.5 \pm 3.5$  in-lb ( $3.9 \pm 0.4$  N-m).

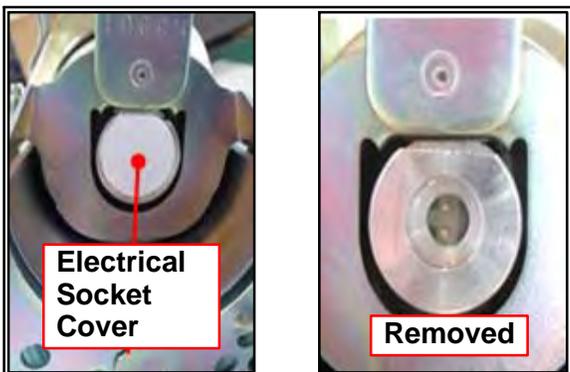
19. Remove the electrical socket cover from the inflator.

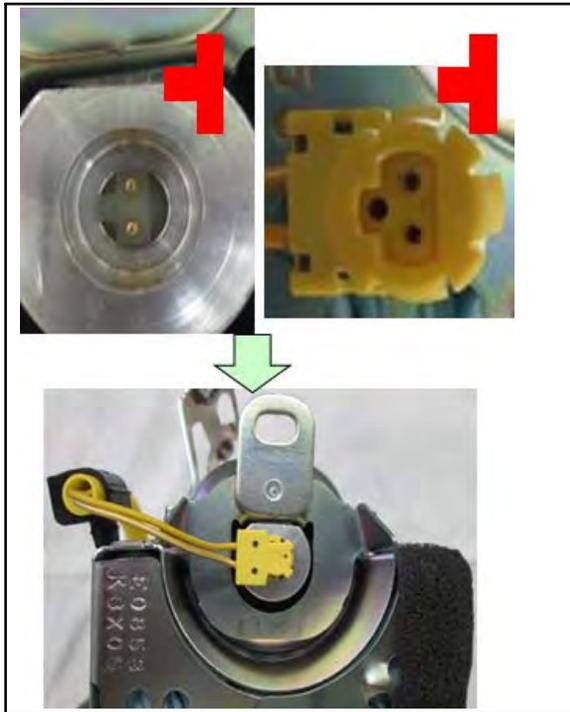
20. Match the wiring harness connector's plug with the shape in the socket and connect it.

**NOTE:** A faint click will be heard when the connector is inserted correctly.

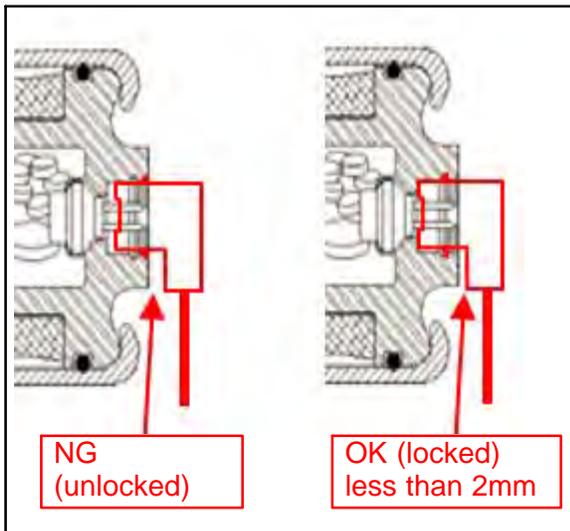
21. Ensure the connector is completely inserted into the electrical socket.

Measure the distance between the inflator and the wiring connector to ensure it is less than 2mm.

If the distance is more than 2mm, the connection is NG.

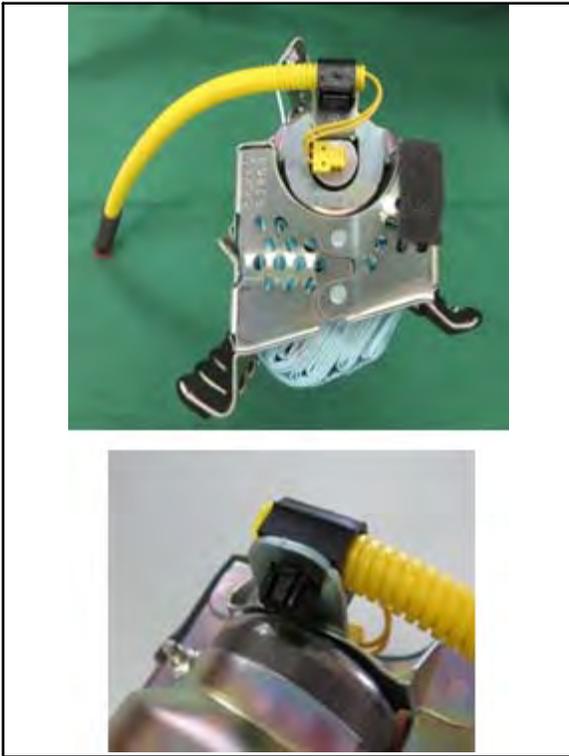
22. Clip the wiring harness connector to the mounting bracket as shown.

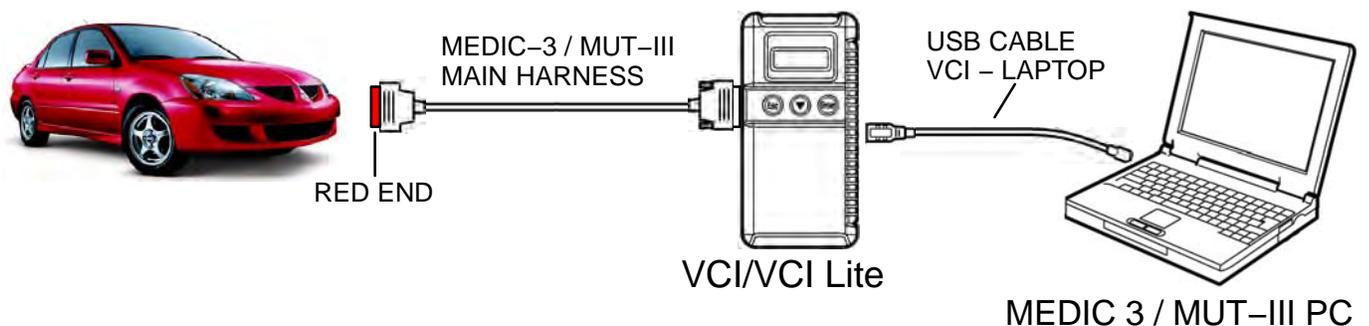
1. Remove the electrical tape and reconnect the negative (–) battery terminal. Tighten the clamp nut securely.
2. Connect the equipment as follows:
  - Turn the laptop computer/tablet on.
  - Connect the USB cable to the VCI/VCI Lite.
  - When the laptop displays the MUT–III main screen, connect the USB cable to the laptop.
  - Connect the MUT–III main harness with the red DLC connector to the VCI/VCI Lite.
  - Connect the red connector of the MUT–III main harness to the vehicle's data link connector.

**NOTE:** VCI and laptop shown for illustration purposes only.
