NHTSA Safety Recall 14V-506

SUBJECT: Campaign #131 – Roof Air Conditioner Damper Plate

INSTRUCTIONS TO PERFORM CAMPAIGN 131

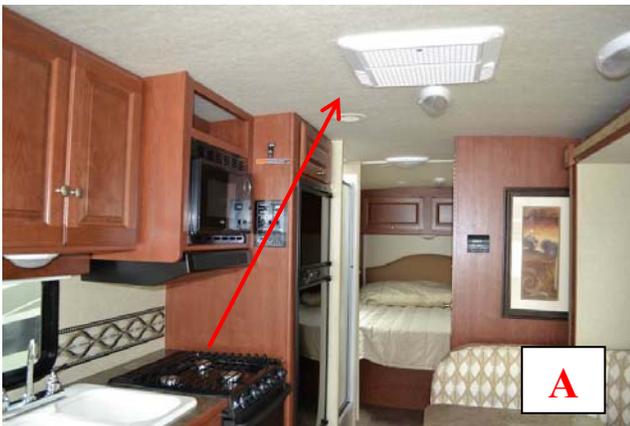
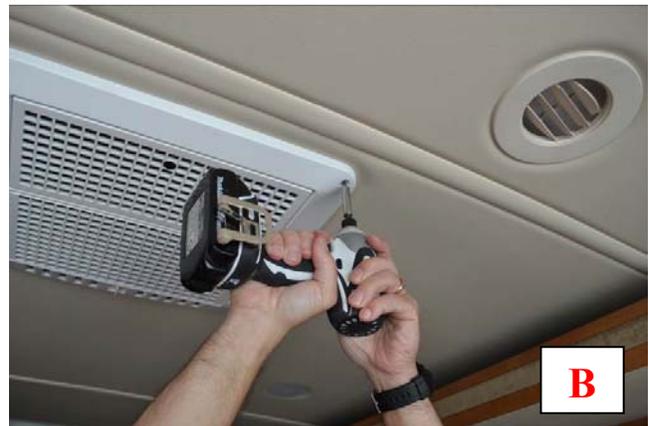
Figure (A) indicates diverter above cooktop that will be replaced with damper plate

1. Remove (4) screws from perimeter of inside roof A/C assembly, (set aside). See *figure A and B*.

6. Reinstall inside A/C shroud.
 - Install (3) screws under return air grate. *See figure D.*
 - Install (4) screws at perimeter of inside assembly. *See figure B.*
 - Install return air grate. *See figure C.*
7. When installation is completed, light the range, then turn on the roof air conditioner. Verify that the range flame remains constant, (even with a low flame).
