IMPORTANT UPDATE

TECHNICAL INSTRUCTIONS FOR SAFETY RECALL ELG FRONT PASSENGER AIRBAG INFLATOR MODULE CERTAIN 2002 – 2005 MODEL YEAR SC430

Updated 10-22-14

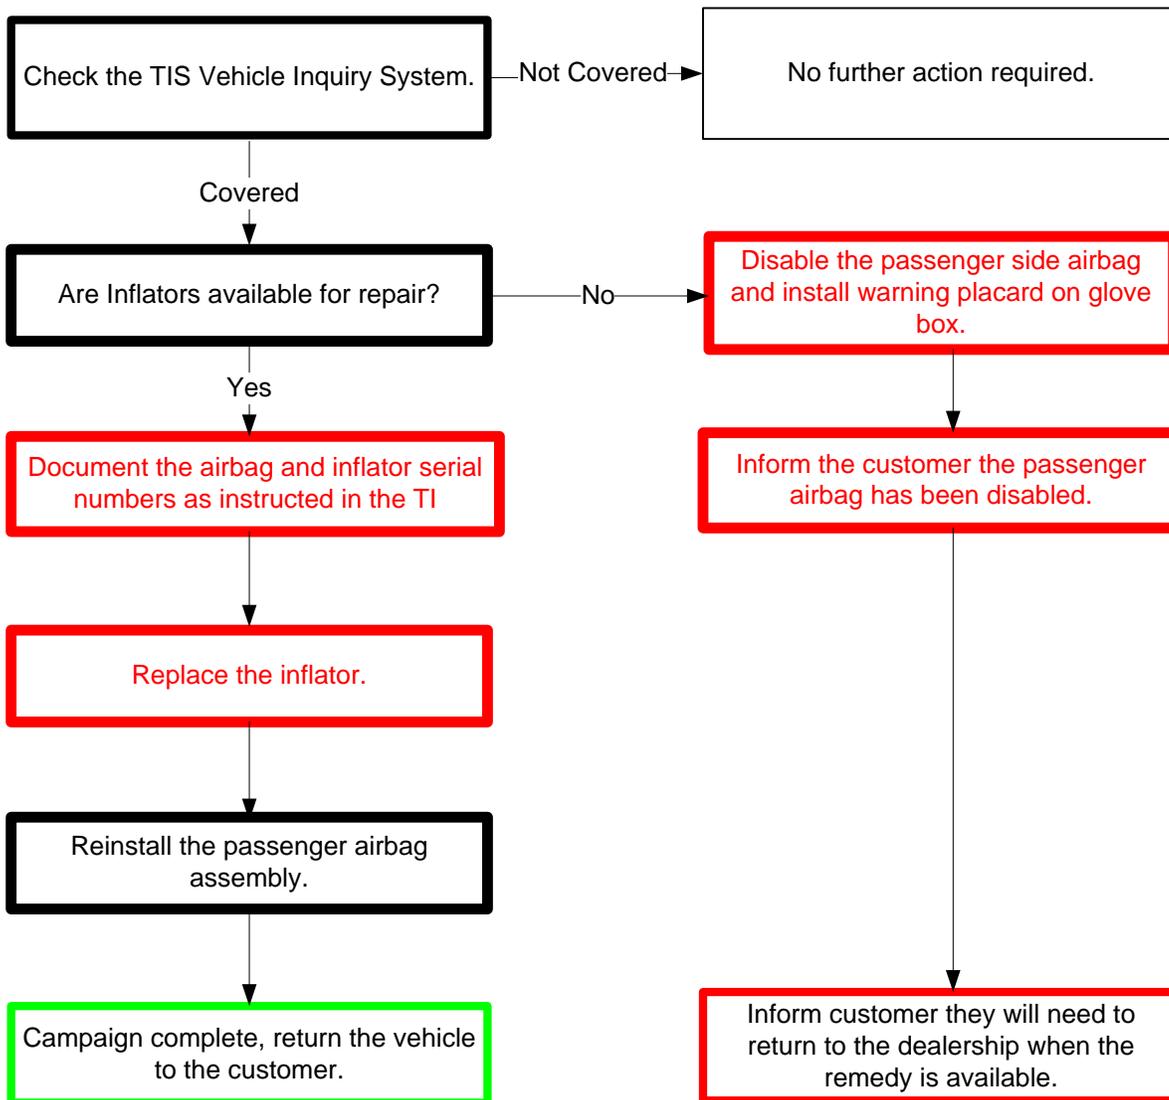
I. OPERATION FLOW CHART

The flow chart is for reference only. **DO NOT** use it in place of the full technical instructions. Follow **ALL** steps as outlined in the full technical instructions to confirm the campaign is completed correctly.

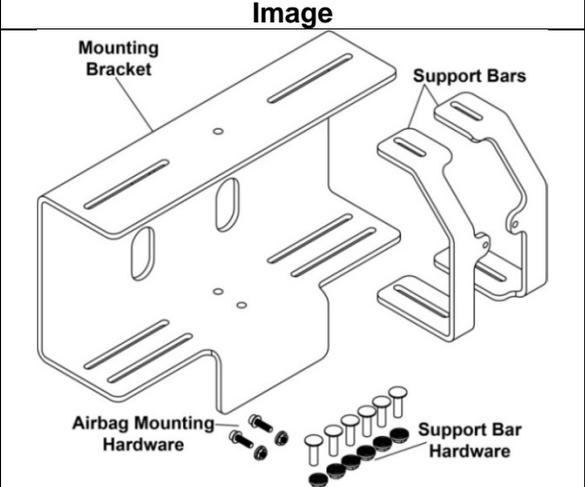
Airbag Mounting Bracket & hardware	1

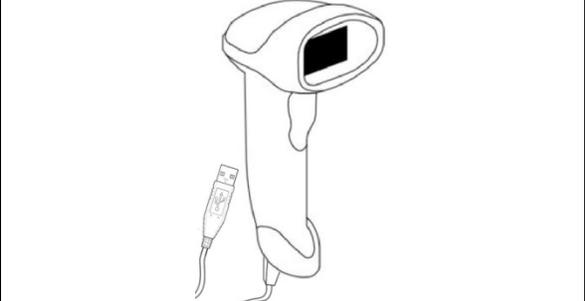
Barcode Scanner	1

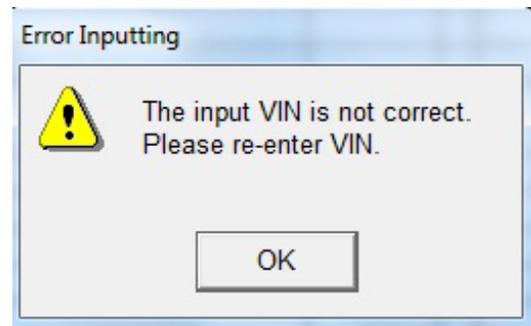
NOTE: If the VIN was not entered in ALL CAPS when Techstream was launched, an error will be displayed and there will be a prompt to reenter the VIN

- Enter the vehicle mileage and repair order information, then click the 'report' button.

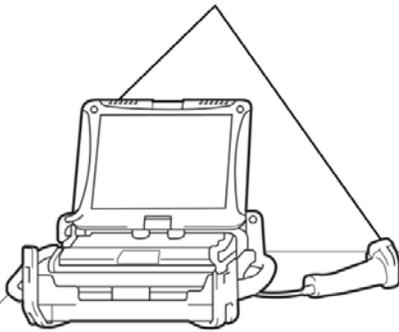
Techstream and barcode scanner

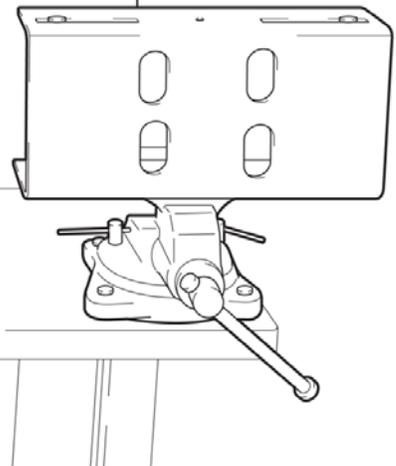
Bracket securely mounted in vise

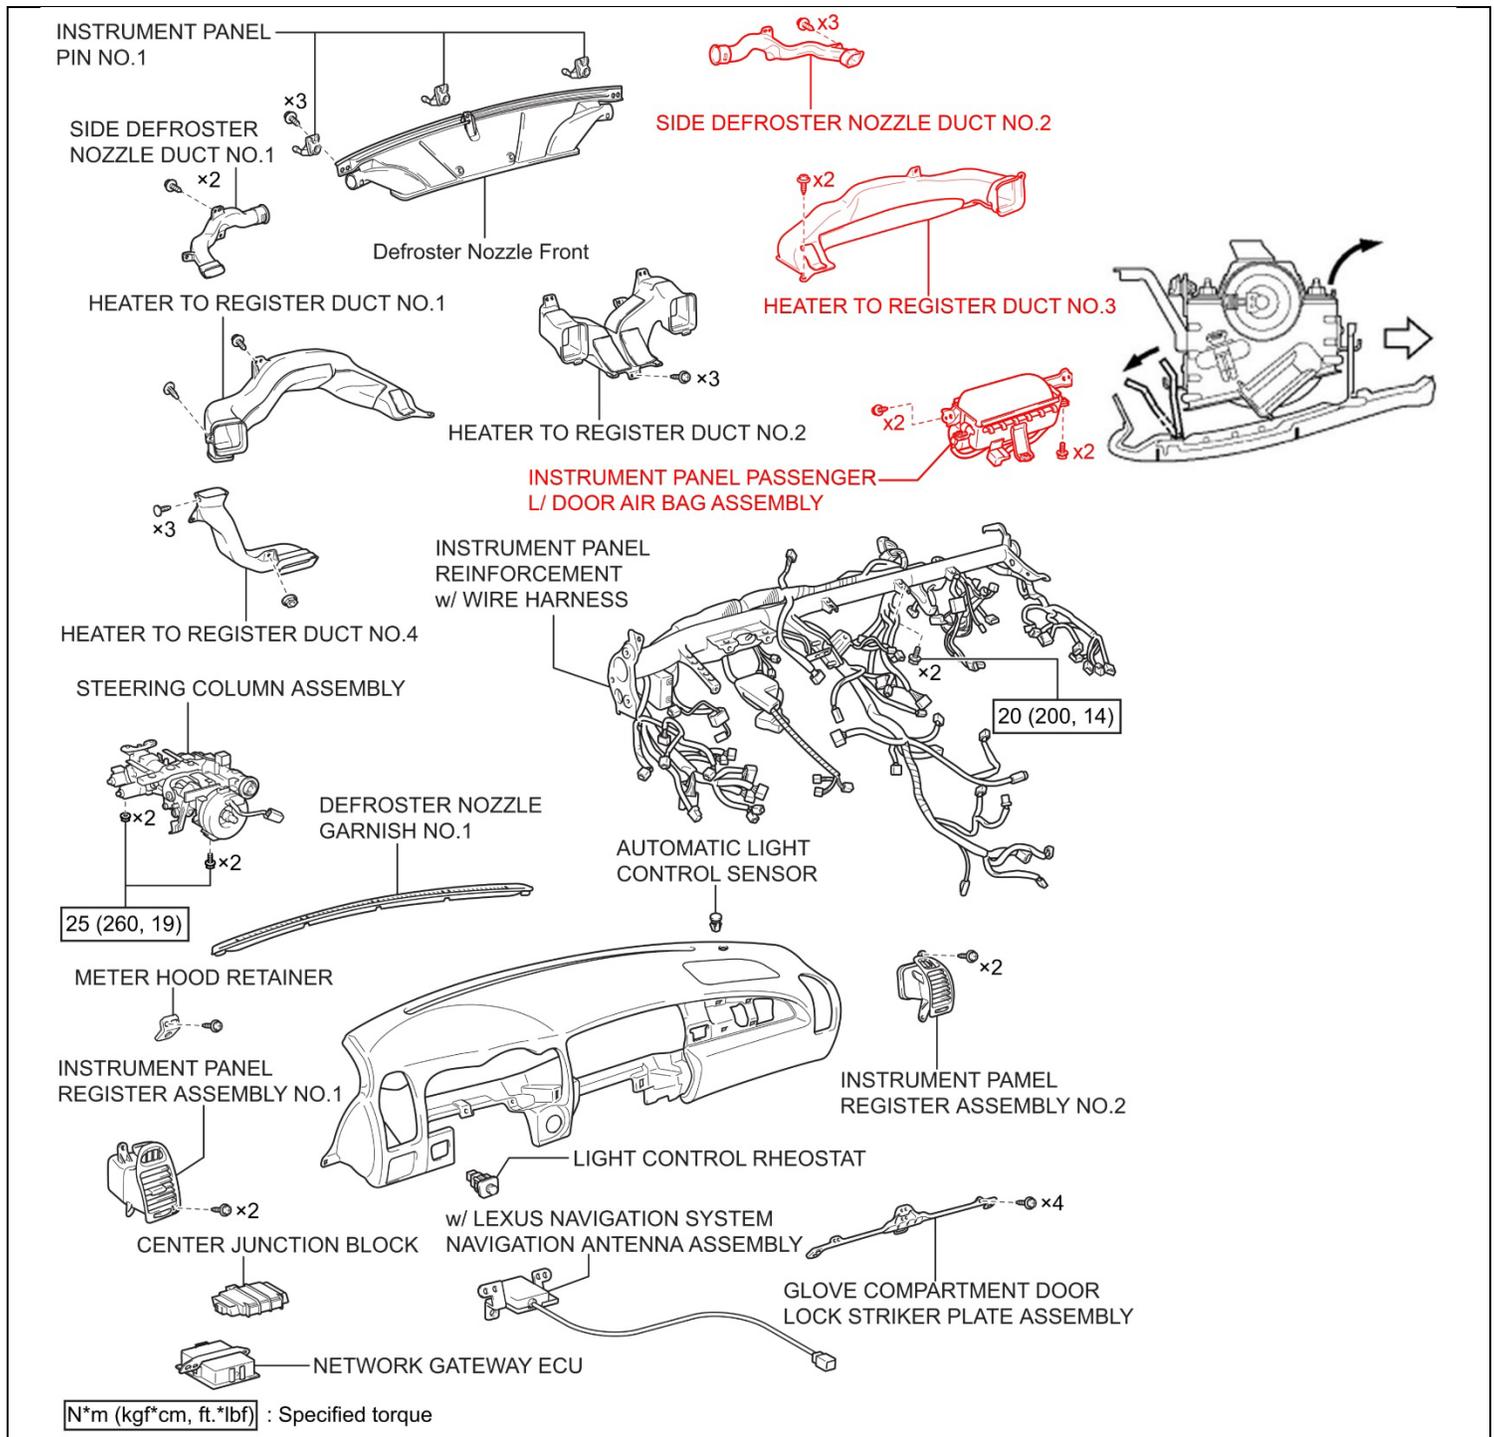
3. REMOVE THE AIRBAG FROM THE INSTRUMENT PANEL

- a) Remove the 3 screws and the side defroster nozzle.
- b) Remove the 2 screws and the heater to register duct.
- c) Remove the 4 bolts, disengage the straps, and then remove the airbag assembly.

NOTE: Only remove the components highlighted in red; there is NO NEED to remove any other components.

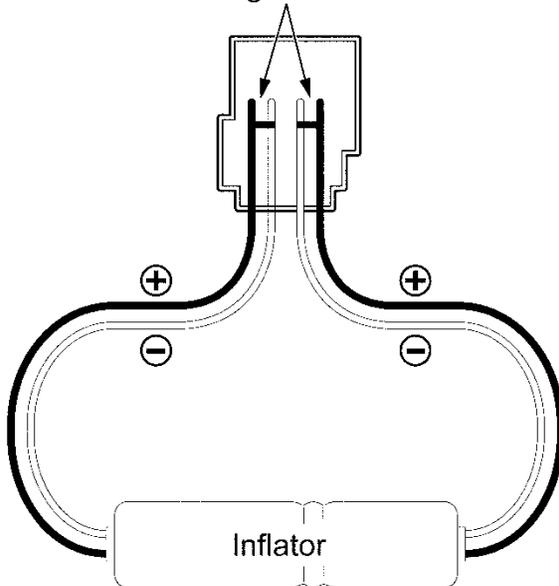
(1)

The connector of the inflator module contains a short circuiting mechanism to eliminate voltage variances when the connector(1) is disconnected. To allow for the replacement of the inflator module, a new short circuit(2) **MUST** be created before cutting the wires(3) and removing the inflator. The following steps **MUST** be followed exactly as described to ensure the work is completed correctly and safely.

Short circuiting on both sides.

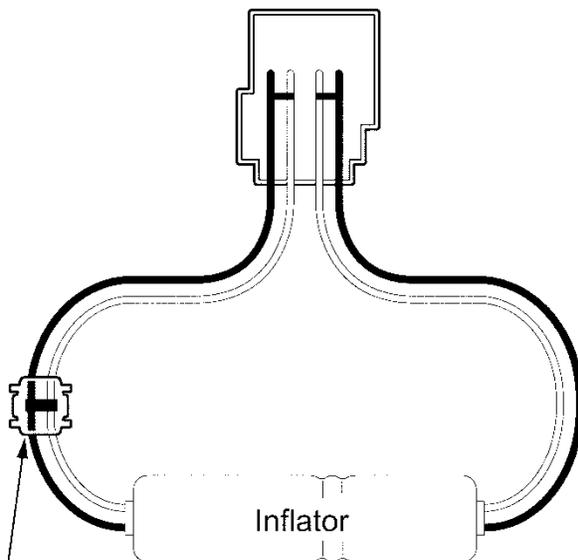
(2)

Create new short circuit using electro tap.

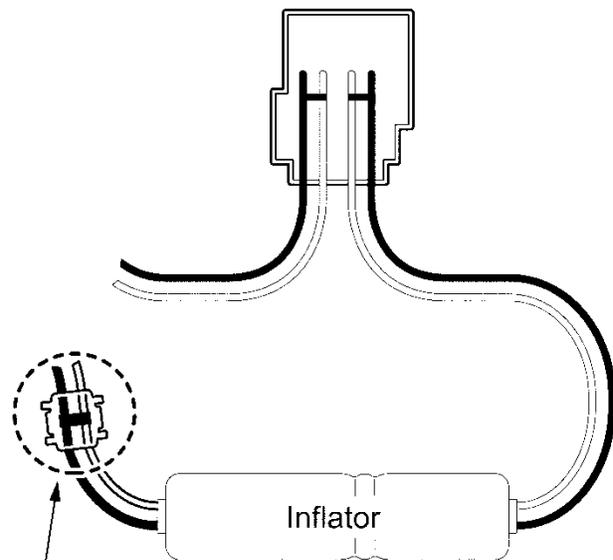
(3)

Short circuiting is maintained even after cutting harness.

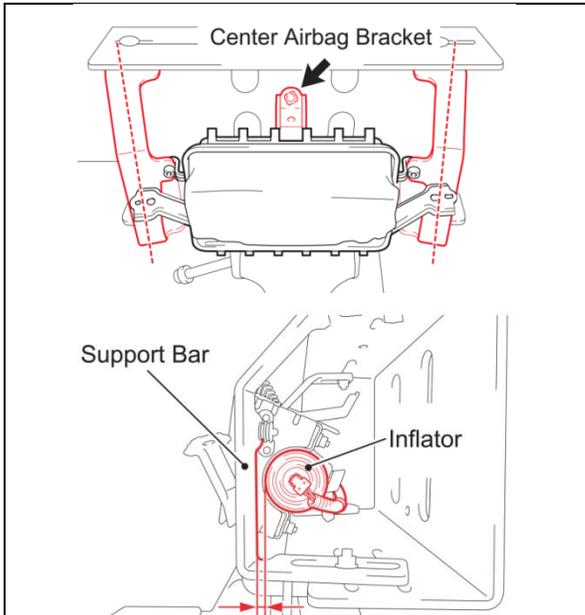
1. MOUNT THE AIRBAG IN THE MOUNTING BRACKET

- a) Position the airbag so that the airbag weld-nuts are between the support bars and mounting bracket and install the bolts.

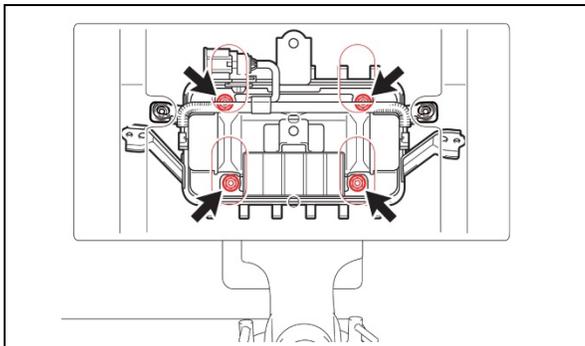
- b) Position the support bars at an angle as shown in the illustration.

- c) Confirm the center airbag bracket is facing up.

NOTE: The position of the support bars is critical to create clearance for the removal of the inflator.

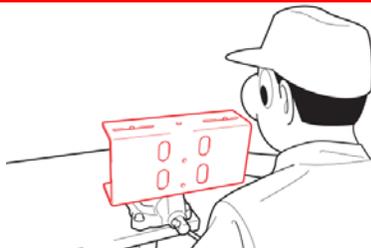
CRITICAL INFORMATION – READ THOROUGHLY

ALWAYS keep as much of your body as possible in front of the bracket when working on the airbag assembly.

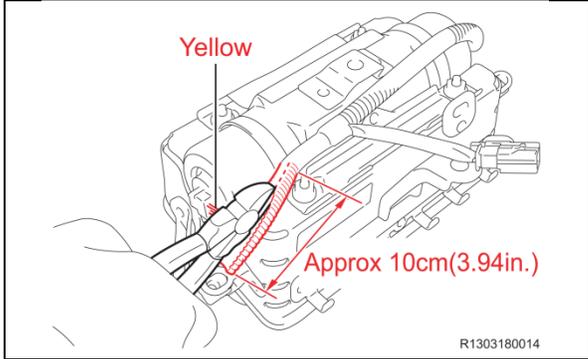
b) Cut the yellow corrugated tube on the harness approximately 4 inches (10 cm) using nippers.

- **DO NOT** damage the wires in the tube.
- **DO NOT** use a knife or razor blade to cut the tube to avoid damaging the wires.
- This may be performed on either end of the inflator.

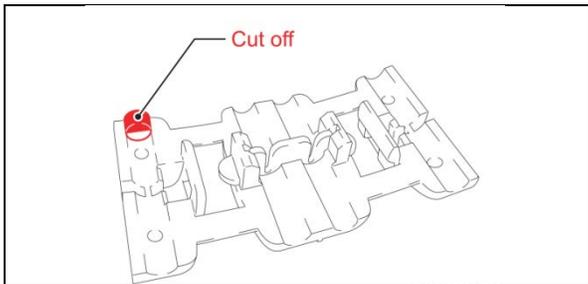
c) Cut off the tab of the electro tap shown in the illustration.

STOP This tab **MUST** be removed to ensure a good short.

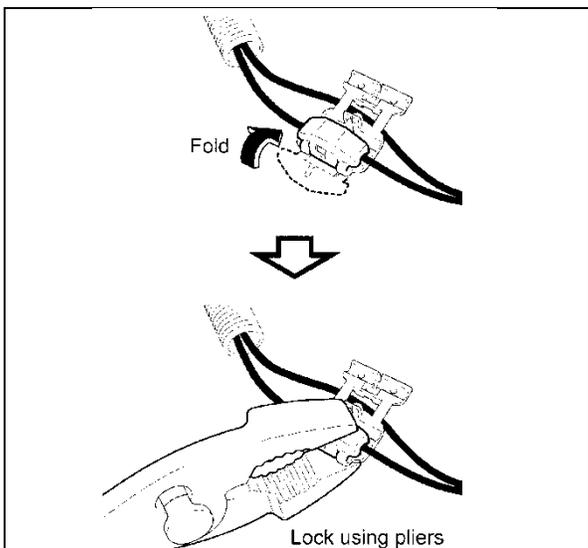
a) Place one wire in the electro tap as shown in the illustration.

b) Fold and pinch the half of the electro tap with the wire and use pliers to lock the electro tap.

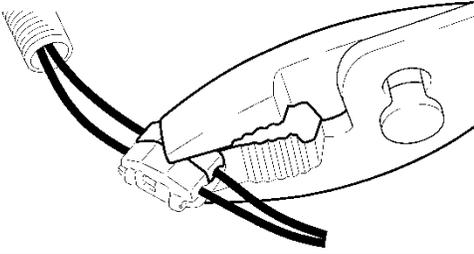
Lock the other wire.

- c) Set the other wire in the electro tap and lock it in place using pliers.

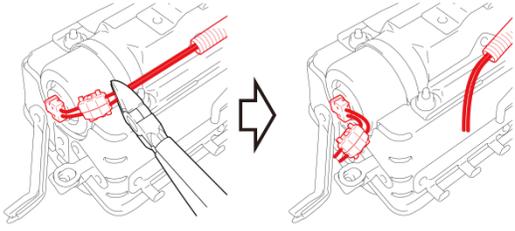
OK

Cut at opposite side to inflator

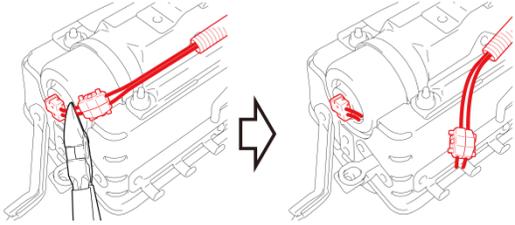
NG

DO NOT cut at inflator side

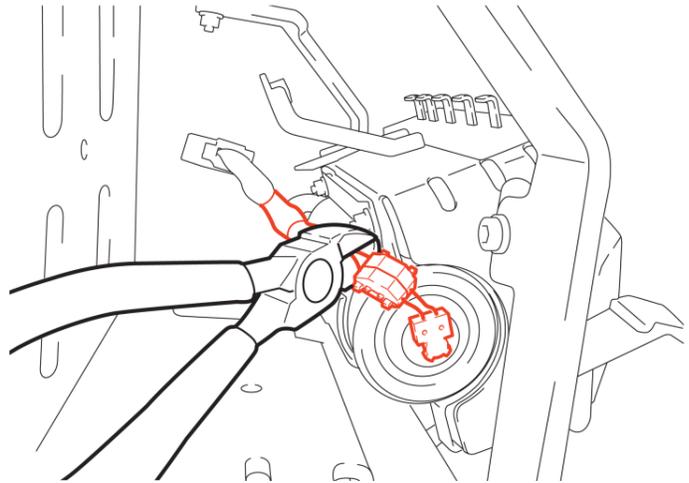
- a) Cut the 2 wires at the side of the electro tap that is farthest away from the inflator.

Cut the wires opposite the inflator

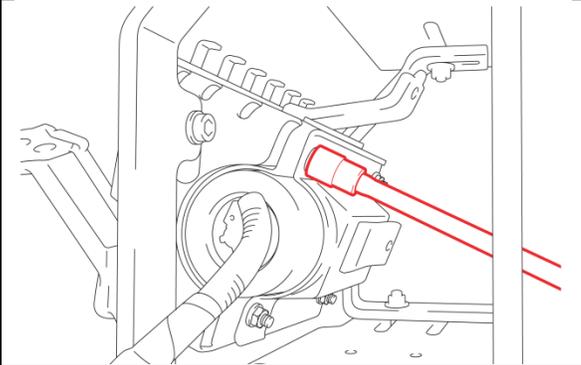
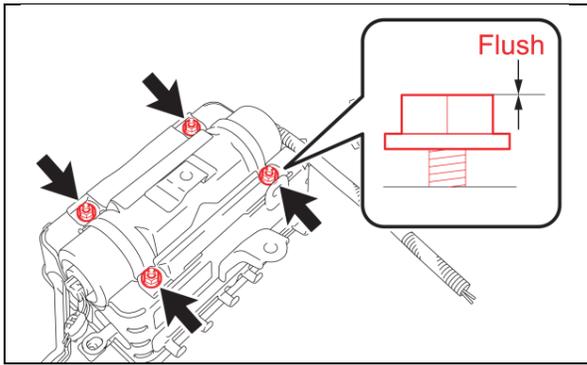
- a) Use the access holes in the bracket to loosen the 4 nuts.

- **DO NOT** use power tools.
- **DO NOT** remove the nuts or the bag may fall out of the airbag assembly.

- b) Loosen the nuts until they are flush with the studs.
 - c) Use a marker to mark the nuts as they are not to be reused.
- NOTE: *DO NOT* reuse the old nuts, new nuts *MUST* be used.**

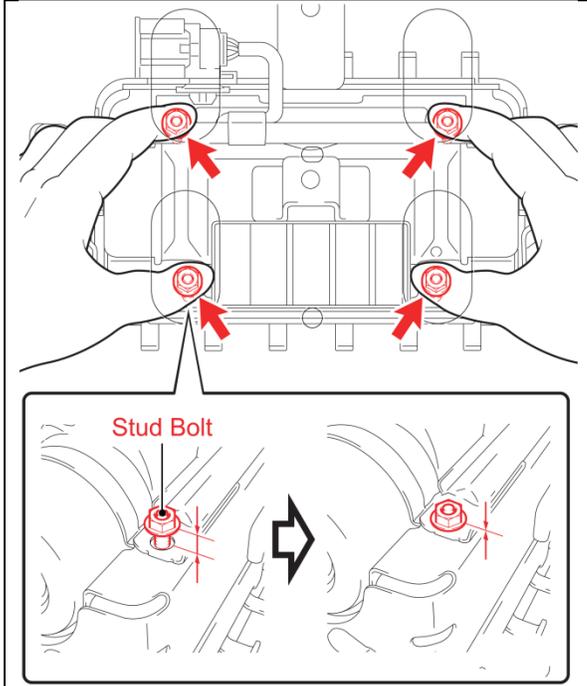
- a) Gently push in the 4 studs until the nuts contact the airbag case to allow for inflator removal.

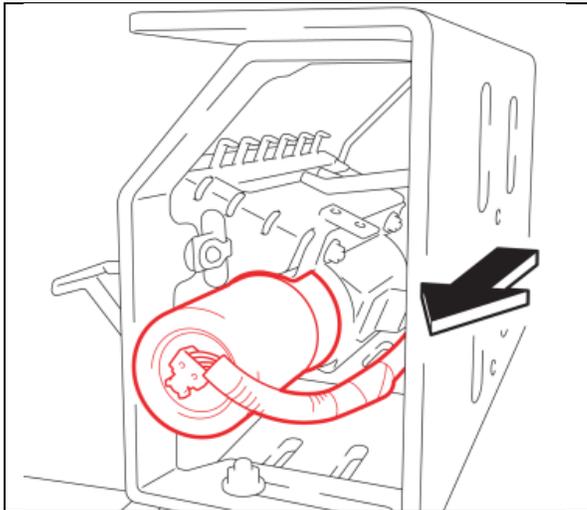
- b) Remove the inflator from the airbag assembly and place it on a safe work surface.

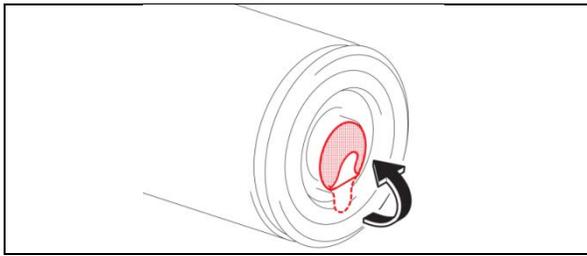
- Carefully slide the new inflator into the airbag assembly.

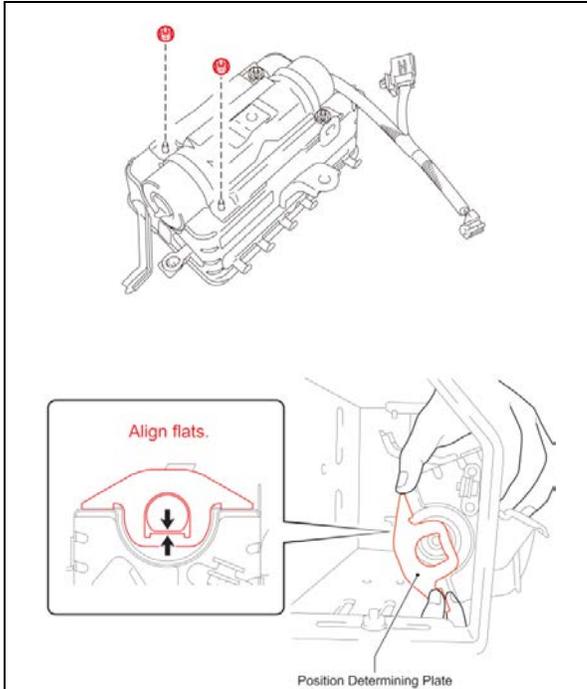
- a) Fold the seal in order to prevent it from being caught under the position determining plate in the next step.

NOTE: DO NOT fully remove the seal until just before connecting the harness.

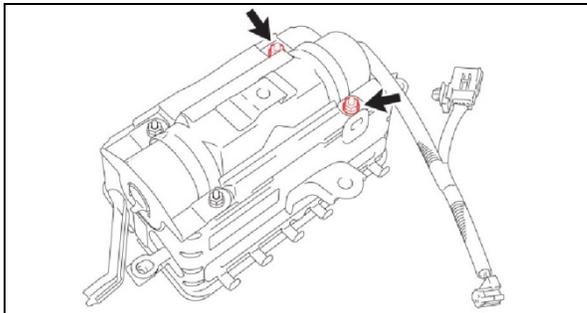
- a) Remove the 2 old nuts.
- b) Install the position determining plate and install the 2 **NEW** nuts by hand. They will be torqued on a later step.

STOP The position determining plate can only be installed on one side in one position, confirm the plate is aligned correctly.

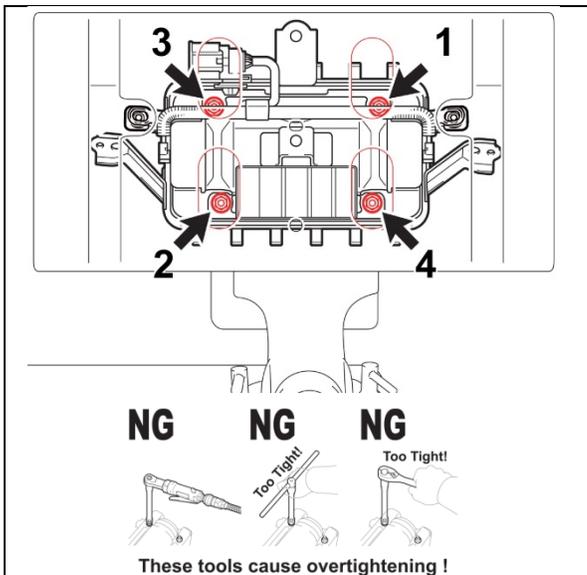
- c) Remove the 2 old nuts.
- d) Install the 2 **NEW** nuts by hand. They will be torqued on the next step.

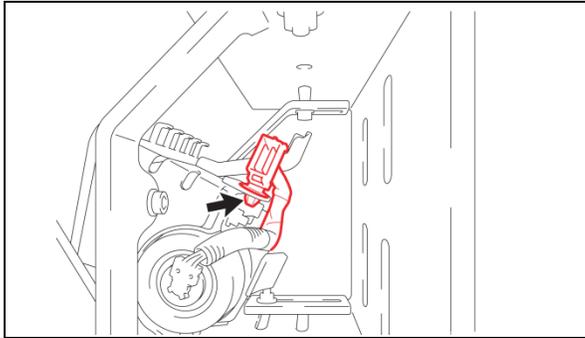
- Remove the connector seal from the inflator.
- Confirm the alignment of the harness connector as shown in the illustration, then connect the harness. The connector wires should lead toward the center mounting bracket on the airbag assembly.

- The connector should be connected **IMMEDIATELY** after removing the seal.
- The connector is one-way, once it is installed it **CANNOT** be removed.
- If the connector is installed in the incorrect orientation the terminals may be bent or the connector may not fully engage.

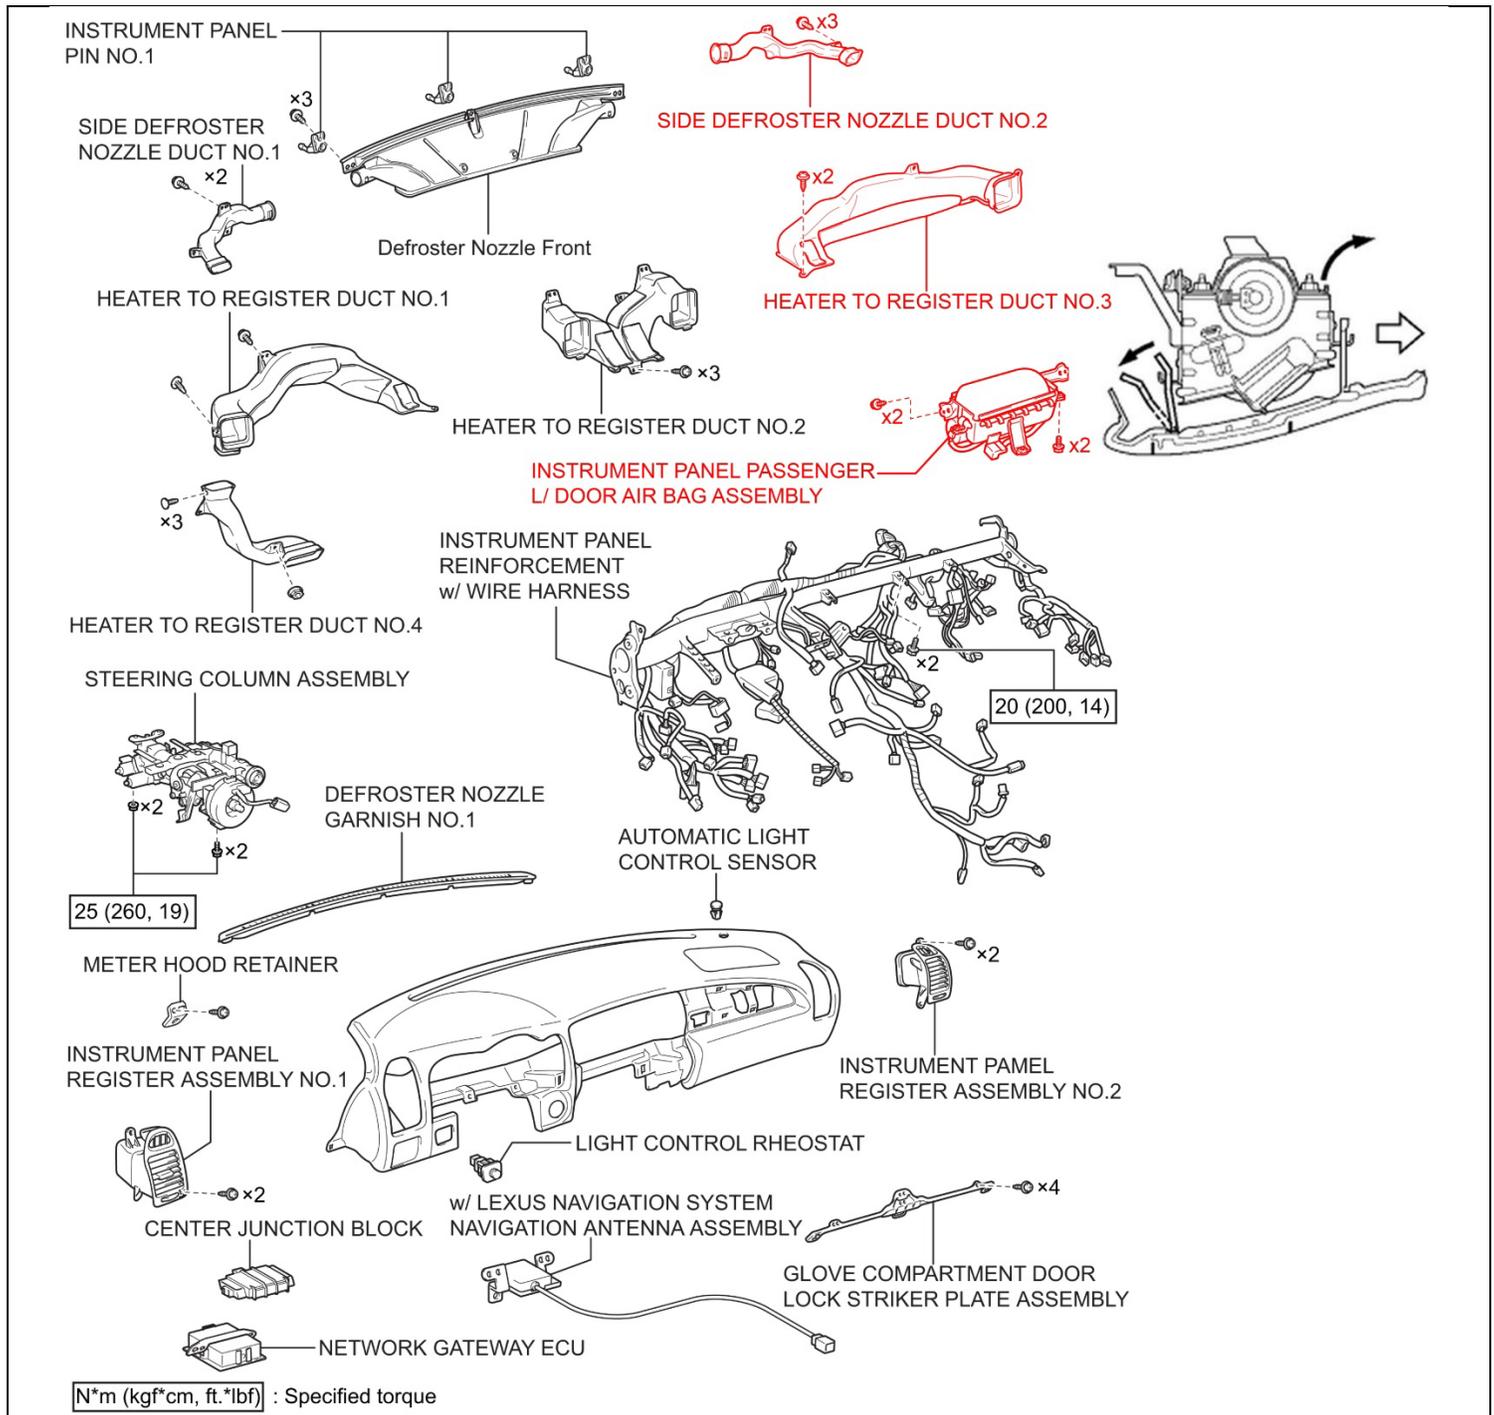
- Position the airbag assembly in the instrument panel, engage the straps, and then install the 4 bolts.
- Install the 2 screws and the heater to register duct.
- Install the 3 screws and the side defroster nozzle.

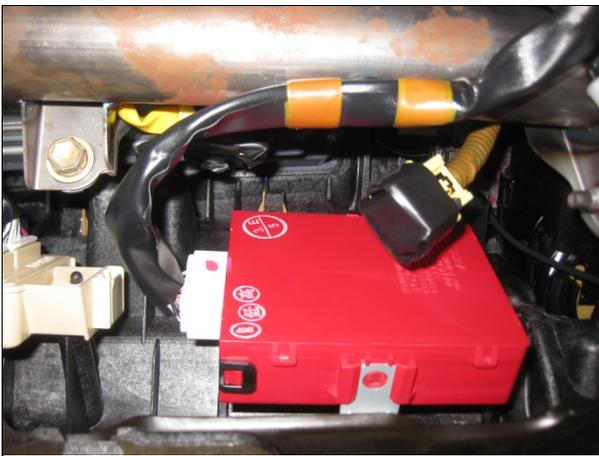
- a) Remove the two 10mm bolts
- b) Open the glove box door and remove the two screws.
- c) Slowly lower the glove box assembly down and remove all the electrical connectors.

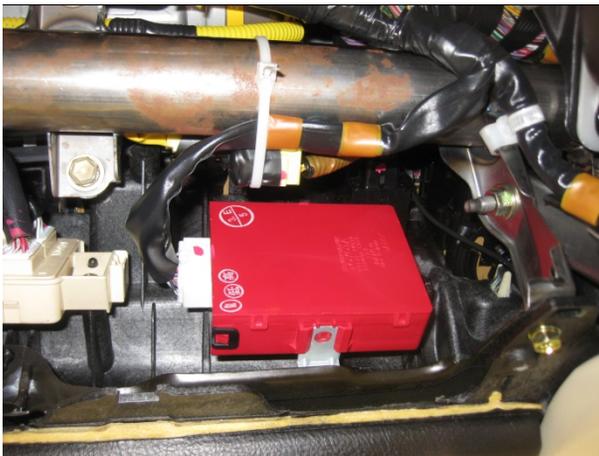
- a) Wrap SRS connectors in tape to protect them.

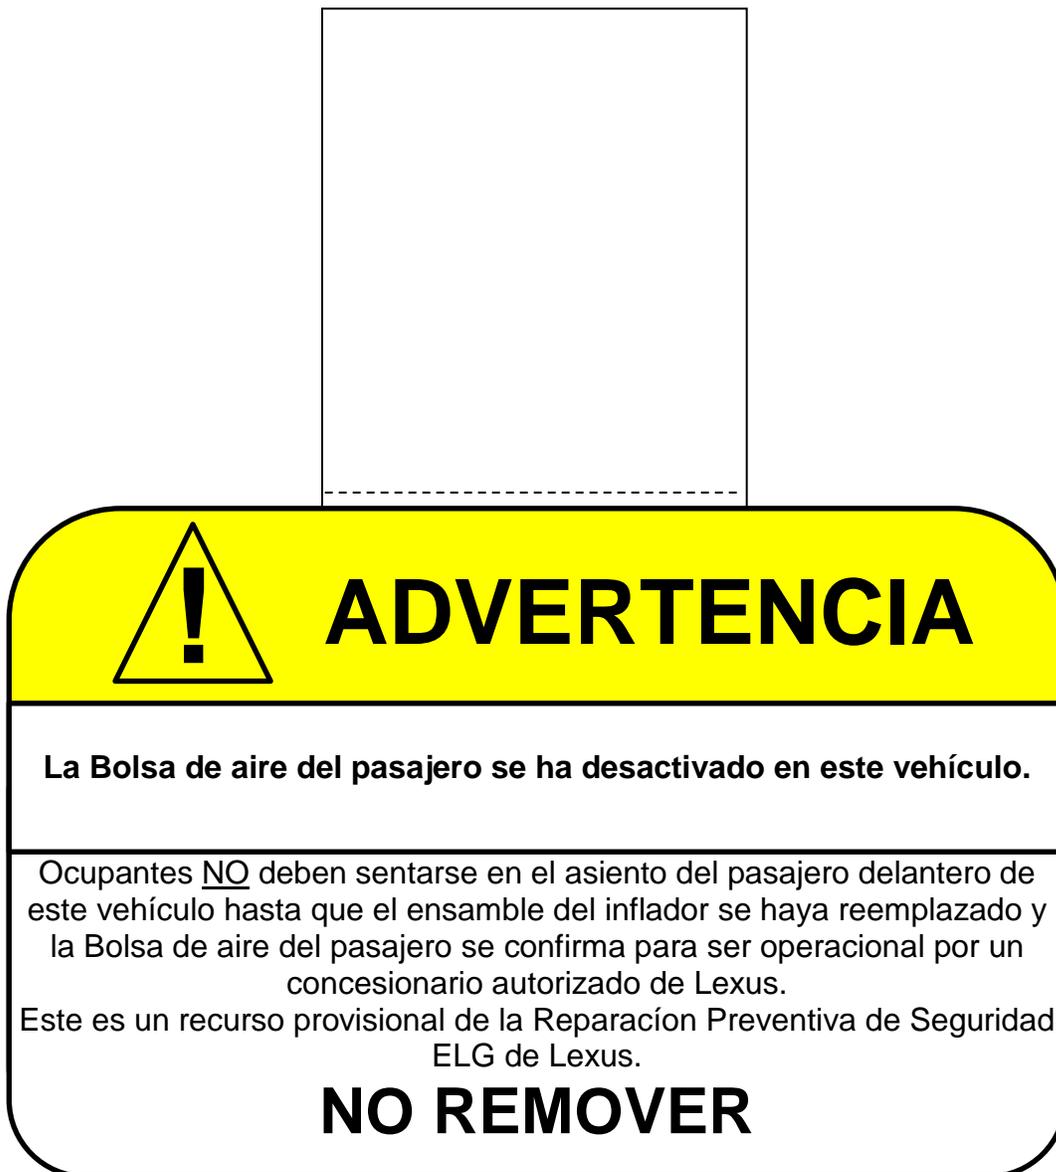
The image shows a warning sign for a deactivated passenger airbag. It features a yellow header with a black exclamation mark inside a triangle and the word "ADVERTENCIA" in bold black letters. Below the header, the text reads: "La Bolsa de aire del pasajero se ha desactivado en este vehículo." followed by a detailed warning: "Ocupantes NO deben sentarse en el asiento del pasajero delantero de este vehículo hasta que el ensamble del inflador se haya reemplazado y la Bolsa de aire del pasajero se confirma para ser operacional por un concesionario autorizado de Lexus. Este es un recurso provisional de la Reparación Preventiva de Seguridad ELG de Lexus." and finally "NO REMOVER" in large bold letters.
