TECHNICAL INSTRUCTIONS
FOR
SAFETY RECALL E0Z
CENTER PILLAR GARNISH INSPECTION
2014 MODEL YEAR TUNDRA

RELEASED SEPTEMBER 10, 2014

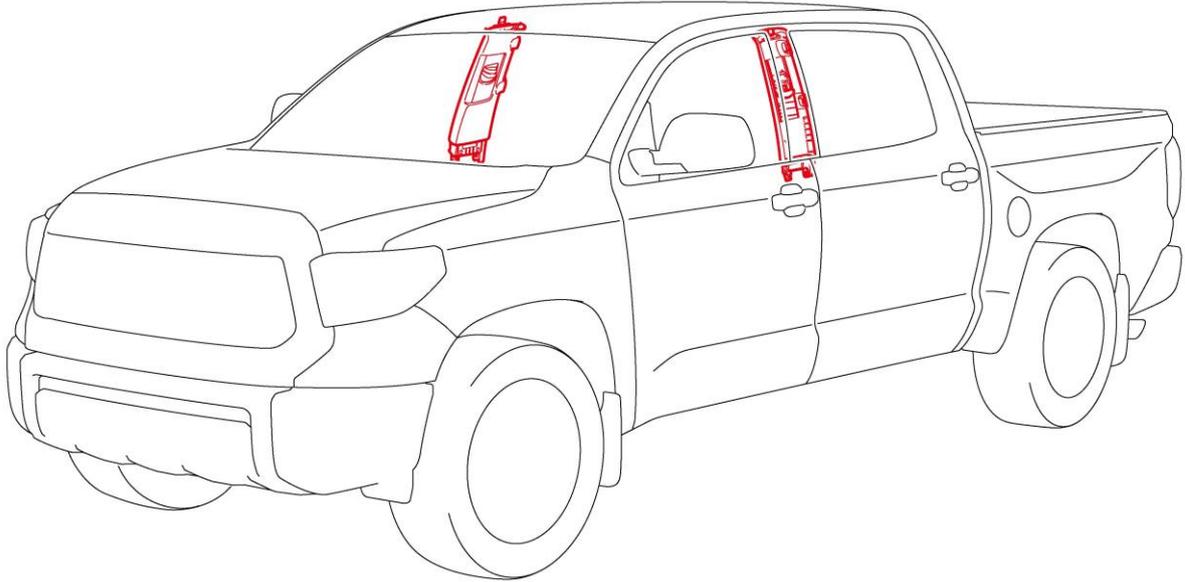
K1400460001

The subject vehicles are equipped with side Curtain-Shield-Airbags (CSA) which deploy from the roof rails in the event of certain types of collisions. Due to the possible mis-installation of a garnish on the center roof pillar, the garnish could interfere with the CSA and not allow it to achieve its intended inflated shape. In some situations, this could increase the risk of injury to an occupant in the event of a crash.

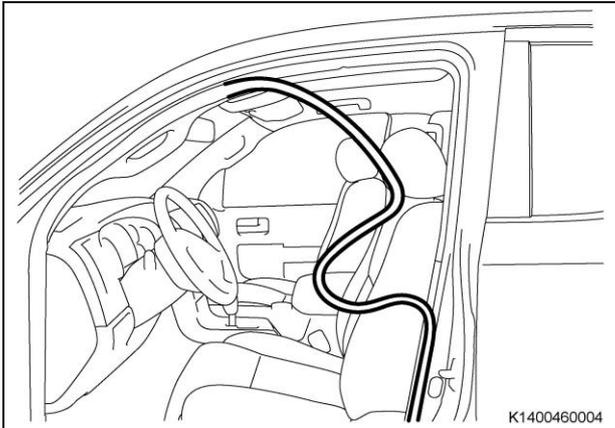
1. PULL WEATHERSTRIPPING AWAY FROM CENTER PILLAR

- a) Carefully pull away the the front door weatherstripping from the Center Pillar.

NOTE: The weatherstripping does not need to be completely removed from the vehicle.

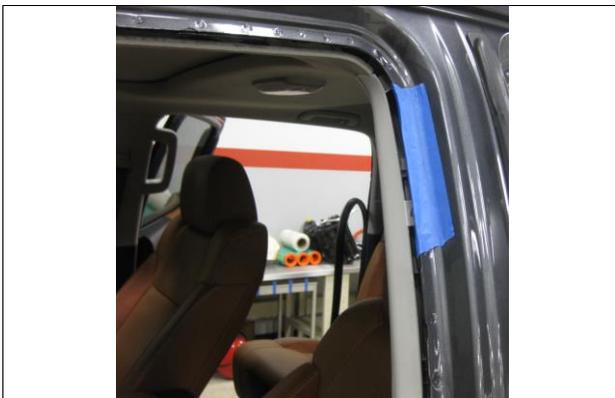
2. APPLY PROTECTIVE TAPE TO THE VEHICLE BODY

- a) Apply protective tape to the vehicle body as shown for the front doors to ensure the paint is not damaged during the inspection process.

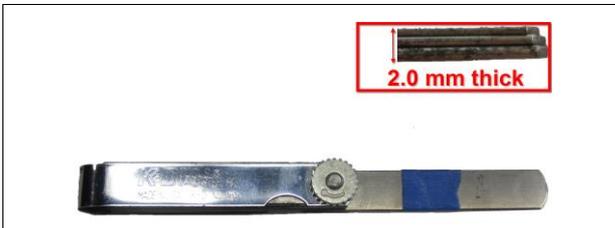
3. PREPARE THE FEELER GAUGE SET

- a) Stack feeler gauges so that they are 2.0 mm thick.
- b) Use tape to secure the feeler gauge blades together.

NOTE: It may be necessary to reorganize the feeler gauge blade stack to ensure that the feeler gauge blades have no gap between them.

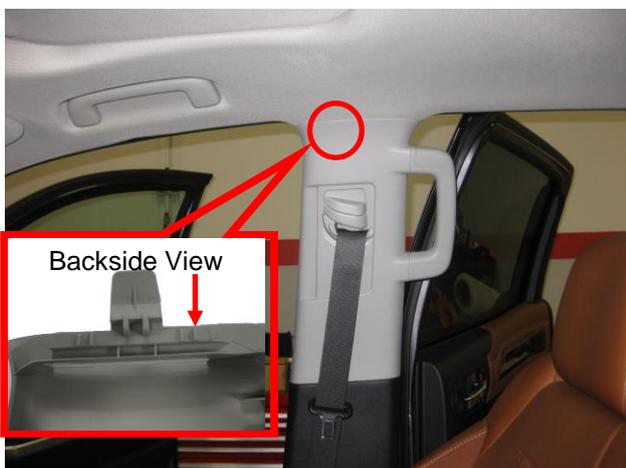
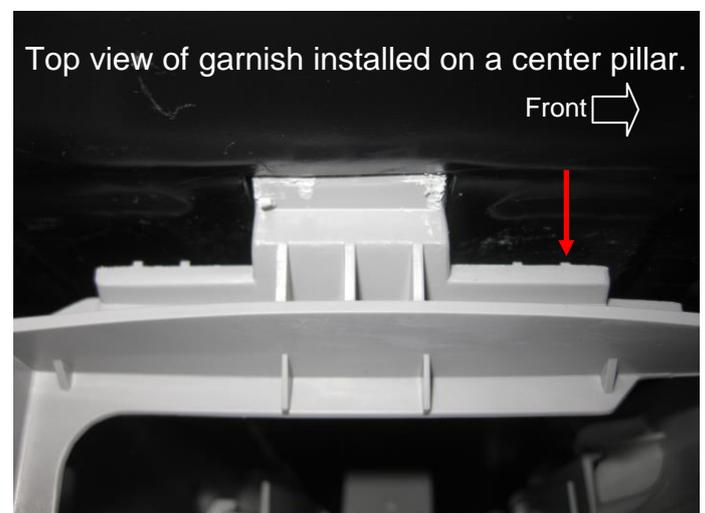
1. INSPECTION LOCATION FOR EACH CENTER PILLAR GARNISH

- a) When inspecting the garnish position, you will need to check the front upper reinforcement rib only from the front door on each side of the vehicle.

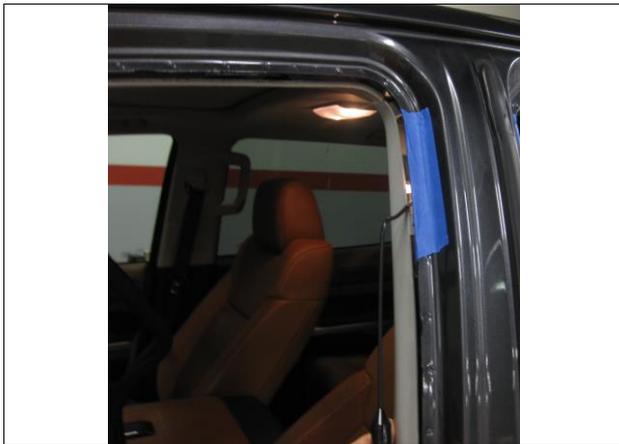
2. CHECK THE GAP BETWEEN THE BODY STRUCTURE AND THE CENTER PILLAR TAB FRONT REINFORCEMENT RIB

a) Using a small flashlight or pen light illuminate the back side of the garnish so you can locate the reinforcement ribs.

- b) From the front door check the clearance between the Center Pillar Garnish Tab Front Reinforcement Rib and the body structure using the feeler gauge.
- c) Repeat the inspection on the other side of the vehicle.

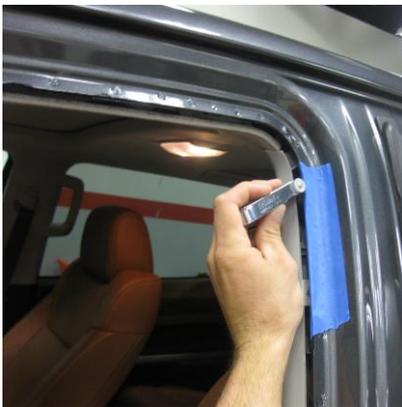
You must check the gap between the front rib and the body structure; ensure that you are measuring at the correct location as shown.

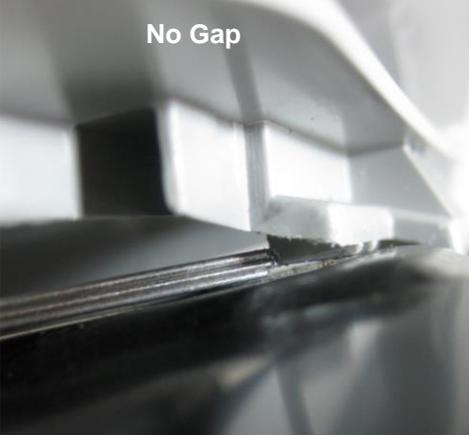
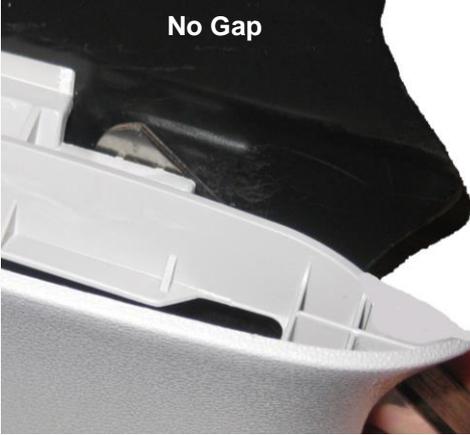
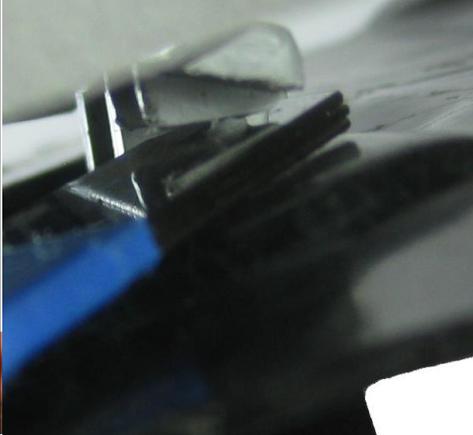
Below are pictures of Good and NG conditions. Each position checked on the Center Pillar Garnish must pass the criteria below.

Good Condition (Extreme Close Up) (Feeler Gauge Interferes with ribs)	Good Condition (Feeler Gauge fits with tension)	NG Condition (Extreme Close Up) (Feeler Fits Loosely)
<p>No Gap</p>

<p>No Gap</p>

Good Condition: Reinstall weatherstripping and return the vehicle to the customer.

NG Condition: Proceed to section VI for garnish replacement.

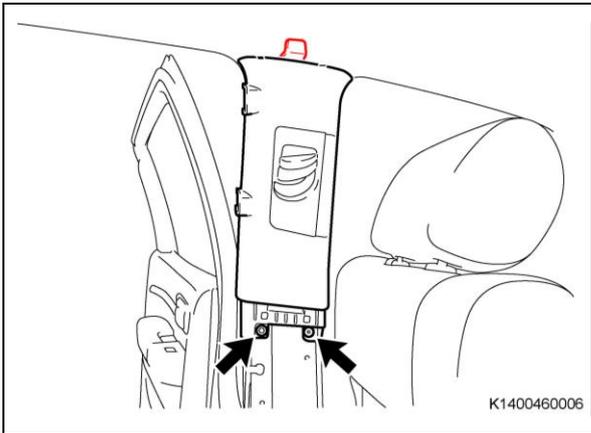
6. REMOVE THE CENTER PILLAR GARNISH

- a) Remove the bolt at the bottom of the center pillar garnish.
- b) Disengage the clip at the bottom of the center pillar garnish.

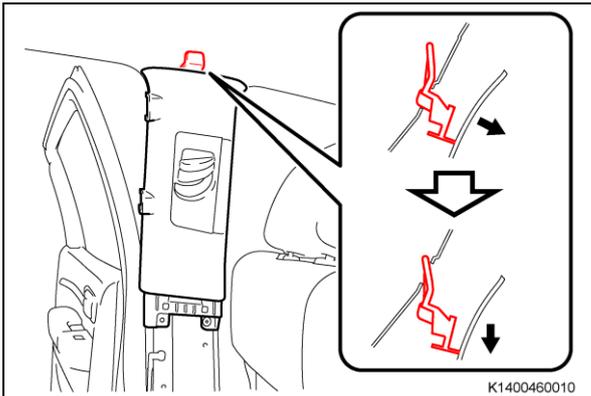
- c) Disengage the claw at the top of the center pillar garnish by pressing up and in at the top of the garnish while pulling the bottom of the garnish outward. This will give the tab reinforcement ribs clearance when being removed from the center pillar body structure.

Note: Mark the old garnish so it will not be reused.

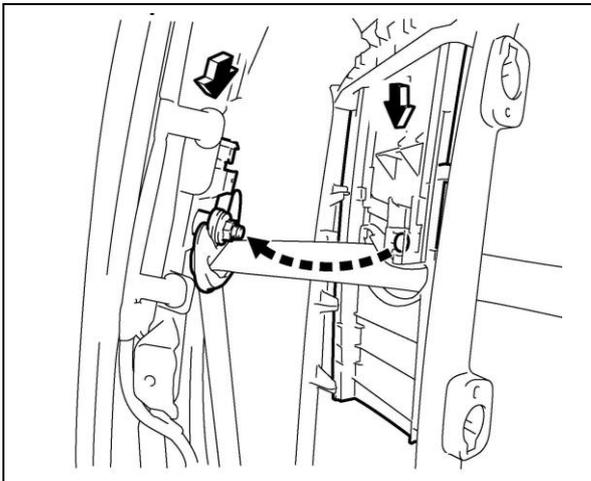
7. INSTALL THE CENTER PILLAR GARNISH

- a) Move the seat belt shoulder position to the lowest position on the vehicle and the center pillar garnish.
- b) Pass the front seat outer belt floor anchor through the center pillar garnish.
NOTE: Do not twist the seat belt.
- c) Temporarily reinstall the seat belt anchor at the base of the center pillar. This will help minimize the chance of the seat belt latch sliding back through the slot in the garnish.

NOTE: Make sure that the garnish and the belt fit correctly by doing so.

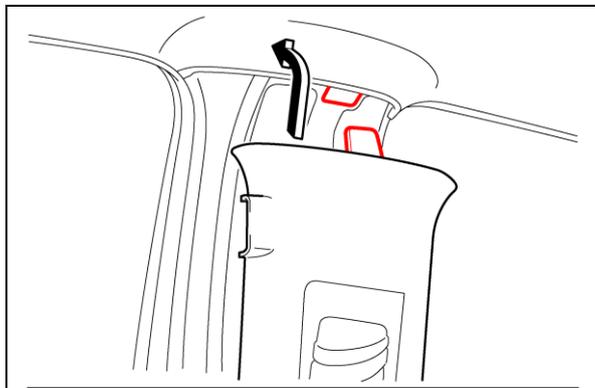
- d) Insert the claw at the top of a new center pillar garnish into a hole of the body by angling the garnish and pressing upward to compress the headliner. Push in at the top of the garnish to ensure that the claw is fully engaged.

Make sure that the claw is inserted into the hole completely.

- e) Engage the clip at the bottom of the center pillar garnish.

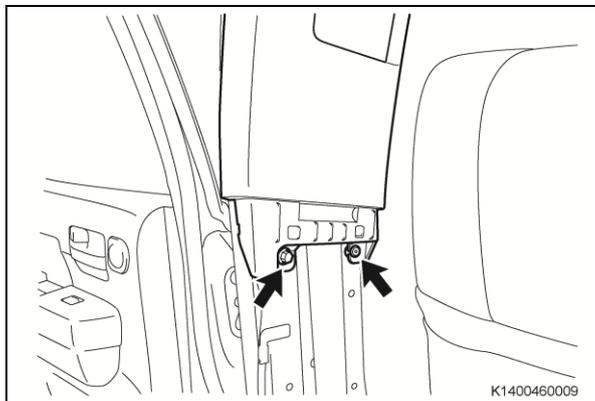
K1400460009

- a) Attach a bolt at the bottom of the center pillar garnish.

Torque: 5.5 N*m (56 kgf*cm, 49 in.*lbf)

- b) Reinstall the assist grip.

Torque: 12 N*m (122 kgf*cm, 9 ft.*lbf)

NOTE: Make sure that the claw of a cap is not protruded from the seating surface for mounting the assist grip.
