**SUBJECT:** Safety Recall Campaign "XC";  
Daytime Running Light (DRL) Module Overheating

**MODEL(S):** Verona (RP625)

**YEAR:** 2004~2006

**Daytime Running Light (DRL) Module Replacement**

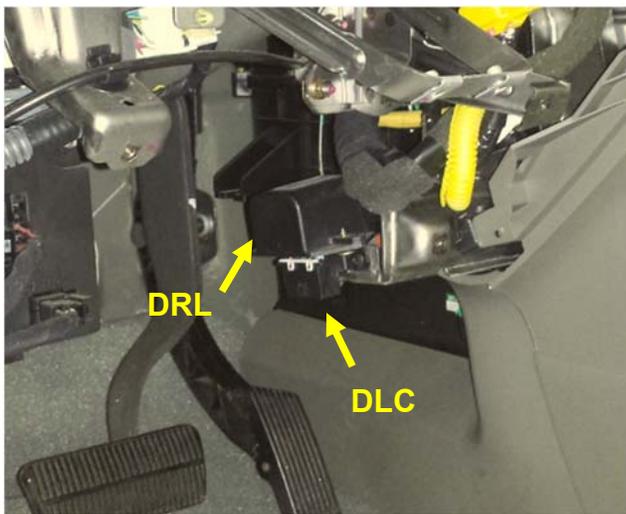
Above the DLC  
(Manual A/C Control)

1. Record the radio presets then turn the ignition switch to the LOCK position and remove the key.
2. Disconnect the battery negative (-) cable and wait at least 90 seconds for the Supplemental Restraint System (SRS) to discharge before proceeding.
3. The location of the DRL module will be in one of two places:
  - a) With Auto A/C Controls: Behind the ash tray assembly and below the radio. Go to step 4.
  - or
  - b) With Manual A/C Controls: Above the Data Link Connector (DLC). Go to Step 9.

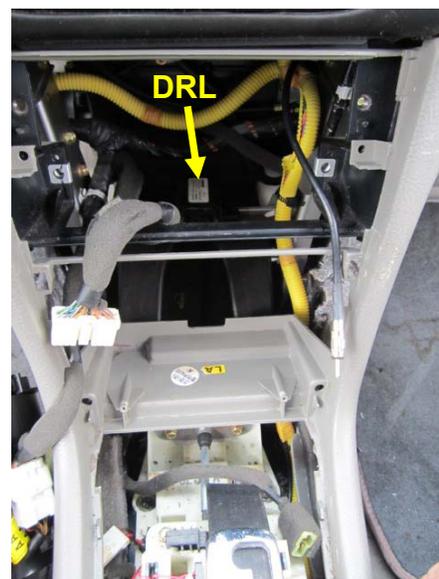
Behind the Ash Tray Assembly  
(Auto A/C Control)

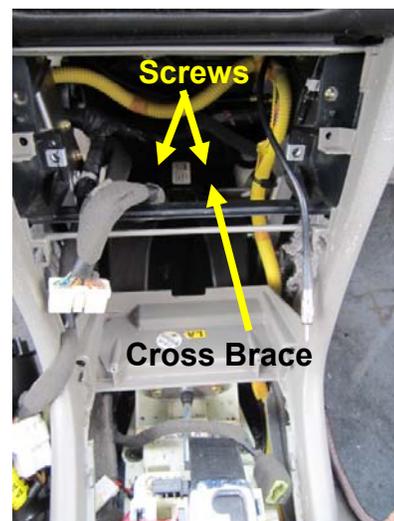
The screws are accessible from the underside of the cross brace.

7. Remove the two screws holding the DRL module in place and disconnect it from its electrical connector.
