| REFERENCE: | Nova Bus Manuals |
| RS N°: | MQR 7621-815 |
| NHTSA RECALL N°: | 14V-381 |

| SUBJECT: | Angled alternator cable terminal |

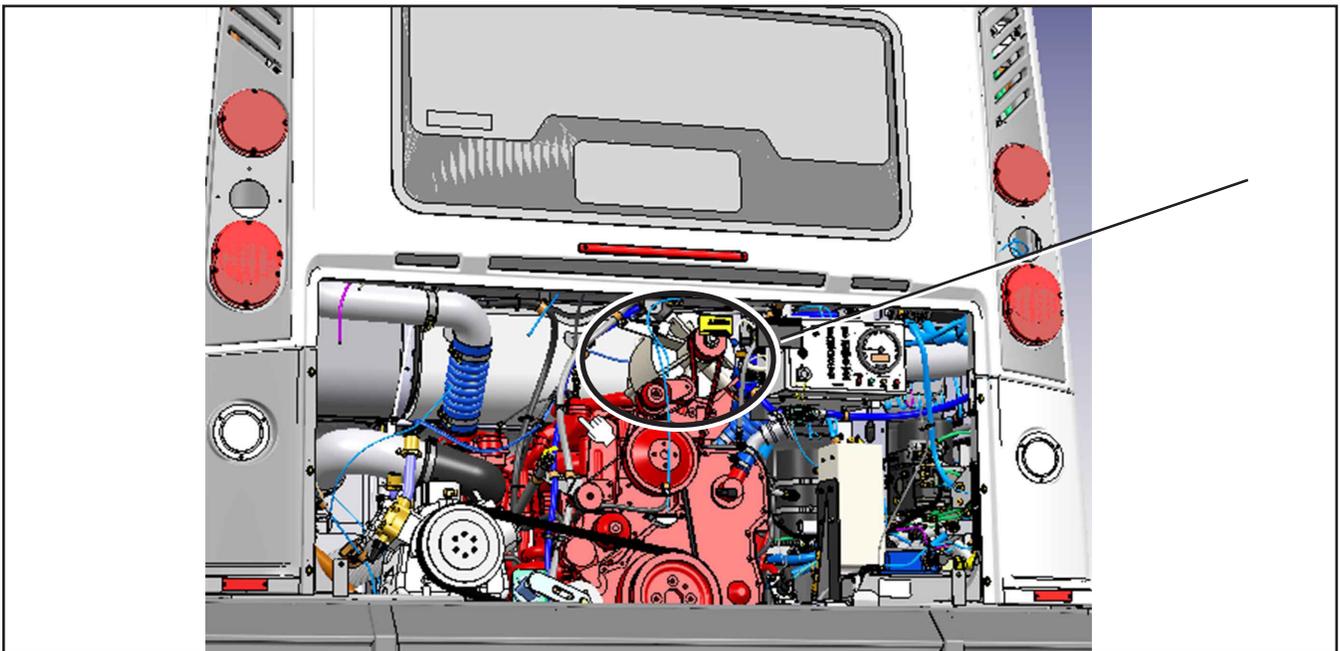
Figure 1 - Alternator Cable Location

- 1.1. Open the rear engine access door and remove the belt guard. Retain the hardware.
- 1.2. Open the engine access panel of the five place seat, inside at the rear of the vehicle. Retain the hardware.
- 1.3. Locate the angled alternator cable terminal . Push up the red boot to free the terminal. Retain the red boot. Remove the existing angled alternator cable terminal. Retain the hardware.

- 1.4. Remove the alternator cable. Retain the hardware.
- 1.5. Install the new angled alternator cable terminal, following the specified routing. Ensure that there is no contact with the surrounding components.
- 1.6. Connect the cable to the alternator as shown in correct alternator cable images.

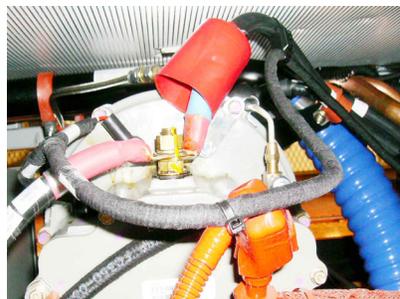
Figure 2 - Correct Alternator Cable Routing

Cable routing

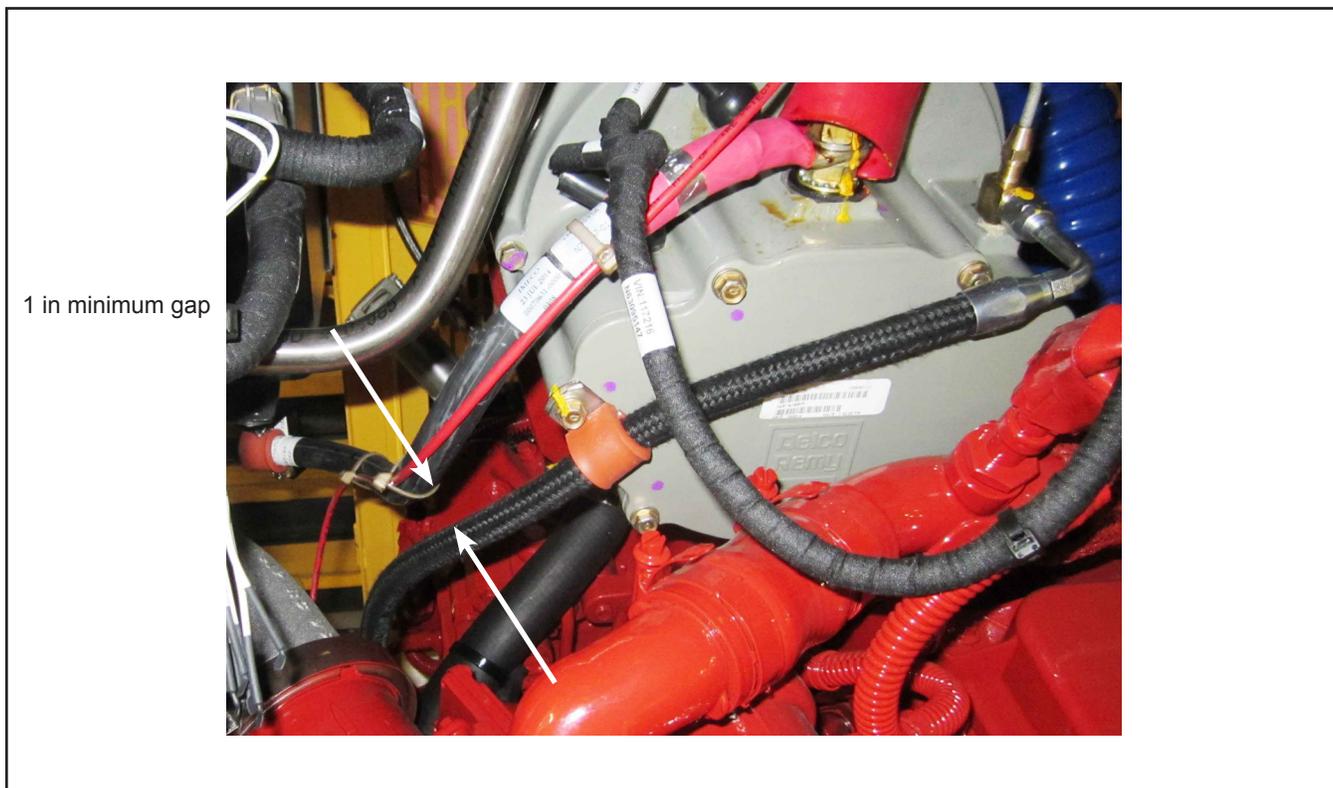
Figure 3 - Flat Terminal Alternator Cable Routing

- 1.7. If electric fans are installed, when performing the installation, ensure that the flat cable terminal is not in contact with the alternator oil flexible hose.

- 1.8. Tighten to the specified torque.
- 1.9. Route the cable to the engine cradle cable connector.
