REFERENCE:	Nova Bus Manuals
SECTION:	09 alternator and voltage regulator
RS N°:	MQR 7621-815
EFFECTIVE IN PROD.:	L777-63 (2014 Au)
TC RECALL N°:	2014-263
NHTSA RECALL N°:	14-381

SUBJECT:	Angled alternator cable terminal
JUSTIFICATION:	The positive alternator cable terminal may have been damaged during installation. As a result, the terminal may fracture and allow the cable to arc to other components, which may result in an engine compartment fire.

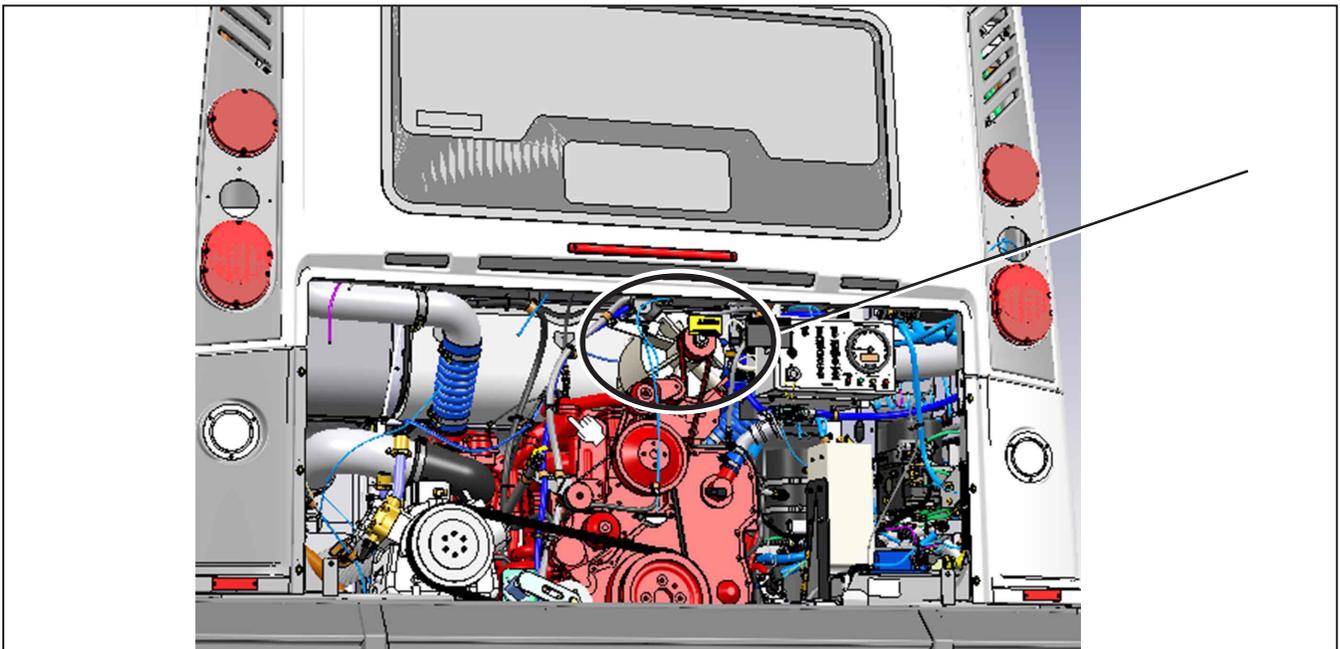
Figure 1 - Alternator Cable Location

- 1.1. Open the rear engine access door and remove the belt guard. Retain the hardware.
- 1.2. Open the engine access panel of the five place seat, inside at the rear of the vehicle. Retain the hardware.
- 1.3. Locate the angled alternator cable terminal . Push up the red boot to free the terminal. . Remove the existing angled alternator cable terminal. Retain the hardware.

- 1.4. Remove the alternator cable. Retain the hardware.
- 1.5. Install the new angled alternator cable terminal, following the specified routing. Ensure that there is no contact with the surrounding components.
- 1.6. Connect the cable to the alternator as shown in correct alternator cable images.

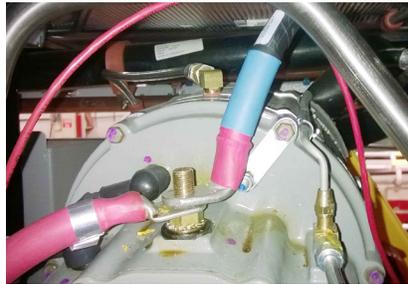
Figure 2 - Flat Terminal Alternator Cable Routing

Install angled terminal with no stress or tension

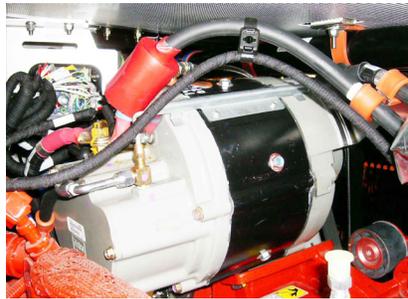
Correct terminal and cable installation

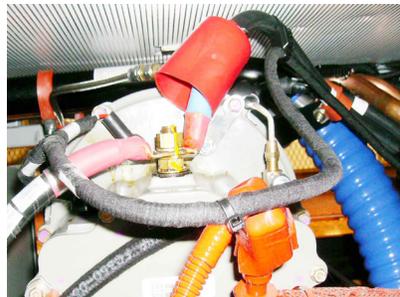
Cable routing

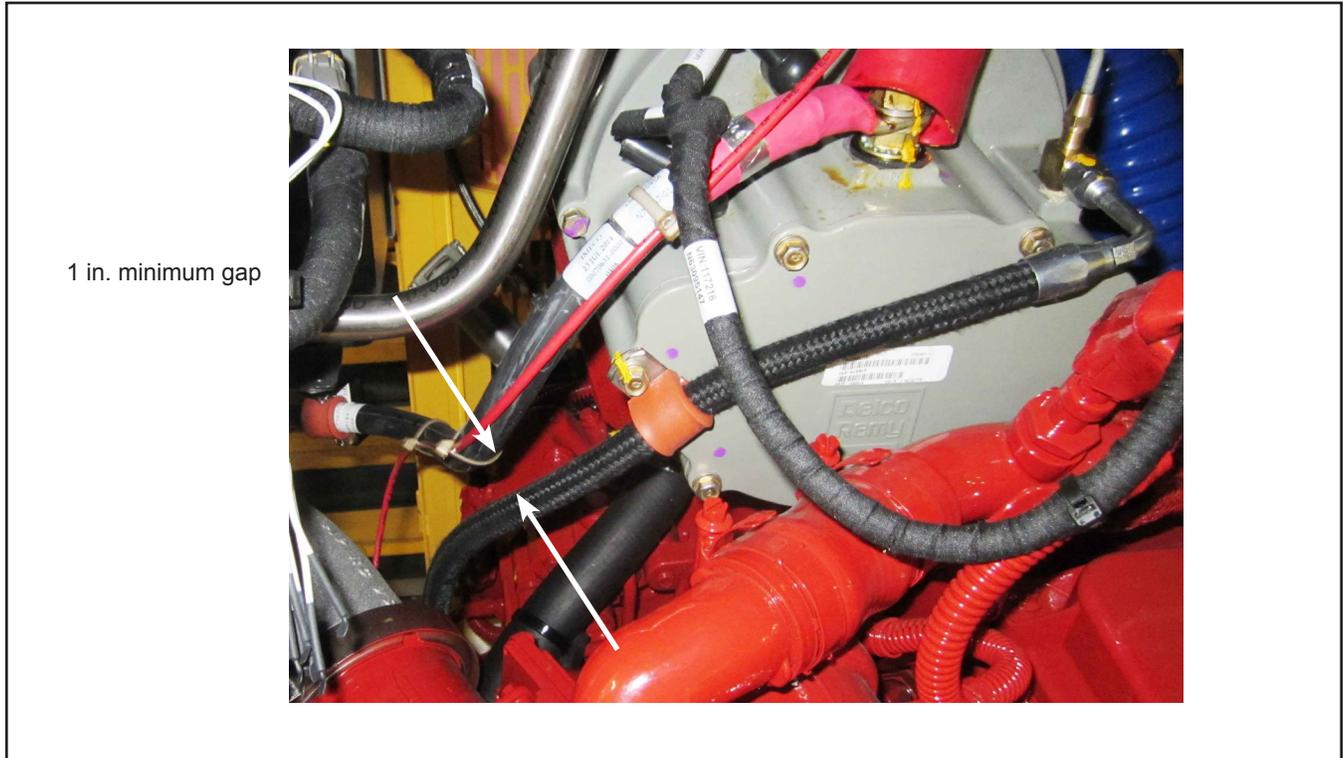
Figure 3 - Correct Alternator Cable Routing

- 1.7. If electric fans are installed, when performing the installation, ensure that the flat cable terminal is not in contact with the alternator oil flexible hose.

- 1.8. Tighten to the specified torque.
- 1.9. Route the cable to the engine cradle cable connector.
