TECHNICAL INSTRUCTIONS FOR SAFETY RECALL E04 FRONT PASSENGER AIRBAG INFLATOR MODULE CERTAIN 2002 –2005 MODEL YEAR SEQUOIA

Updated 01-07-2015

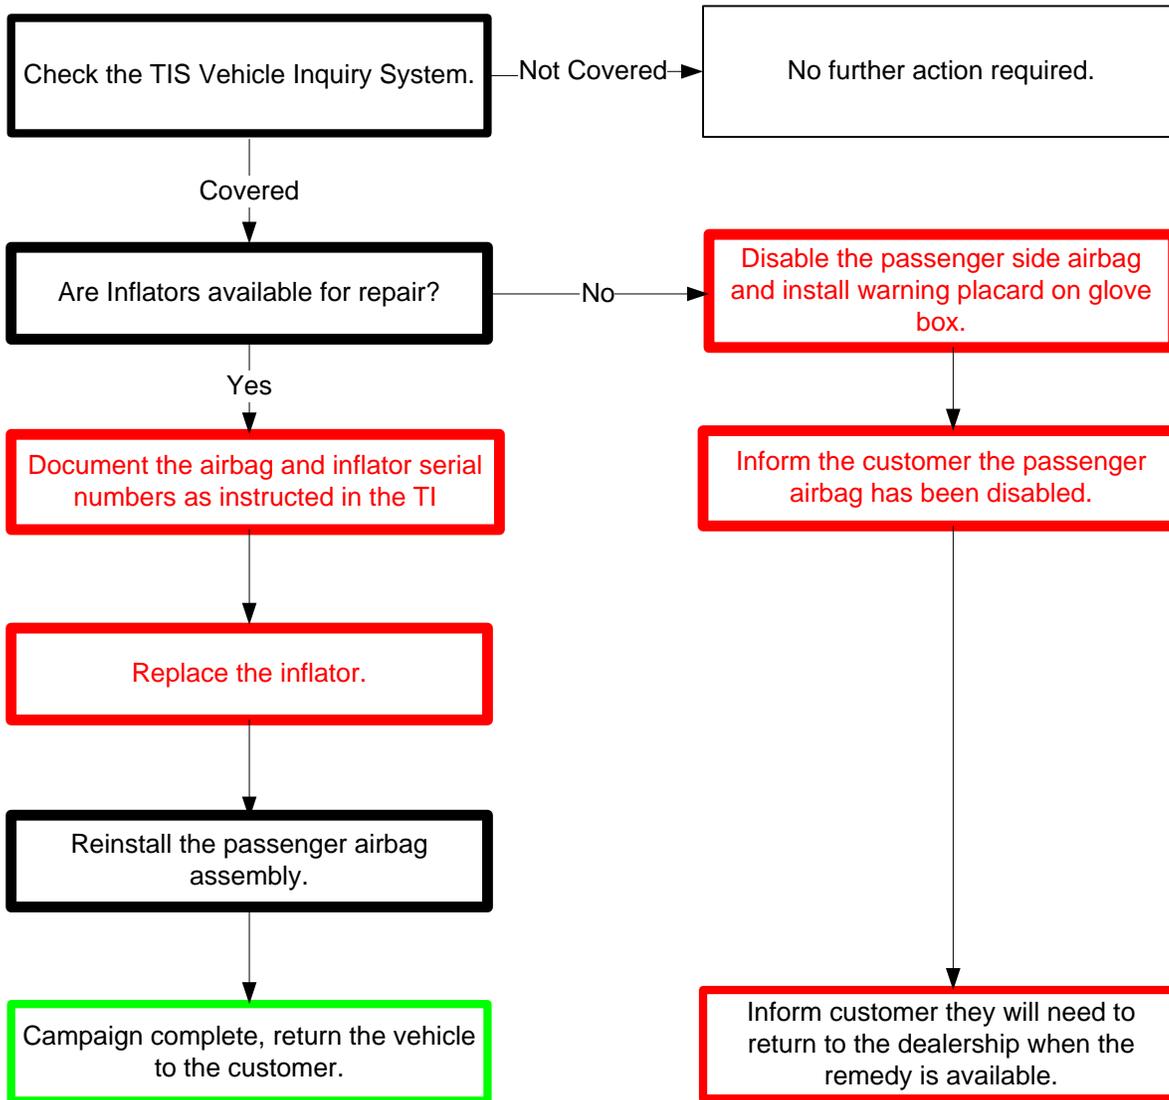
I. OPERATION FLOW CHART

The flow chart is for reference only. **DO NOT** use it in place of the full technical instructions. Follow **ALL** steps as outlined in the full technical instructions to confirm the campaign is completed correctly.

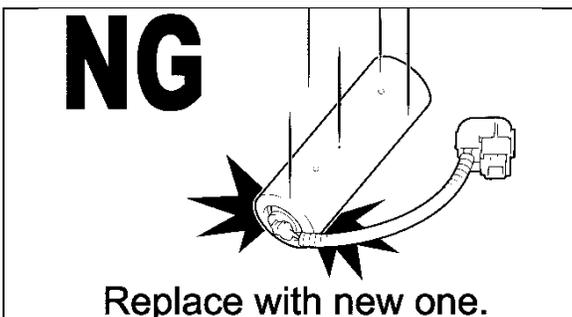
2. DO NOT MEASURE RESISTANCE

- a) **DO NOT** measure resistance of airbag components, this may cause accidental activation.

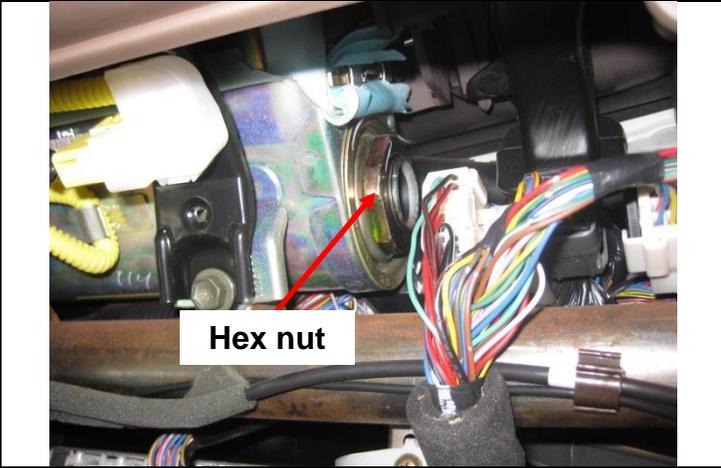
2. INSPECT INFLATOR TYPE

- a) Inspect the inflator to determine if it has a large nut on the right side as shown.

NO: Proceed to section VIII.

YES: The vehicle is **NOT INVOLVED** in the Safety Recall.

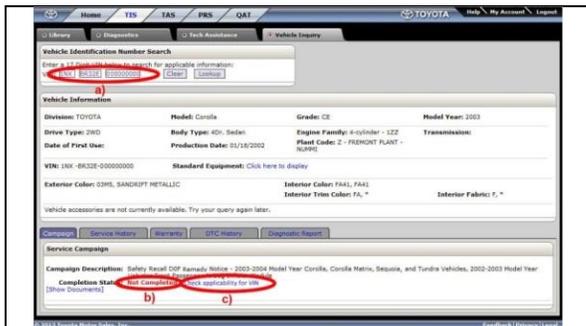
- The **AIRBAG ASSEMBLY, ORIGINAL INFLATOR, and NEW INFLATOR** serial numbers **MUST** be recorded using the barcode scanner (provided at the launch of SSC D0F).
- The barcode scanner application **MUST** be completed on every vehicle. These numbers **MUST** be included on every warranty claim that is submitted for inflator module replacement or the claim may be subject to debit.
- The technician performing the work **MUST** have valid TIS login credentials and an internet connection to perform the inspection and scanning process.

- a) Log in to TIS and input the VIN of the vehicle in the Vehicle Inquiry tab.
- b) Confirm the VIN is applicable and that the campaign has not been completed.
- c) Click on the link to launch the serial number recording application.

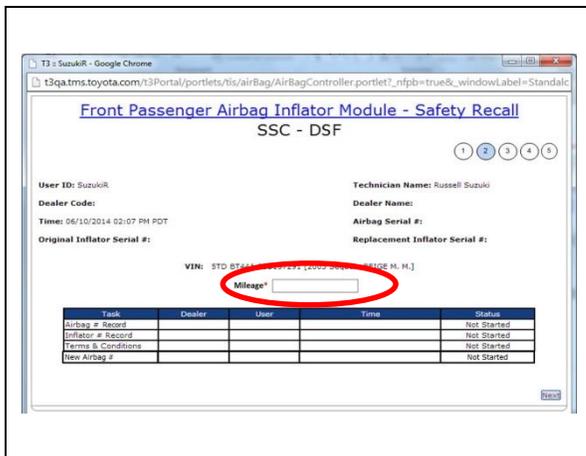
d) Reenter TIS password in the serial number recording application.

NOTE: The person logged-in to TIS MUST be the person performing the repair.

e) Record the vehicle mileage into the serial number recording application.

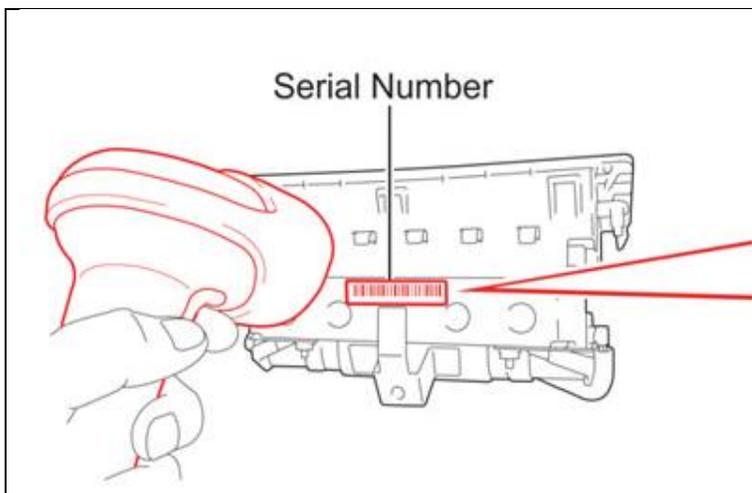
Airbag Serial Number Label Example

- The airbag serial number is **ALWAYS** the 12 **DIGITS** located between the asterisks.
- The 3 digits before the asterisk **ARE NOT** part of the serial number, and **SHOULD NOT** be entered or an inaccurate response may be returned.

The **AIRBAG ASSEMBLY** serial number and the **INFLATOR** serial number are **DIFFERENT**. The **AIRBAG ASSEMBLY** serial number **MUST** be recorded prior to replacement.

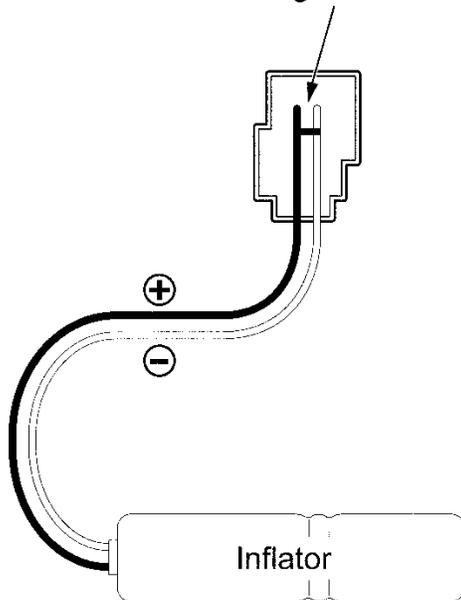
(1)

The connector of the inflator module contains a short circuiting mechanism to eliminate voltage variances when the connector(1) is disconnected. To allow for the replacement of the inflator module, a new short circuit(2) **MUST** be created before cutting the wires(3) and removing the inflator. The following steps **MUST** be followed exactly as described to ensure the work is completed correctly and safely.

Short circuiting on both sides.

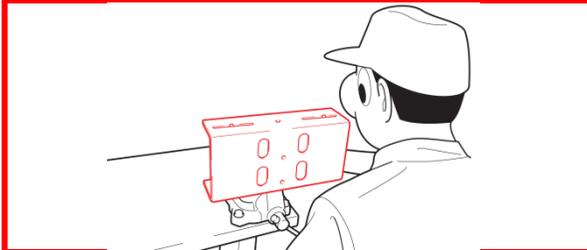
CRITICAL INFORMATION – READ THOROUGHLY

ALWAYS keep as much of your body as possible in front of the bracket when working on the airbag assembly.

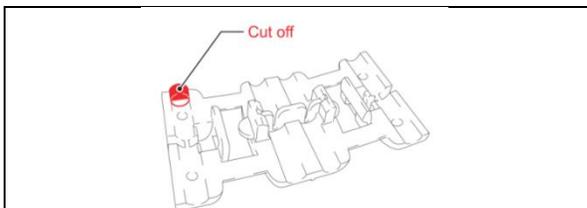
- b) Cut off the tab of the electro tap shown in the illustration.

This tab **MUST** be removed to ensure a good short.

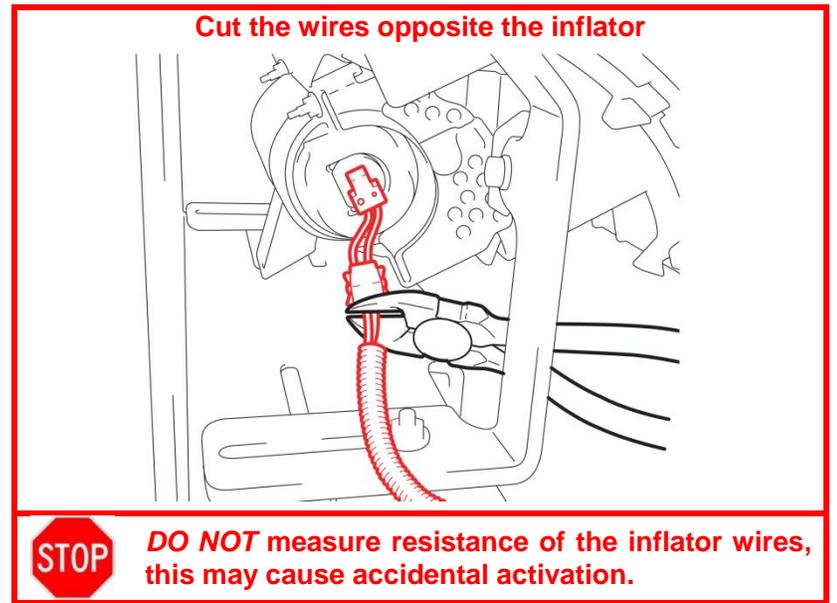
4. CUT THE INFLATOR WIRES

- a) Cut the 2 wires at the side of the electro tap that is farthest away from the inflator.

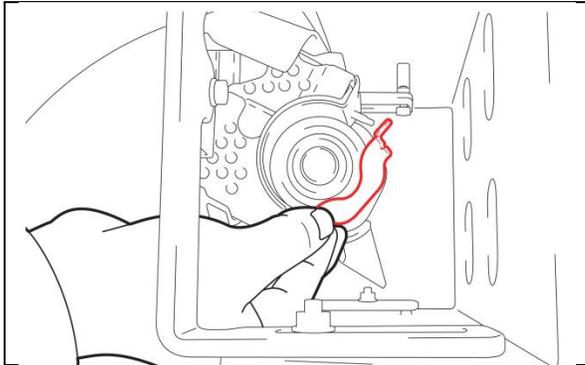
b) Remove the stopper plate and place in a secure location because it will be reused.

STOP **DO NOT** discard the Stopper Plate, it will be reused.

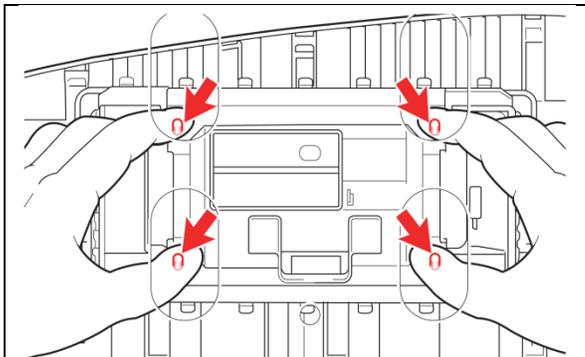
6. REMOVE THE INFLATOR

a) Gently push in the 4 studs to loosen the inflator for removal.

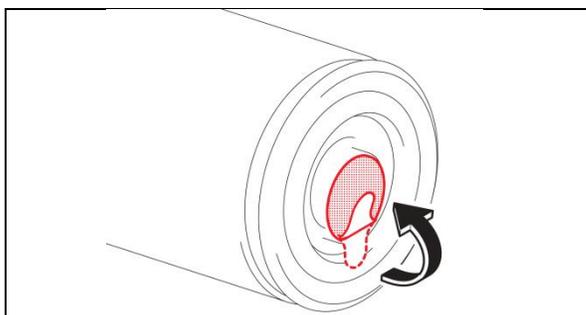
8. FOLD THE CONNECTOR SEAL

- Fold the seal in order to prevent it from being caught under the airbag assembly bracket in the next step.

NOTE: DO NOT fully remove the seal until just before connecting the harness.

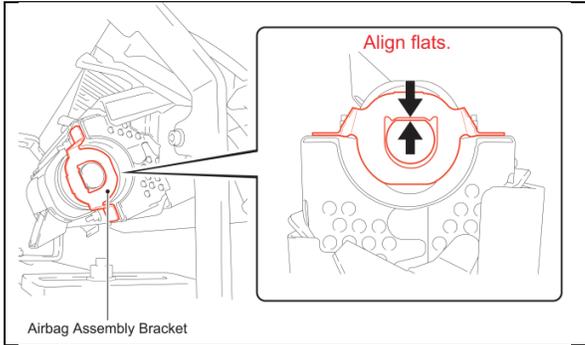
10. CONFIRM THE INFLATOR ALIGNMENT

- a) Align the flat on the inflator with the flat on the airbag assembly bracket.

Confirm the flats on the airbag assembly and inflator are aligned.

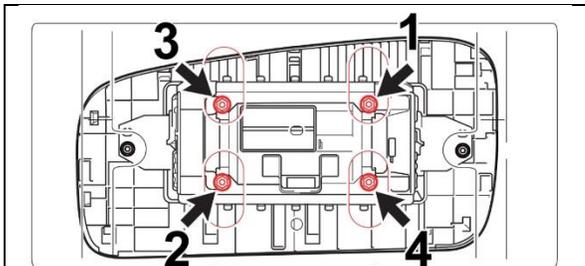
12. TORQUE THE PLATE NUTS

- a) Tighten the nuts evenly in two increments following the sequence shown in the illustration. Use a socket driver or torque wrench to tighten the nuts.

- There will be some resistance when tightening the nuts because they are self-locking, confirm the nuts are tightened correctly.
- **DO NOT** use a power tool, T-handle, or ratchet when tightening the nuts to avoid over torqueing.

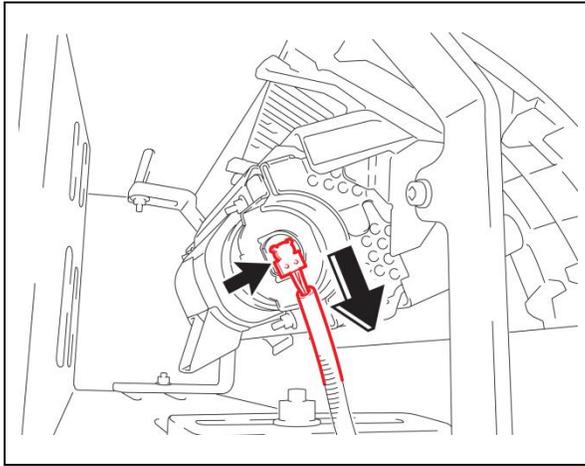
13. CONNECT THE INFLATOR CONNECTOR

- a) Remove the connector seal from the inflator.
- b) Confirm the alignment of the harness connector as shown in the illustration, then connect the harness. The connector wires should lead downward toward the center airbag mounting bracket.

- The connector should be connected **IMMEDIATELY** after removing the seal.
- The connector is one-way, once it is installed it **CANNOT** be removed.
- If the connector is installed in the incorrect orientation the terminals may be bent or the connector may not fully engage.

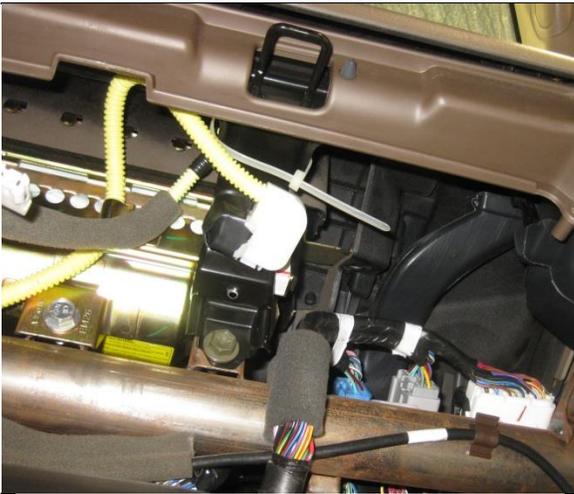
- d) Tie-wrap the SRS connector to the upper portion of the glove box latch bracket as shown to prevent the wire harness from creating a rattle.
