**HYUNDAI**NEW THINKING.
NEW POSSIBILITIES.**Technical Service Bulletin**

15-01-008

See Below**SUBJECT: STOP LAMP SWITCH REPLACEMENT (RECALL 110)**

Description: This bulletin describes the procedure to replace the stop lamp switch.

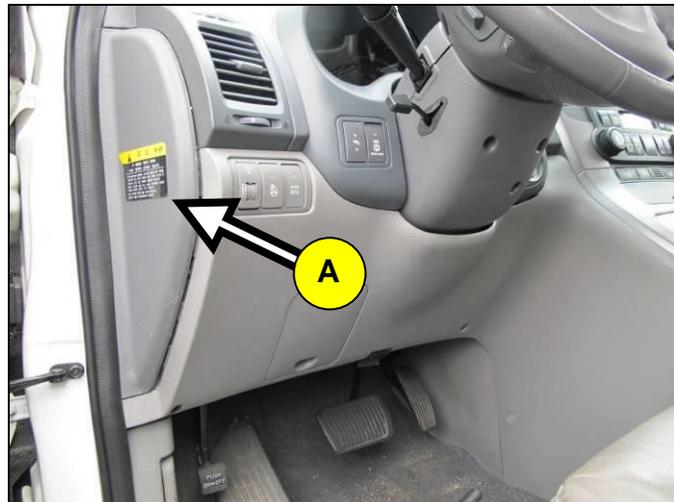
1. Disconnect the battery negative (-) terminal.
2. Remove the left hand side cover (A).

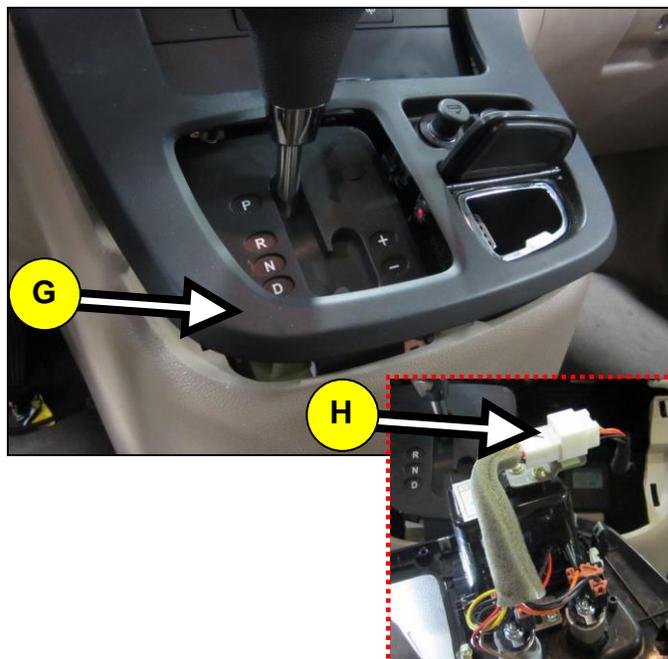
5. Using a plastic trim tool, carefully pry up and remove the upper cover (G) surrounding the shift lever. Disconnect the cigarette lighter and power outlet (H). Set aside the cover.
