April 14, 2015

42306-01678

Safety Recall: Driver's Airbag Inflator Can Be Over-Pressurized

Supersedes 09-033, dated September 26, 2014; to revise the information highlighted in **yellow**

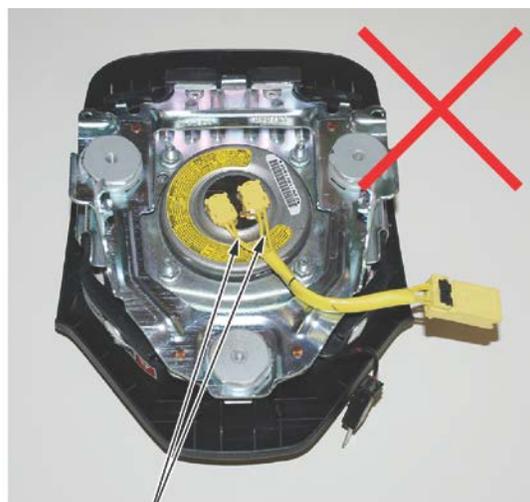
4. Visually inspect the airbag and the inflator for any unusual writing or markings.

- If there is nothing unusual about the airbag or the inflator, go to step 5.
- If there are any unusual markings, like an incorrect label or a model year written in marker, the airbag and inflator may not be the correct airbag and/or inflator for the vehicle or it may be a counterfeit part. For more information about counterfeit airbags, you can refer to safecar.gov, enter keywords **MANAGING COUNTERFEIT**, and select **Recommended Dealer Guidance for Managing Counterfeit Air Bags** from the list. **If you suspect that the airbag or inflator is counterfeit, do not continue this procedure.** Contact your DPSM for assistance.

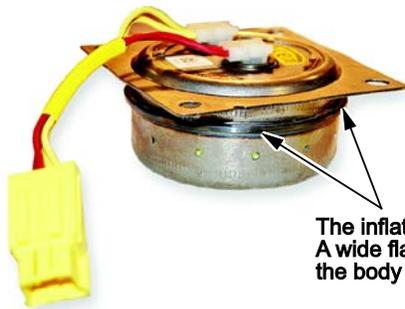
04770-S5A-405

Refer to **Driver's Inflator Type 2** in the video.

The inflator is one piece.
A wide flange is halfway up
the body of the inflator.
