ATB 51811-01830 Version 7

Safety Recall: Front Passenger's Airbag Inflator Can Be Over-Pressurized

Supersedes 14-040, dated December 11, 2014, to revise the information highlighted in **yellow**

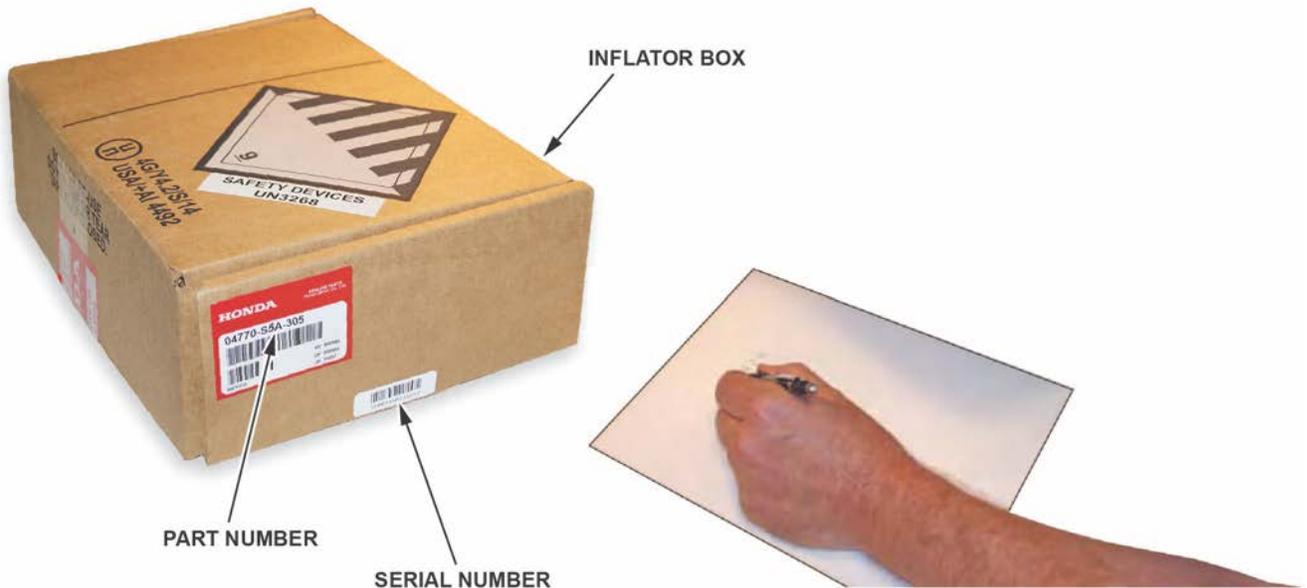
1. Write down the serial number located on the right side of the new inflator box. For the warranty claim to be paid, the **replacement inflator part number that you received** must be on the warranty claim and your warranty clerk must enter the serial number in the Diagnostic Trouble Codes field.

NOTE: Make sure you give the warranty clerk the part number of the inflator you received, not the part number that was ordered.

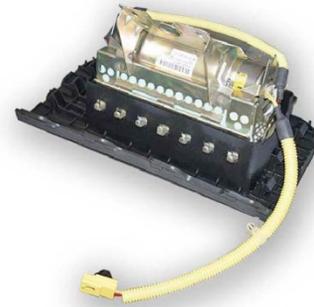
PILOT

3. Place the airbag face-down on a clean shop towel as shown.

- The orientation of the airbag is critical because if the inflator is installed incorrectly, the harness will be too short when you reinstall the airbag.
- The brackets between the various models are similar but may differ from the example shown in the procedure.

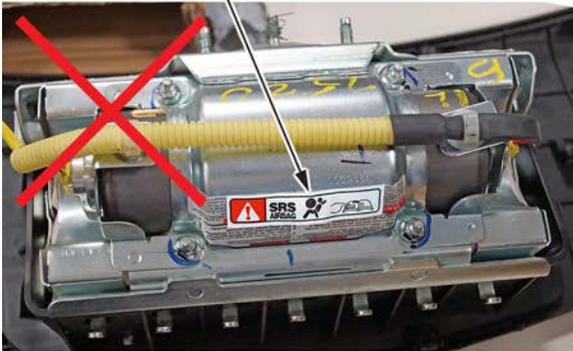
NON-STANDARD SAFETY LABEL

4. Visually inspect the airbag and the inflator for any unusual writing or markings.

- If there is nothing unusual about the airbag or the inflator, go to step 5.
- If there are any unusual markings, like an incorrect label or a model year written in marker, the airbag and inflator may not be the correct airbag and/or inflator for the vehicle or it may be a counterfeit part. For more information about counterfeit airbags, you can refer to safercar.gov, enter keywords **MANAGING COUNTERFEIT**, and select **Recommended Dealer Guidance for Managing Counterfeit Air Bags** from the list. **If you suspect that the airbag or inflator is counterfeit, do not continue this procedure.** Contact your DPSM for assistance.

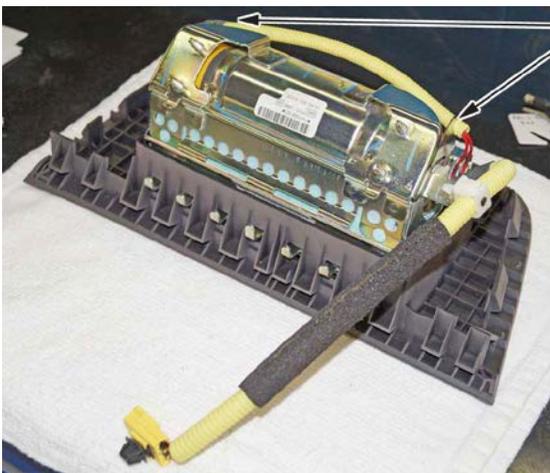
INFLATOR BRACKETS

5. Remove the harness from both ends of the inflator bracket.

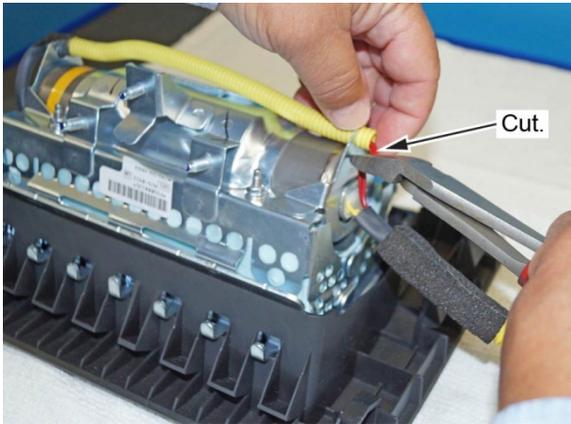
6. Short the red wires.

NOTE: **You must cut and short the wires** as indicated to prevent any accidental deployment.

- Cut the red wires as shown.

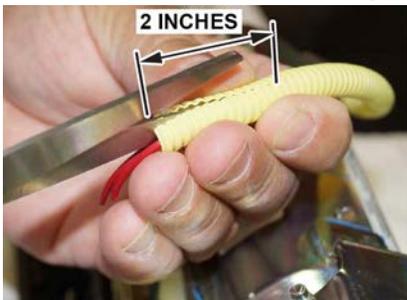
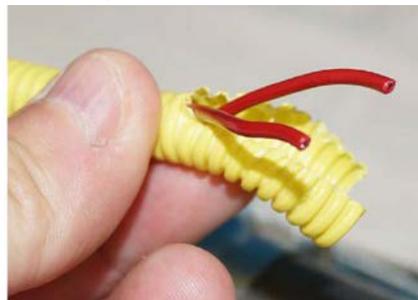
- Cut about 2 inches of the corrugated tube, then pull out the two red wires.

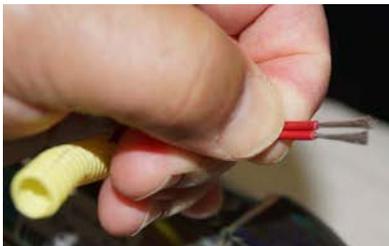
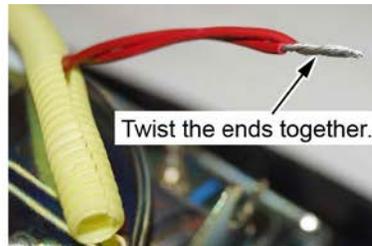
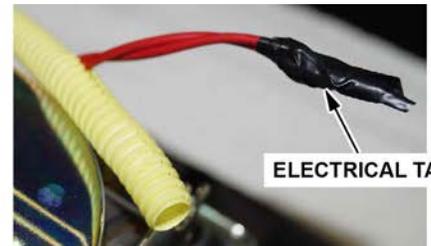
- Strip away about 1 inch of the wire insulation, then twist the wires together.

- Tape the twisted ends with electrical tape.

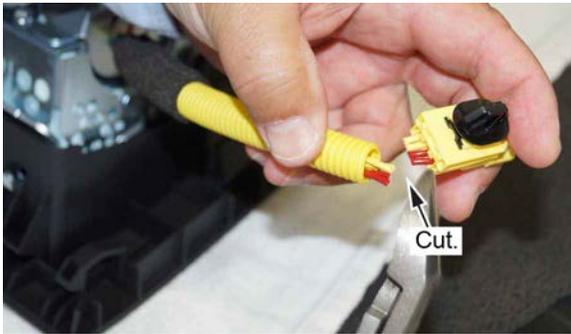
7. Cut off the connector and short the yellow wires.

- Cut all four wires to remove the connector.

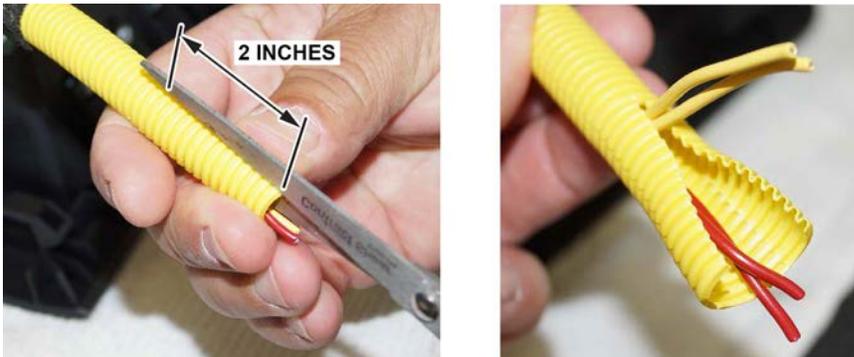
- Cut about 2 inches of the corrugated tube, then pull out the yellow wires.

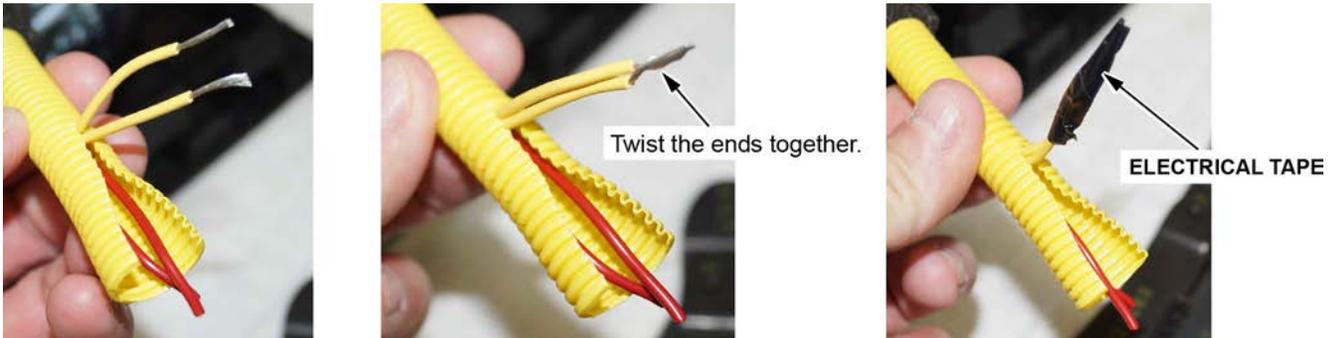
- Strip away about an inch of the wire insulation, then twist the wires together.

- Tape the twisted ends with electrical tape.

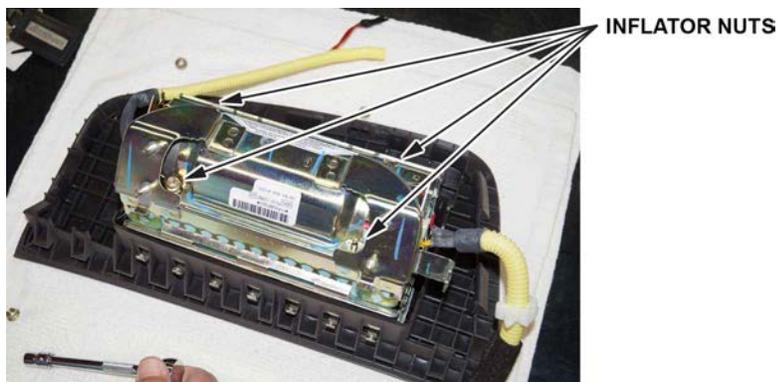
8. Remove the four inflator nuts.

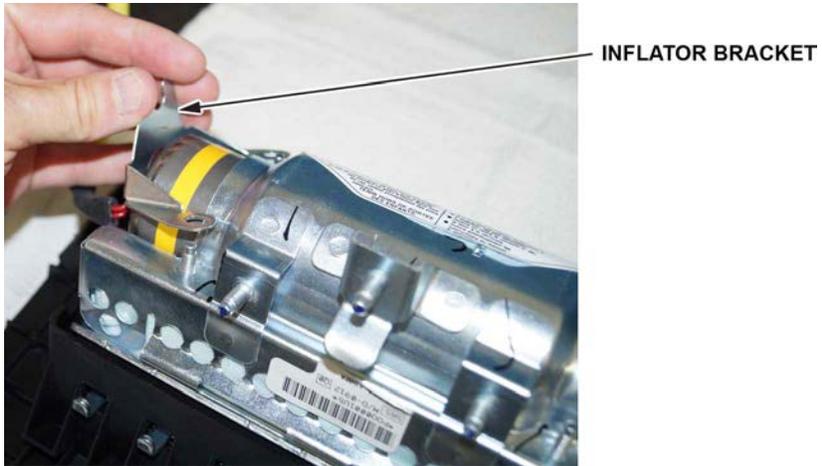
9. Remove the inflator bracket.

NOTE: You can only remove one of the brackets, as the other is welded to the airbag housing.

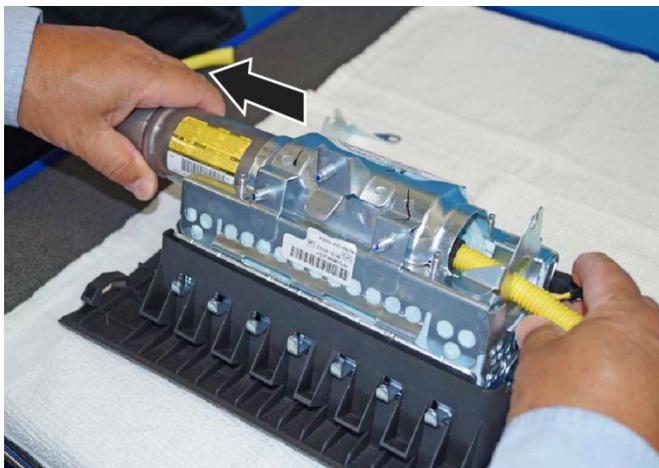
10. Remove the inflator by pushing it out.

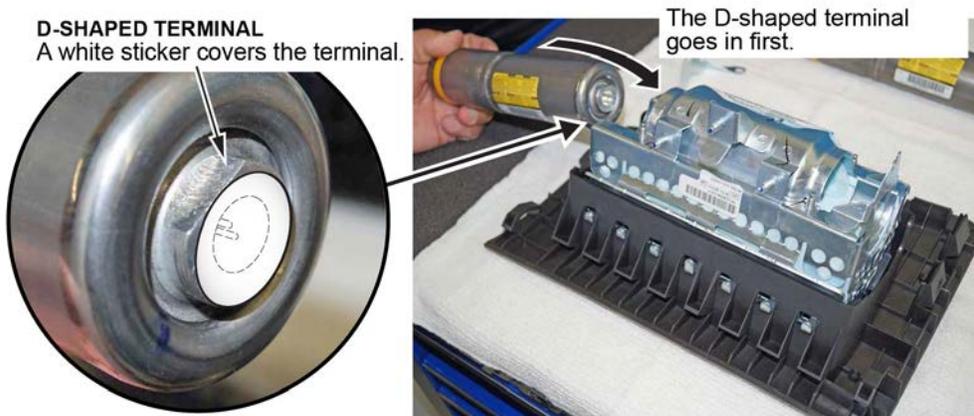
- One connector looks like a "D" whereas the other connector is a circle. Make sure you insert the "D" connector into the airbag first.

NOTE: There is a yellow band marking on the circle side.

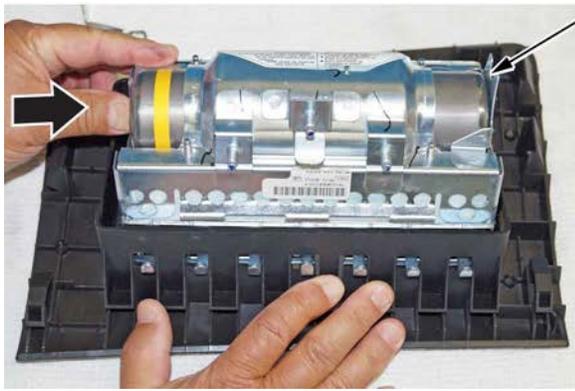
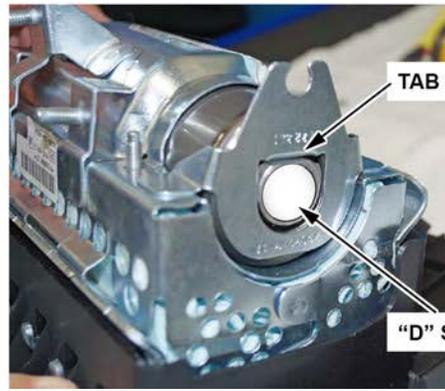
No gap.

- Slide the inflator in until the “D” aligns with the tab on the inflator bracket. There should be no space or gap between the inflator and bracket.

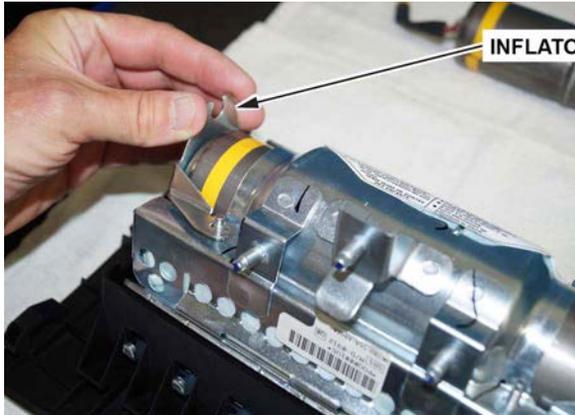
- Reinstall the inflator bracket. There should be no space or gap between the bracket and inflator.

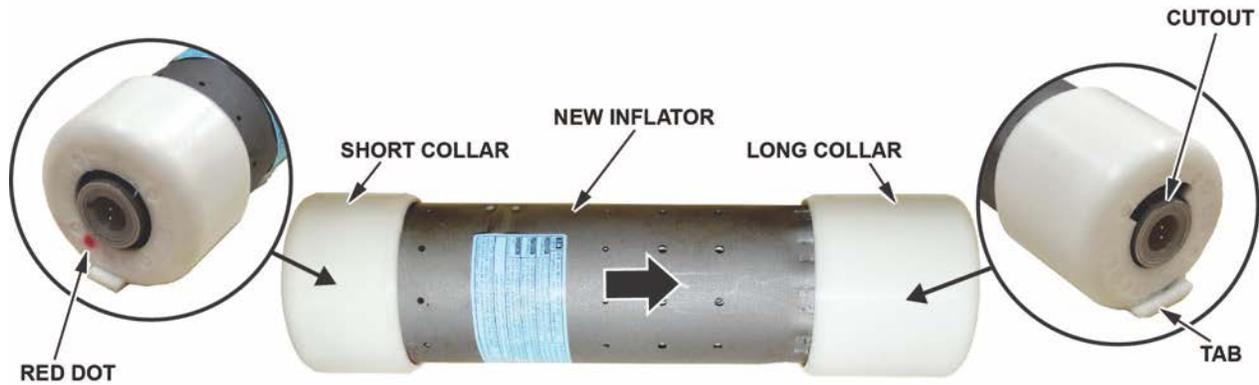
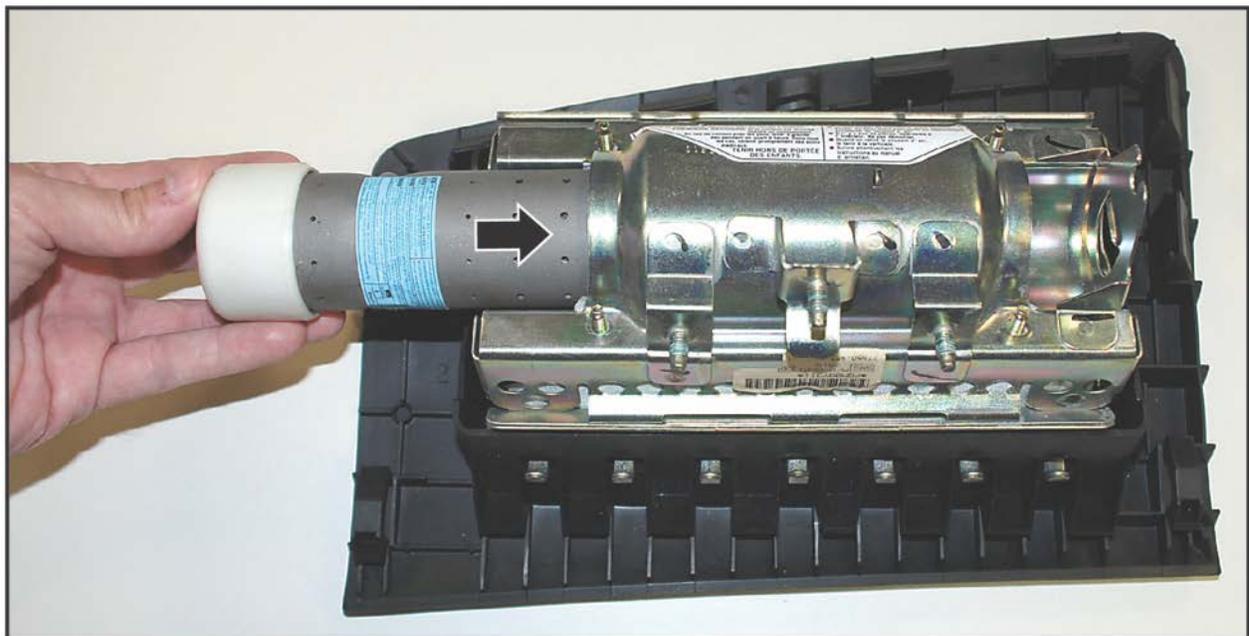
- One side of the inflator has a longer collar, a longer tab, a plastic cutout, and a small flat spot on the connector. The other side of the inflator has a shorter collar, a shorter tab, and a red dot. Make sure you insert the end with the longer collar into the airbag first.

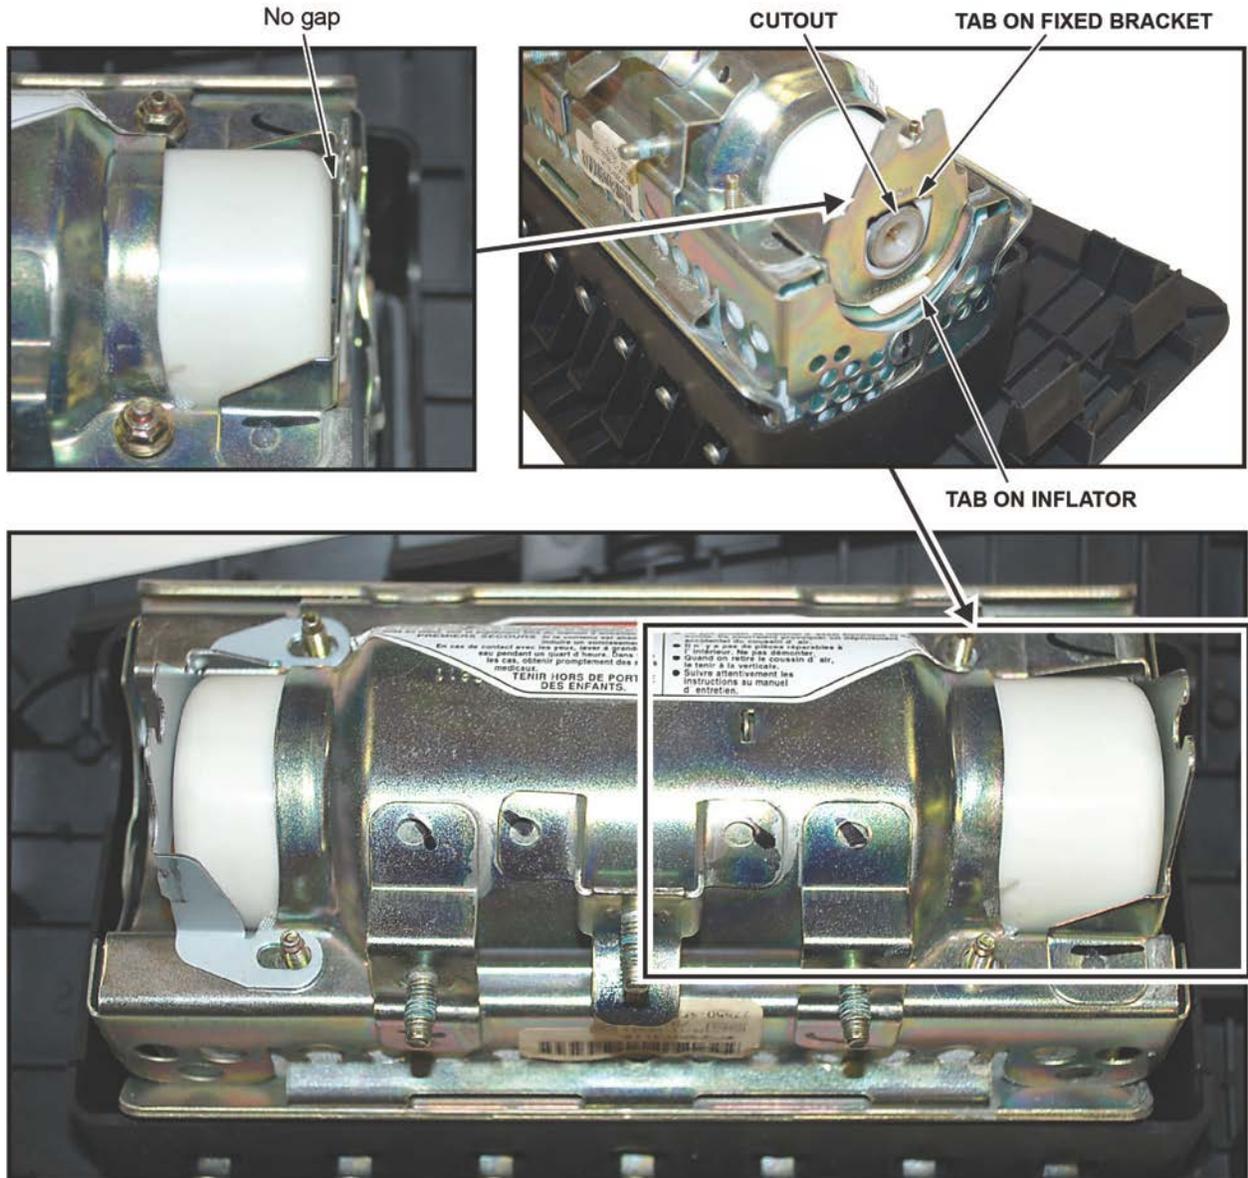
FIXED BRACKET END

- Slide the inflator in until the plastic cutout and the small flat spot align with the tab on the bracket. There should be no space or gap between the inflator and bracket.

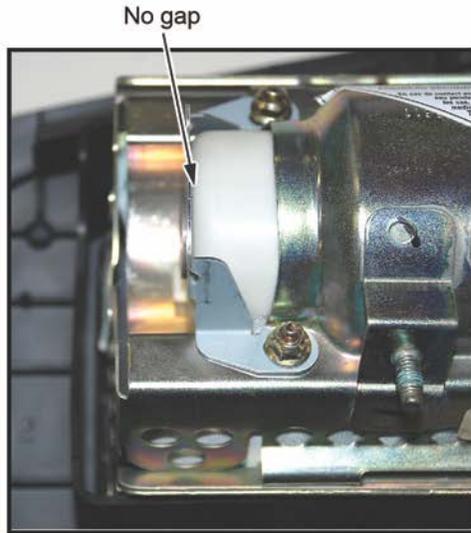
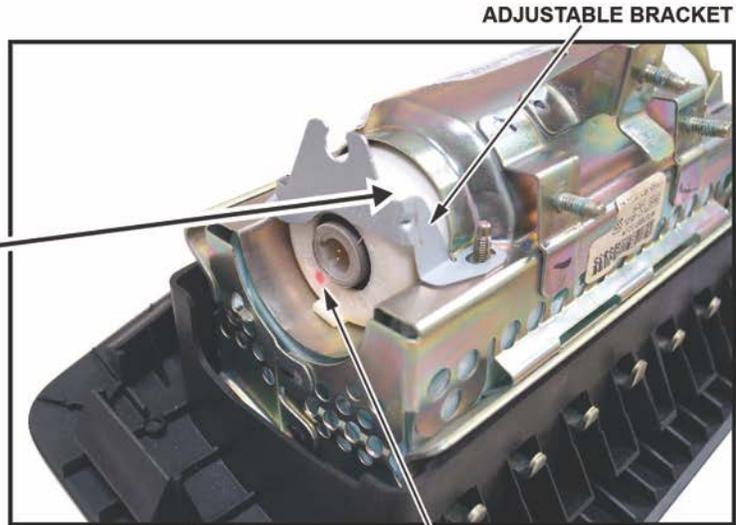
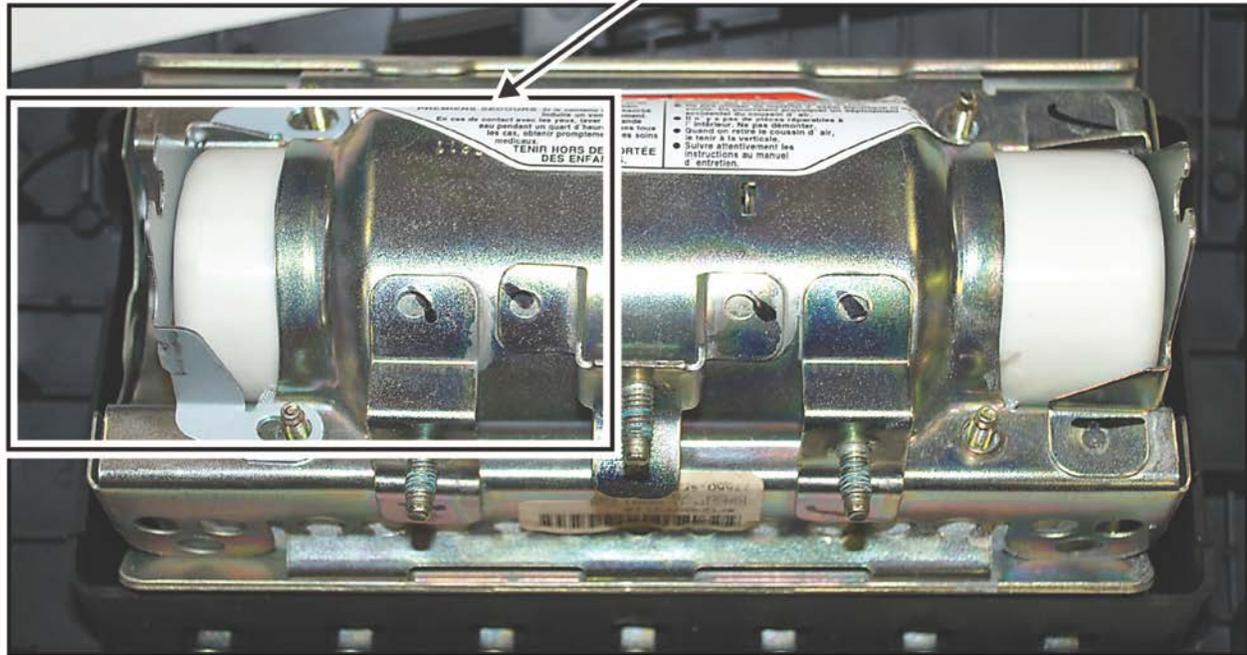
ADJUSTABLE BRACKET END

- Install the bracket included in the kit onto the airbag module. There should be a red dot visible on the end of the plastic connector. There should be no space or gap between the inflator and bracket.

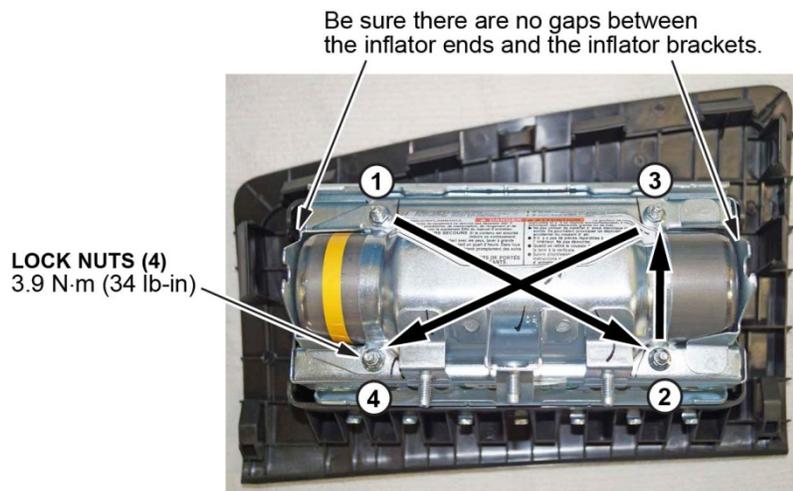
12. Install the new 5 mm locknuts and torque them in sequence to **3.9 N•m (34 lb-in)**.

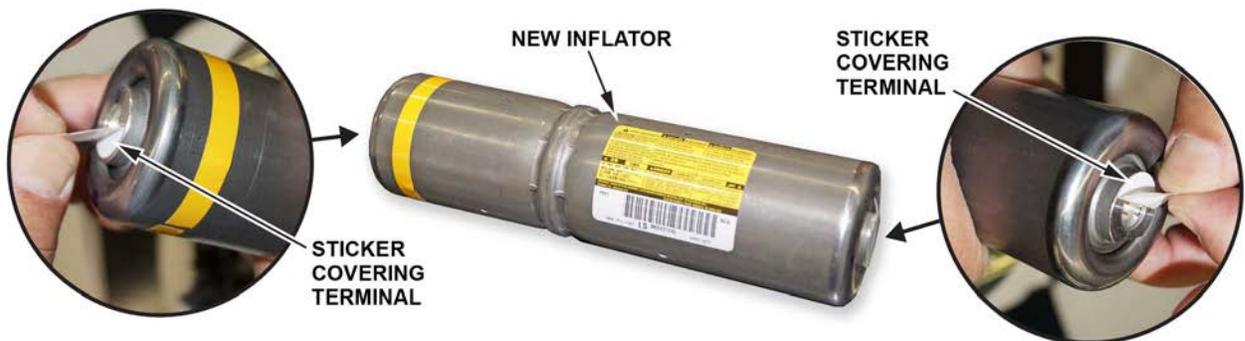
13. Remove the stickers covering the terminals on both sides of the new inflator.

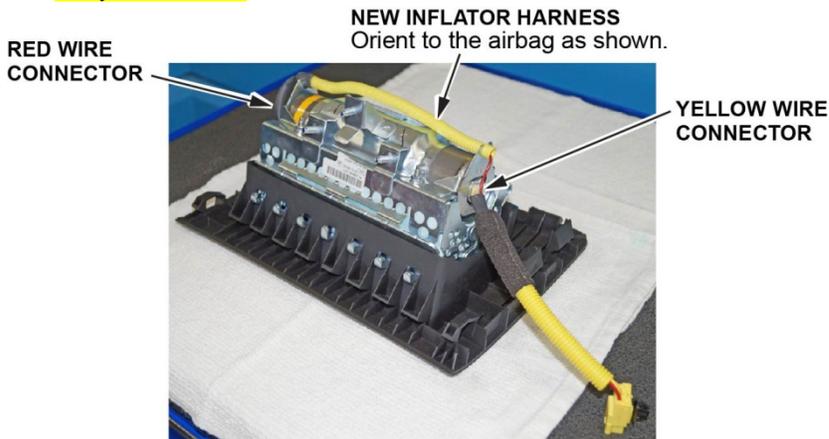
- Make sure the airbag and harness are aligned as shown.

- **Make sure you have the orientation correct as shown below.** If you connect the harness incorrectly, the harness cannot be removed, and you will not be able to reinstall the airbag because the harness will be too short.
- On the replacement inflators with plastic collars, connect the red wire connector to the connector with the red dot.
- On the replacement inflators without plastic collars, connect the red wire connector to the connector nearest the yellow band.

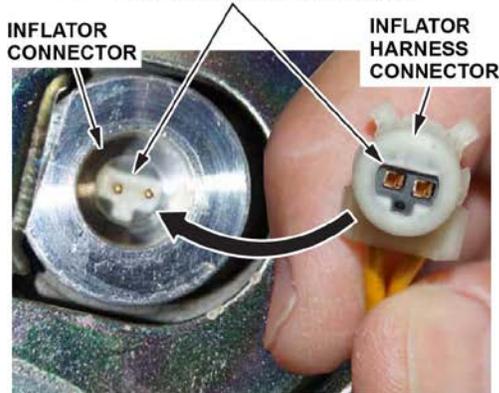
- Connect the two connectors. **Align the "T" shape in the inflator harness connector with the T-shaped inflator connector**, then press the connector into place.

① Match up the "T" shape as shown. The connectors are directional.

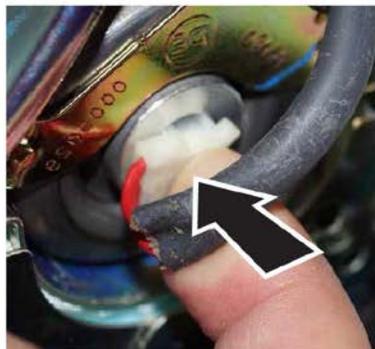
② Press the connector into place until it clicks.

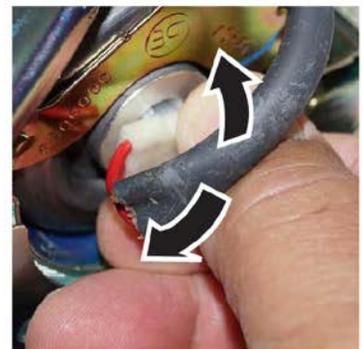
③ Wiggle the connector to make sure it's secure.

- After you hear each connector click, wiggle it to make sure it is secure.
NOTE: If the connector is not properly aligned, it will come out.

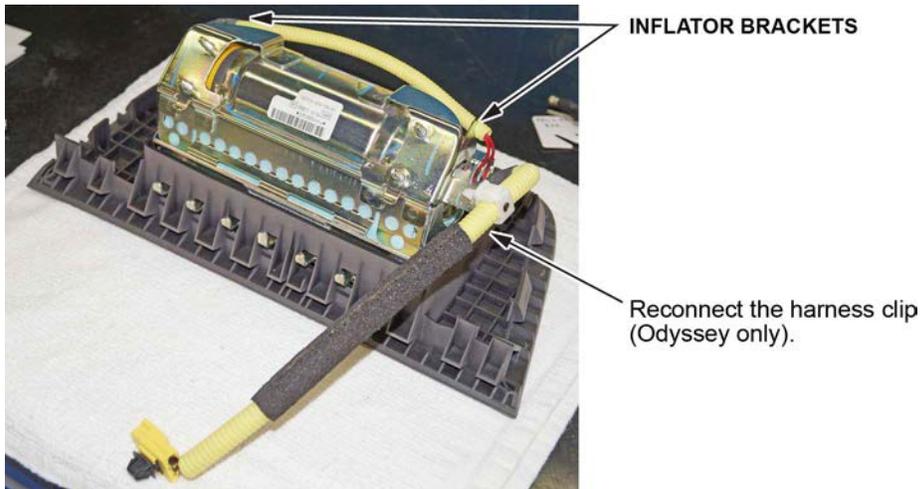
15. Connect the harness to the inflator brackets.

- Insert the side without the shrink-wrap tubing first. Insert the harness at the third “valley” in the corrugated tube.
- Insert the side of the harness with the shrink-wrap tubing into the inflator bracket. Make sure the harness is securely inserted and that it does not sag.
