ATB 51971-01676 Version 7

Recall: Driver's Airbag Inflator May Produce Excessive Pressure After Long-Term Exposure to High Absolute Humidity

Supersedes 14-045, dated December 19, 2014, to revise the information highlighted in yellow

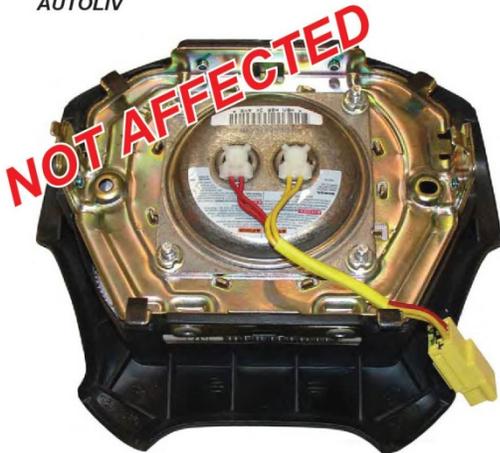
AUTOLIV

5. **Civic only** - Determine if the airbag is made by Autoliv or Takata by comparing the inflators to those in the images below.

NOTE: The Autoliv serial number label is different from the Takata label; the Autoliv has 11 characters, the Takata has 9.

- If the airbag is made by Autoliv, the airbag is OK. Reinstall the airbag using new Torx bolts. Torque the bolts to **9.8 N·m (7.2 lb-ft)**. If you already received a replacement inflator, return the unopened kit to American Honda.
- If the airbag is made by Takata, go to step 6.

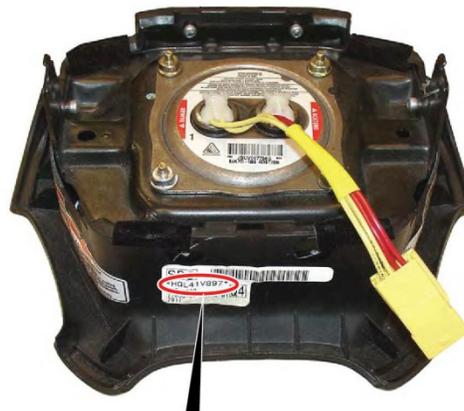
TAKATA

Locate serial number here.

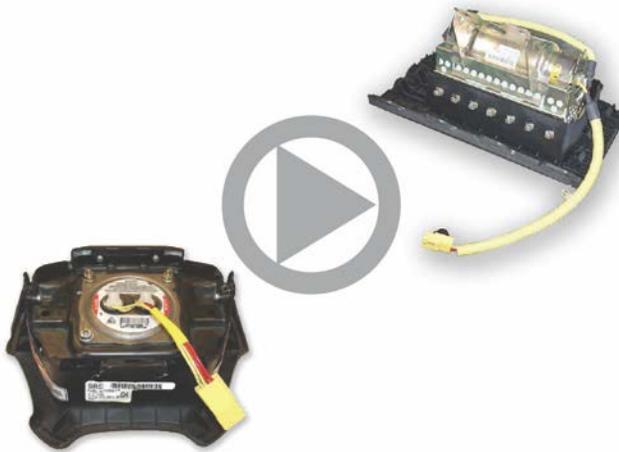
Click on the image below for a short video about the different variations of the driver's and front passenger's replacement inflators involved with the recalls related to replacing Takata inflators. While both the driver's and front passenger's inflators are shown in the video, this is informational only. Replace inflators only as directed by the iN VIN status inquiry.

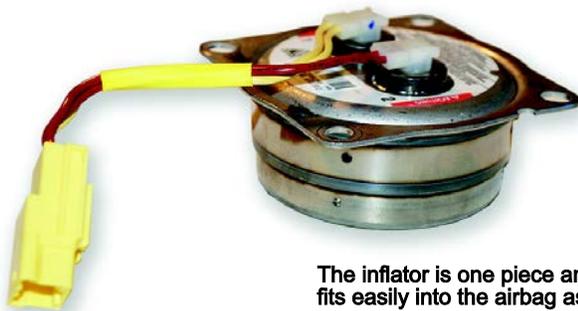
Refer to **Driver's Inflator Type 1** in the video.

The inflator is one piece and fits easily into the airbag assembly.

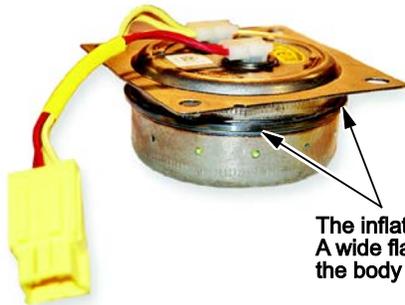
Refer to **Driver's Inflator Type 2** in the video.

The inflator is one piece.
A wide flange is halfway up
the body of the inflator.
