51970-01893 Version 6

Recall: Driver's Airbag Inflator May Produce Excessive Pressure After Long-Term Exposure to High Absolute Humidity

Supersedes 14-029, dated April 14, 2015, to revise the information highlighted in **yellow**

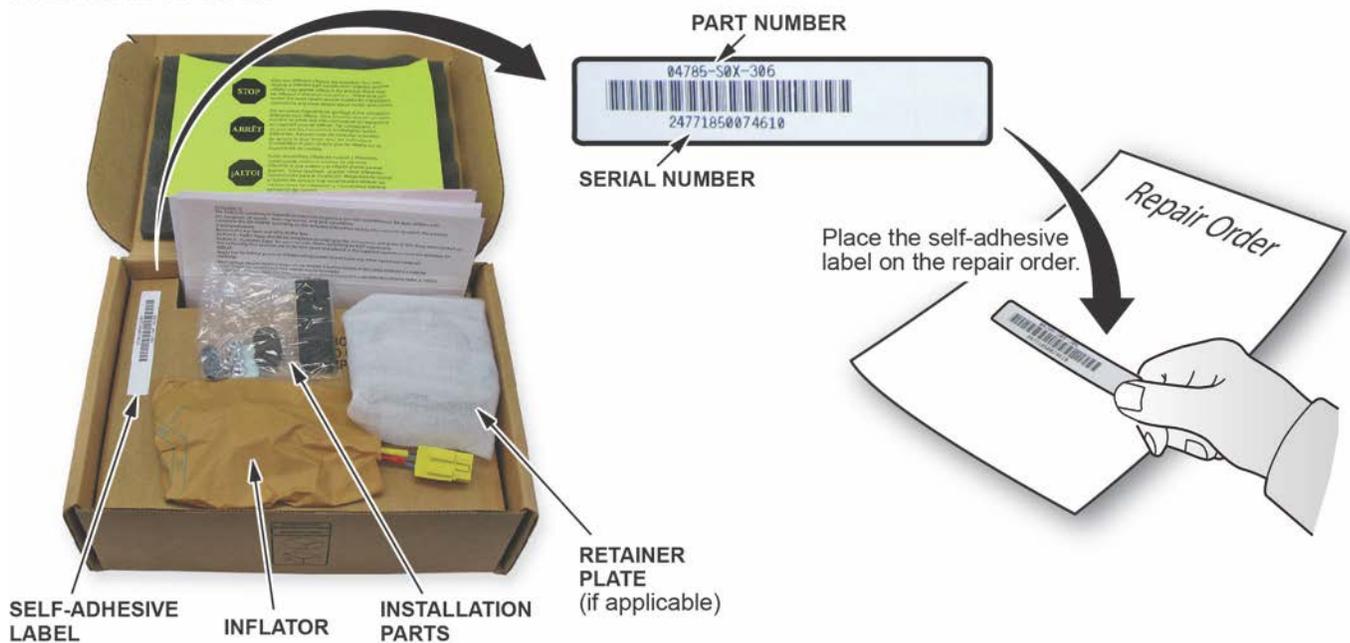
INFLATOR PARTS BOX

2. Peel the label located inside the inflator box from its backing and attach it to the R.O. For the warranty claim to be paid, the **replacement inflator part number that you received** must be on the warranty claim and your warranty clerk must enter the serial number in the Diagnostic Trouble Codes field.

- The replacement part number is printed on the top part of the label and the serial number is printed on the bottom. **Make sure you attach the label to the R.O. and give it to the warranty clerk.**
- There may also be a colored sticker located in the kit, ignore it because it is not used.
- Not all inflator kits have a label included. In those cases, write the serial number and part number from the side of the inflator box on the R.O. The part number always starts with 047.

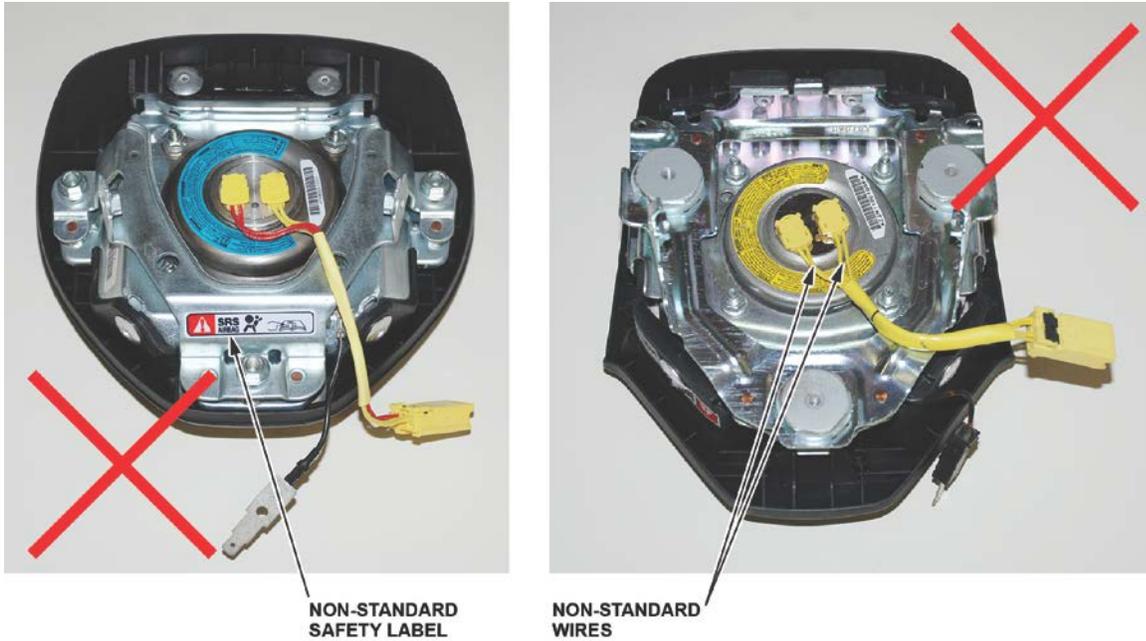
4. Visually inspect the airbag and the inflator for any unusual writing or markings.
 - If there is nothing unusual about the airbag or the inflator, go to step 5.
 - If there are any unusual markings, like an incorrect label or a model year written in marker, the airbag and inflator may not be the correct airbag and/or inflator for the vehicle or it may be a counterfeit part. For more information about counterfeit airbags, you can refer to safercar.gov, enter keywords **MANAGING COUNTERFEIT**, and select **Recommended Dealer Guidance for Managing Counterfeit Air Bags** from the list. **If you suspect that the airbag or inflator is counterfeit, do not continue this procedure.** Contact your DPSM for assistance.

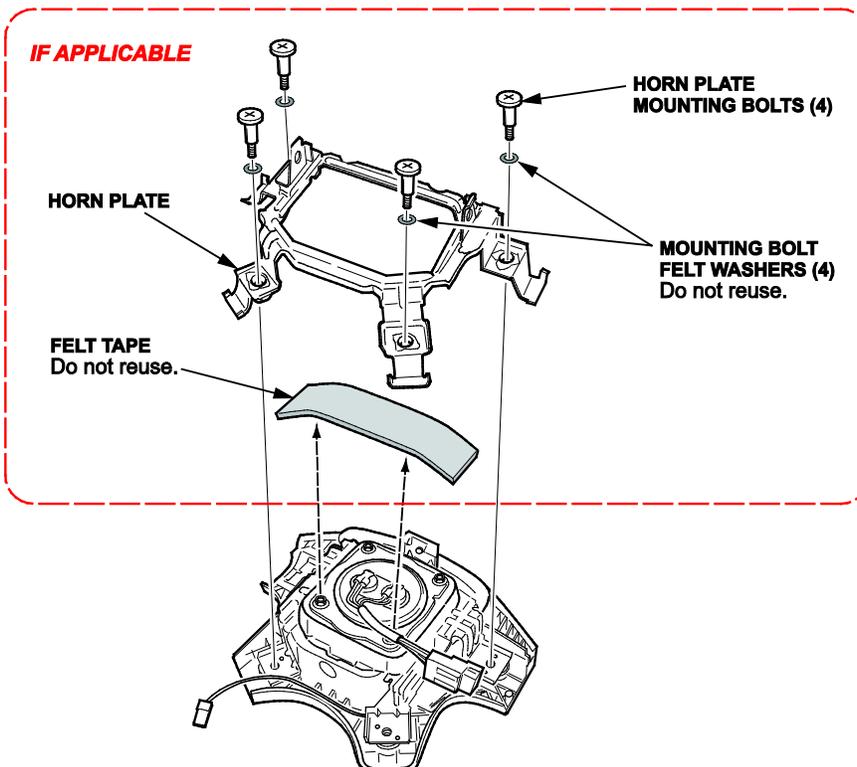
5. If there is no horn plate installed, go to step 7. If there is a horn plate installed, remove the four horn plate mounting bolts, the mounting bolt felt washers, the horn plate, and remove the felt tape covering the lower two inflator locknuts. The felt washers and felt tape will not be reused.

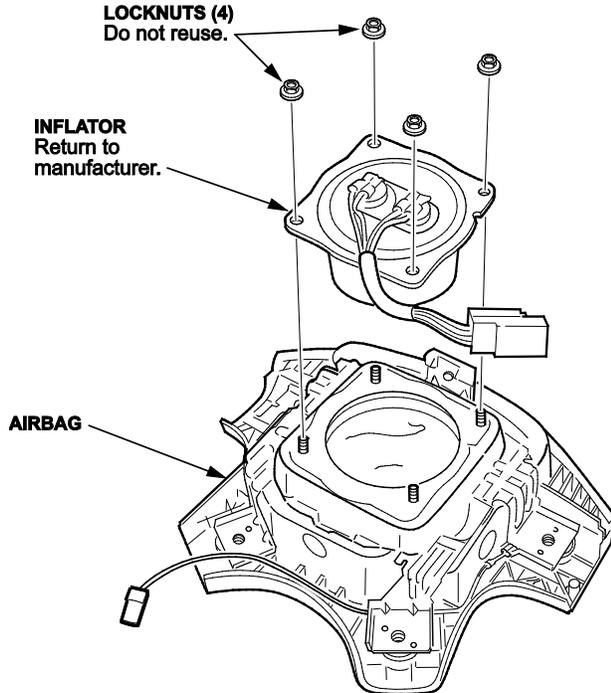
- Using needle-nose vise grips or a 3/8 in. 6-point socket, remove the four locknuts from the inflator. The locknuts will not be reused.

NOTE: Do not remove the inflator from the airbag until you complete step 7.

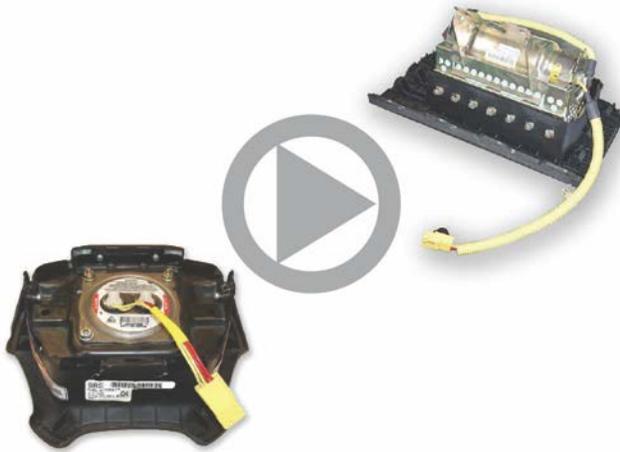
NOTE: There may be some minor surface rust or corrosion on the new inflator; this is OK.
Click on the image below for a short video about the different inflators.

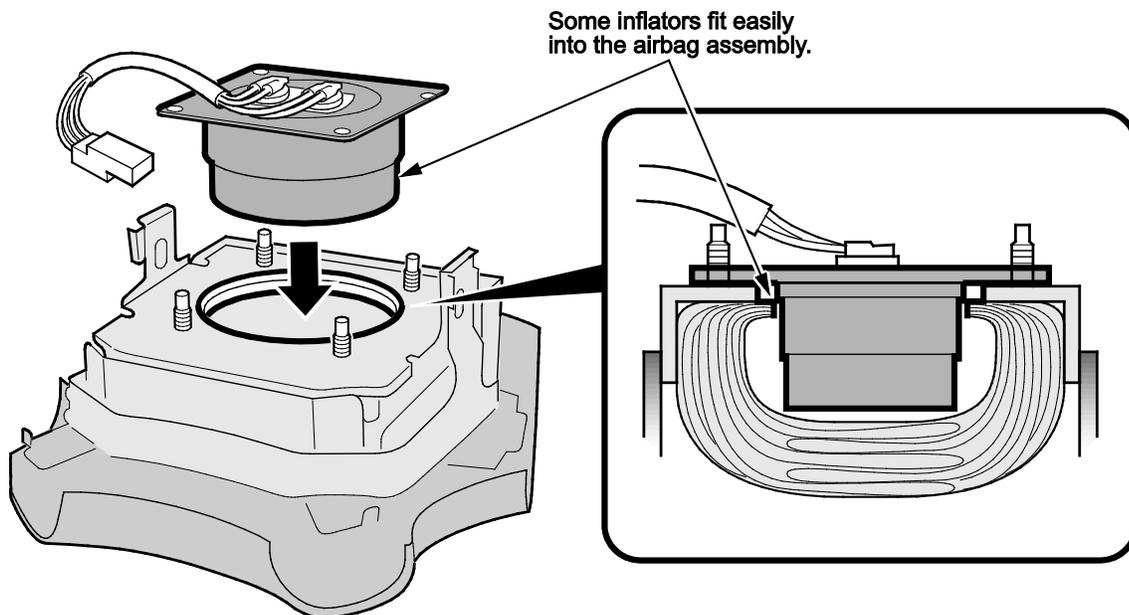
- Insert the inflator into the opening.

NOTE: Make sure the inflator wires are positioned toward the bottom of the airbag. If you install the inflator incorrectly, you may not be able to reconnect the SRS airbag harness.

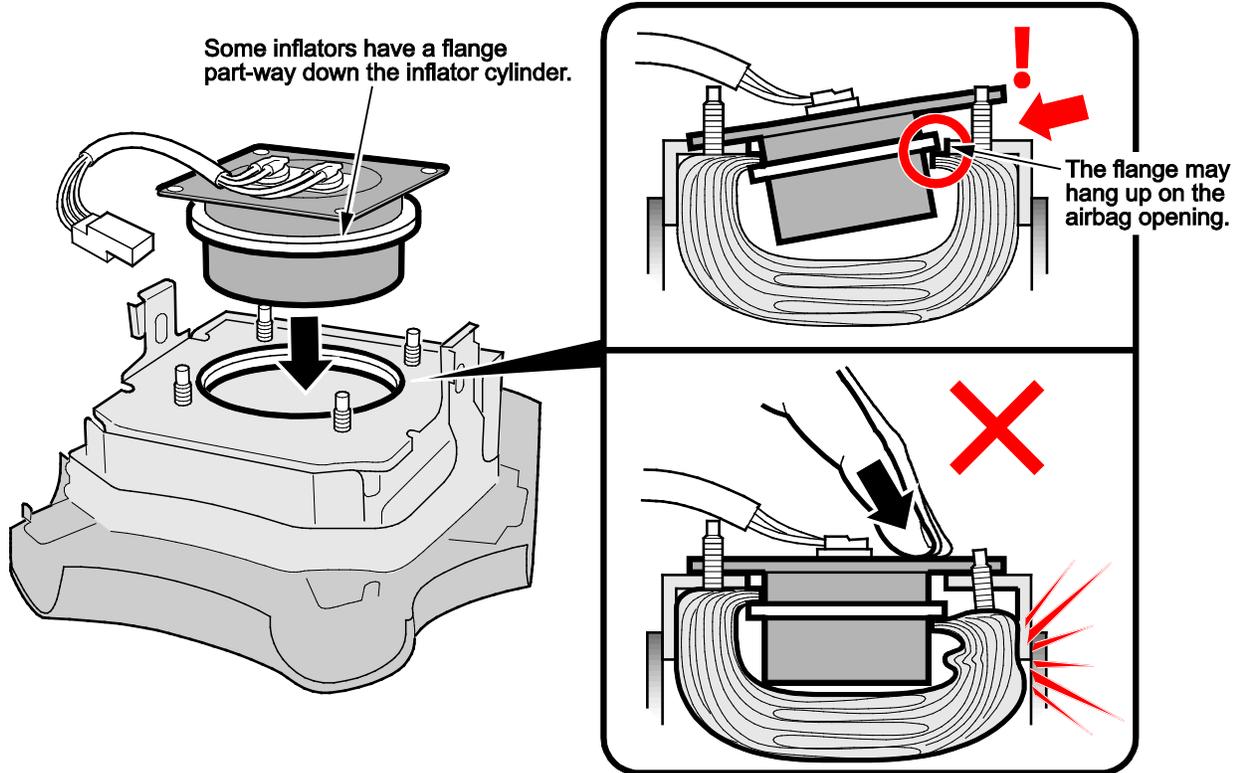
- Insert the inflator into the opening. Do not force it into the airbag module.

NOTE: Make sure the inflator wires are positioned toward the bottom of the airbag. If you install the inflator incorrectly, you may not be able to reconnect the SRS airbag harness.

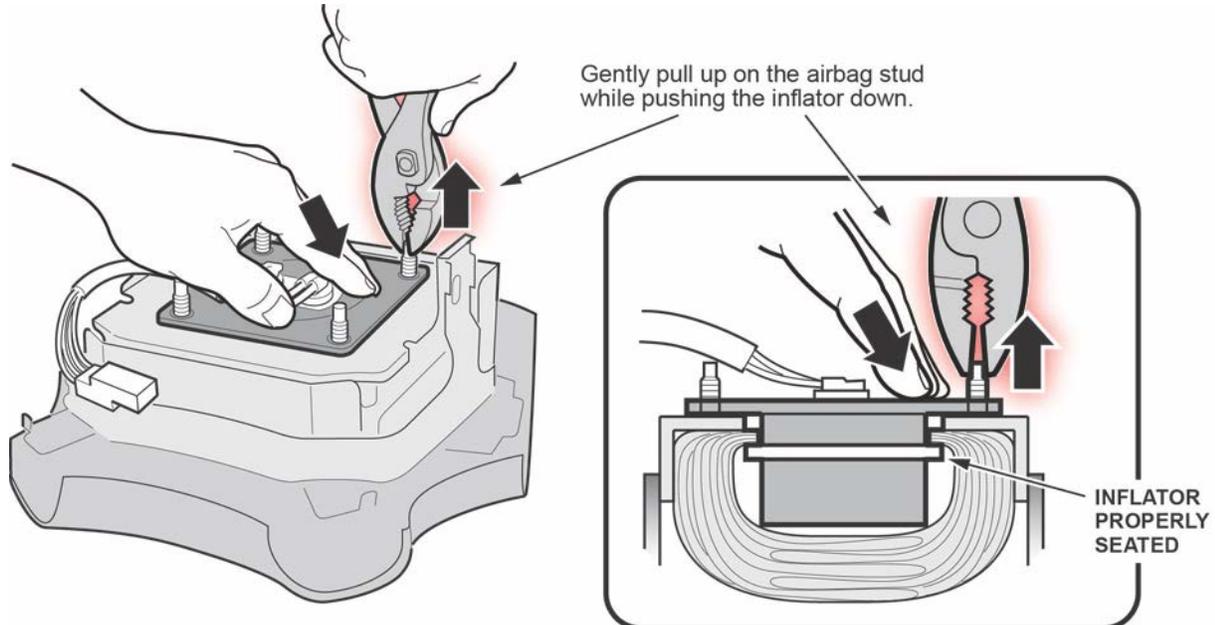
- Using a pair of pliers, gently pull up on each stud up while pushing the inflator module down until the airbag is properly seated within the airbag module.

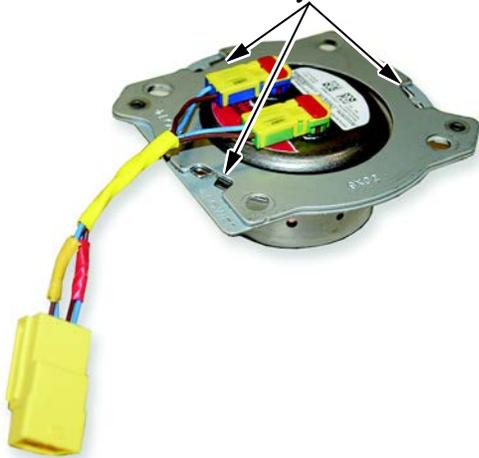
The inflator is held down by a directional retainer that is keyed to the inflator.

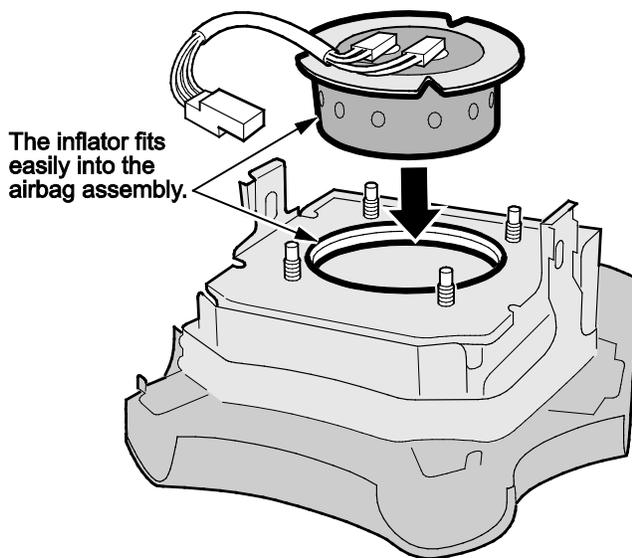
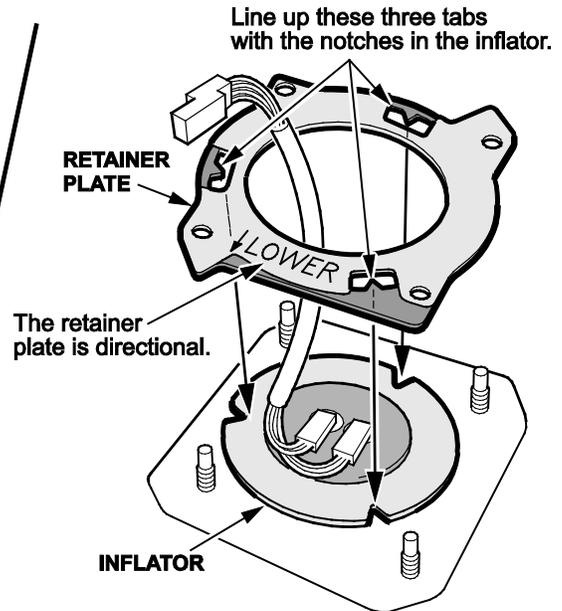
- Place the inflator into the opening with the inflator harness toward the bottom of the airbag.

- Install the bracket onto the studs with the stamp **LOWER** at the bottom of the airbag.
- Make sure the three tabs and notches are properly aligned.

- The tabs and notches are designed to align in one direction only. If the tabs and notches are not aligned, the inflator and bracket are not installed correctly.
- Make sure the harness comes out through the center opening. Do not install the bracket over the harness wires.
