SAFETY RECALL

SUBJECT:	Front Axle U-Bolt Replacement
DATE:	05/14/2015
BULLETIN NO.:	RCB-005-15
CAMPAIGN NO.:	M0280
AFFECTED MODELS:	2015MY- 2016MY Conventional Hino Trucks.

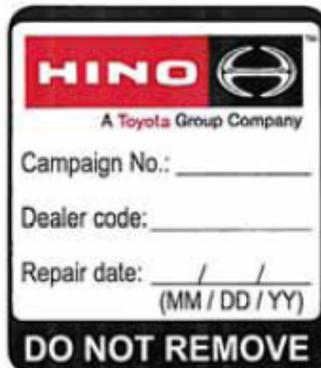
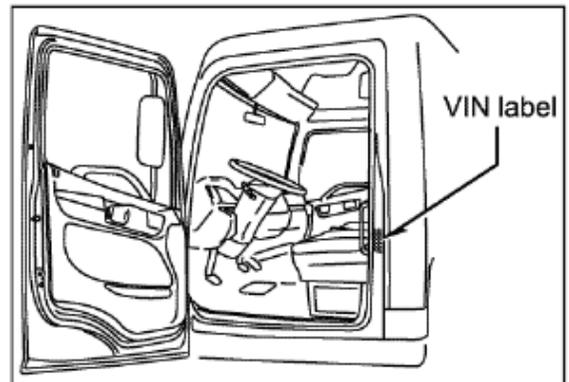
Complete a recall sticker and affix to the left door jam above the V.I.N. decal.

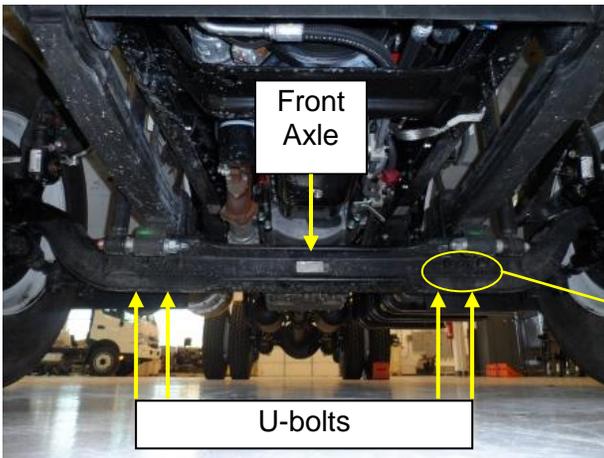
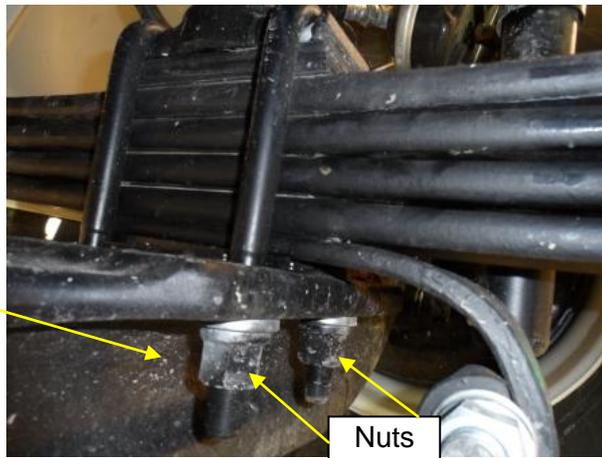
1. With the vehicle on the ground, locate the 4 U-bolts which secure the front leaf springs to the front axle. Start with the left front U-bolt. Remove and discard the 2 nuts and 2 washers which secure the left front U-bolt to the front axle. Remove and discard the U-bolt.

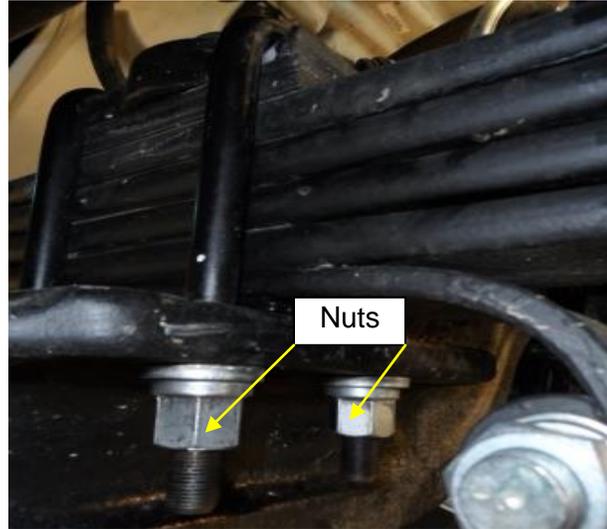
2. Install a new U-bolt in the left front position using 2 new nuts and 2 new washers. Temporarily tighten the 2 nuts until snug. An equal number of threads should be exposed on each U-bolt below the nut. The nuts will be torqued to specification in step 5, below.

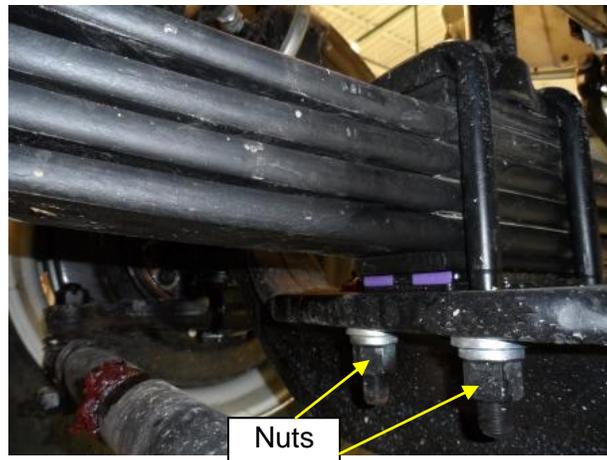
3. Remove and discard the 2 nuts and 2 washers which secure the left rear U-bolt to the front axle. Remove and discard the U-bolt.

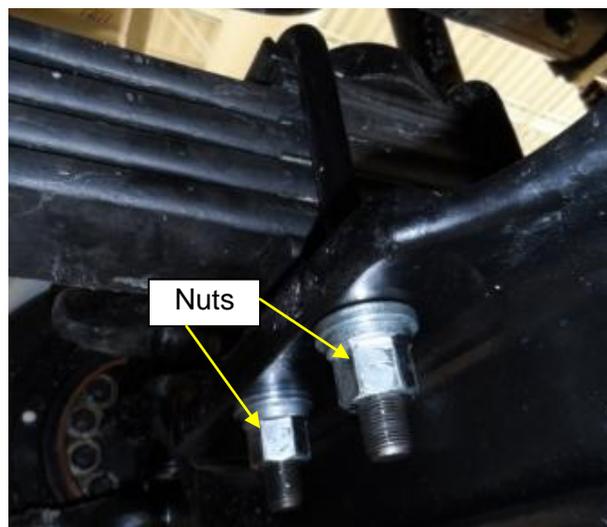
4. Install a new U-bolt in the left rear position using 2 new nuts and 2 new washers. Temporarily tighten the 2 nuts until snug. An equal number of threads should be exposed on each U-bolt below the nut. The nuts will be torqued to specification in step 5, below.

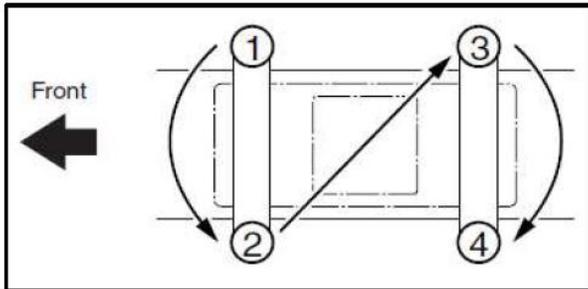
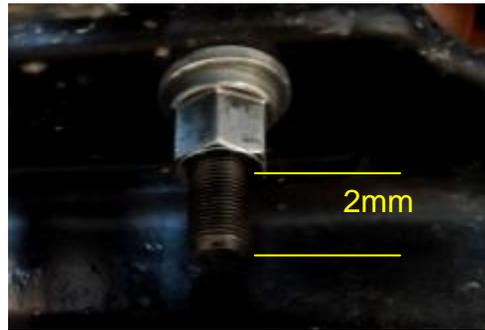
5. Tighten the 4 left side U-bolt nuts in four graduated steps until the specified torque is reached. Follow the torque sequence illustrated below for each of the four graduated steps.

Specified Torque: 311 lb-ft (421 Nm) *

**After torquing, ensure the U-bolt threads extend at least 2mm past the nuts. Results will vary depending on the number of shims present between the axle and leaf spring.*

NOTICE: Inspect the U-bolts and nuts for signs of deformation or thread damage. If found, the U-bolts and nuts must be replaced. In addition, if a U-bolt is loosened and torqued more than three times, it must be replaced.

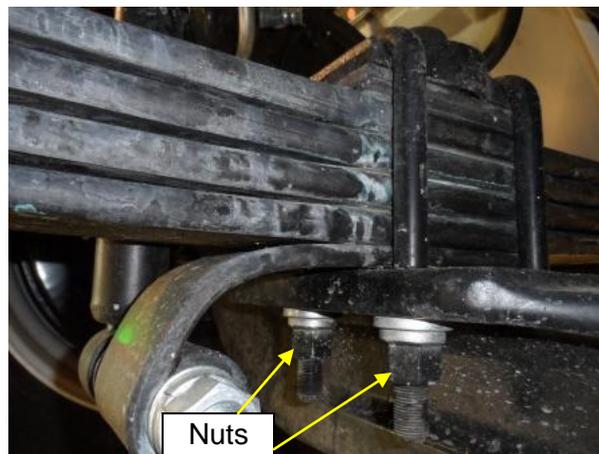
6. Remove and discard the 2 nuts and 2 washers which secure the right front U-bolt to the front axle. Remove and discard the U-bolt.

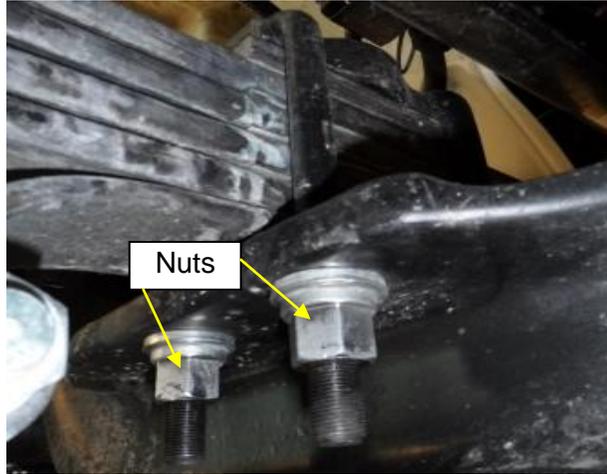
7. Install a new U-bolt in the right front position using 2 new nuts and 2 new washers. Temporarily tighten the 2 nuts until snug. An equal number of threads should be exposed on each U-bolt below the nut. The nuts will be torqued to specification in step 10, below.

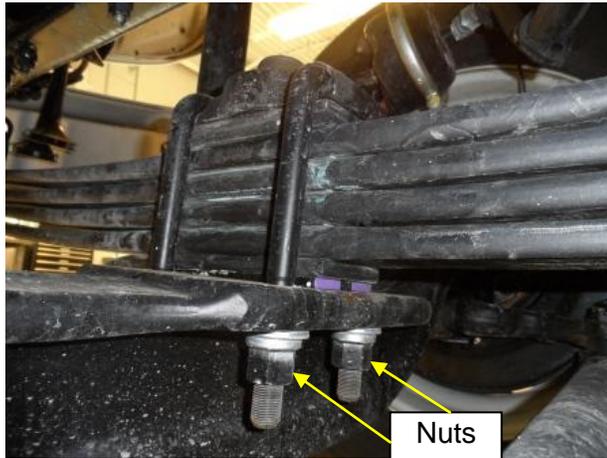
8. Remove and discard the 2 nuts and 2 washers which secure the right rear U-bolt to the front axle. Remove and discard the U-bolt.

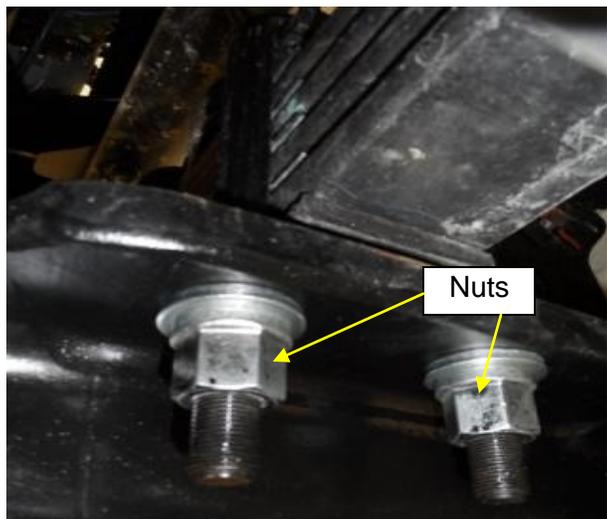
9. Install a new U-bolt in the right rear position using 2 new nuts and 2 new washers. Temporarily tighten the 2 nuts until snug. An equal number of threads should be exposed on each U-bolt below the nut. The nuts will be torqued to specification in step 10, below.

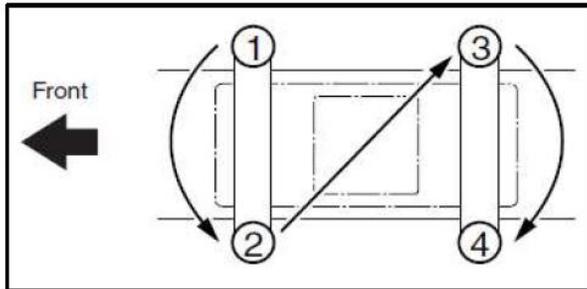
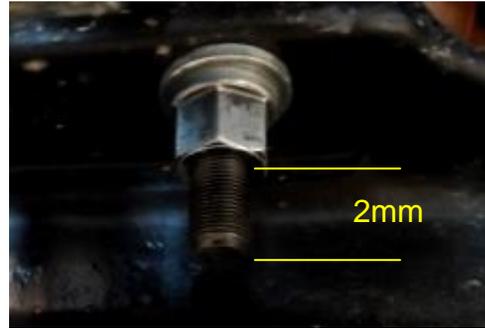
10. Tighten the 4 right side U-bolt nuts in four graduated steps until the specified torque is reached. Follow the torque sequence illustrated below for each of the four graduated steps.

Specified Torque: 311 lb-ft (421 Nm) *

*After torquing, ensure the U-bolt threads extend at least 2mm past the nuts. Results will vary depending on the number of shims present between the axle and leaf spring.

NOTICE: Inspect the U-bolts and nuts for signs of deformation or thread damage. If found, the U-bolts and nuts must be replaced. In addition, if a U-bolt is loosened and torqued more than three times, it must be replaced.
