IMPORTANT SAFETY RECALL

**Subject: Safety Recall Notice
NHTSA Recall No. 15V260**

Alternator Cable Securement Procedure

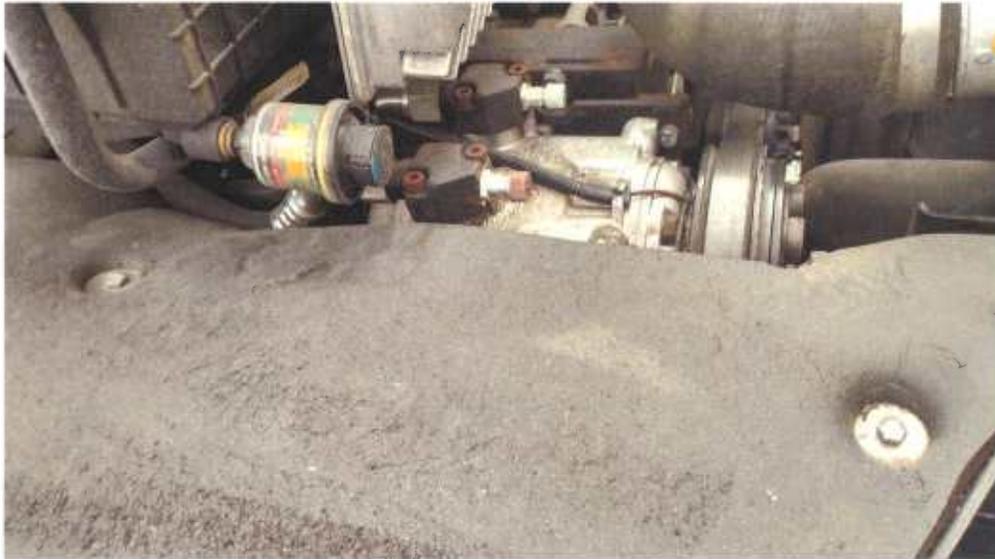
Step 2: Open hood and remove inner curbside fender liner.

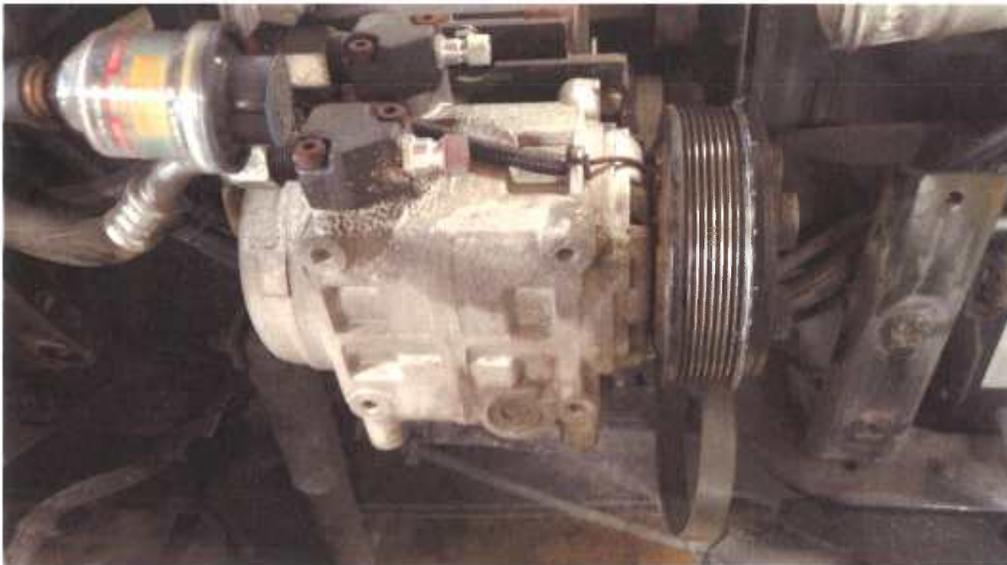
Step 3: Remove charge air cooler hose located above aux. A/C compressor.

Step 4: Remove A/C belt.

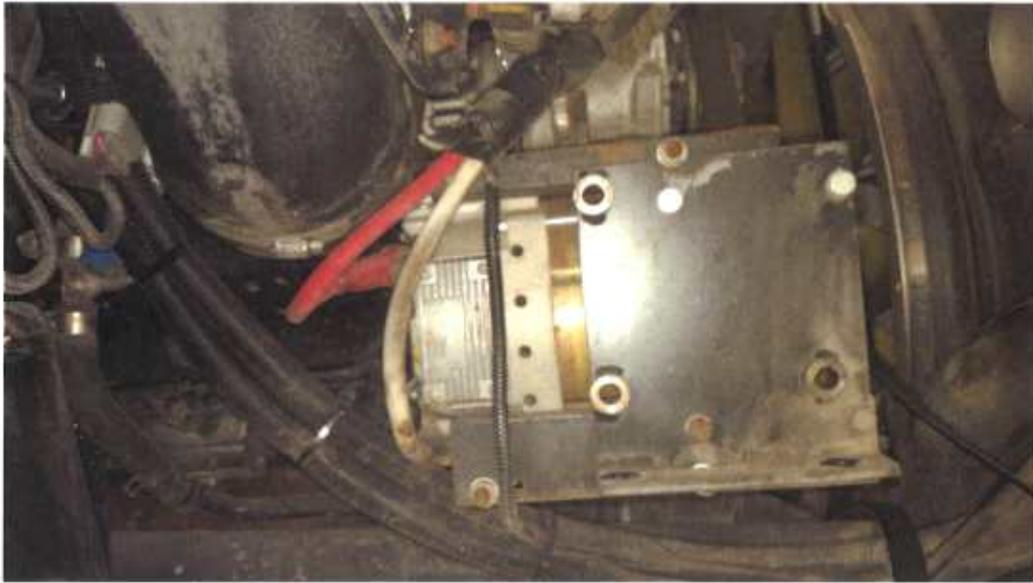
Step 5: Remove 5 bolts from A/C compressor and move compressor to a safe resting position. Note: Do Not Discharge A/C System.

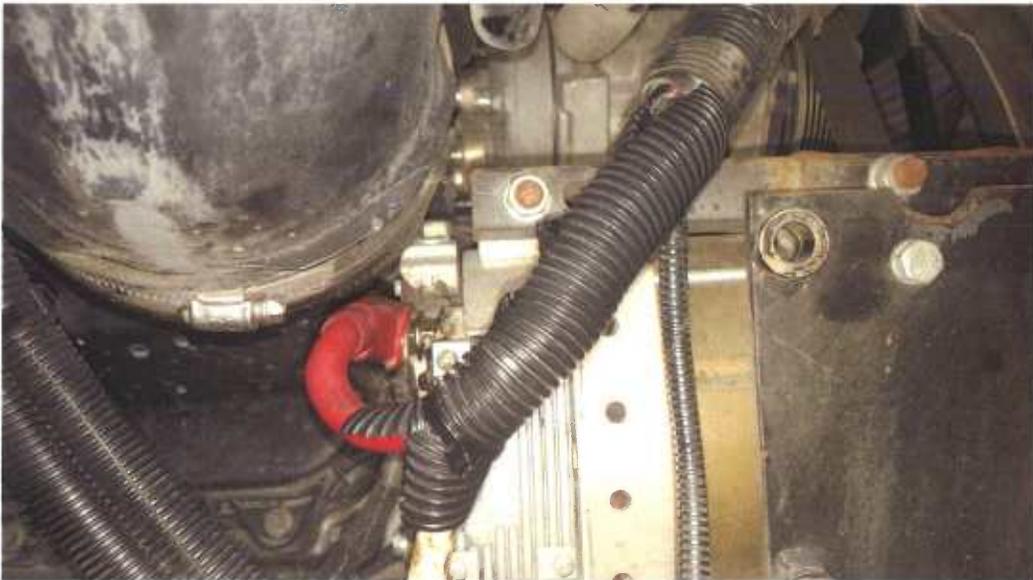
Step 6: Check condition of both alternator cables.

Step 7: Install plastic loom around alternator cables and secure.

Vehicles subject to this recall campaign were manufactured with an alternator cable routed in an area, which over time, could rub through the cable insulation potentially causing an electrical short and possibly cause a fire. Eldorado has determined that this cable needs to be inspected and secured so it can not rub any sharp areas that might cut through the insulation of the cable and cause a short or the risk of a fire.

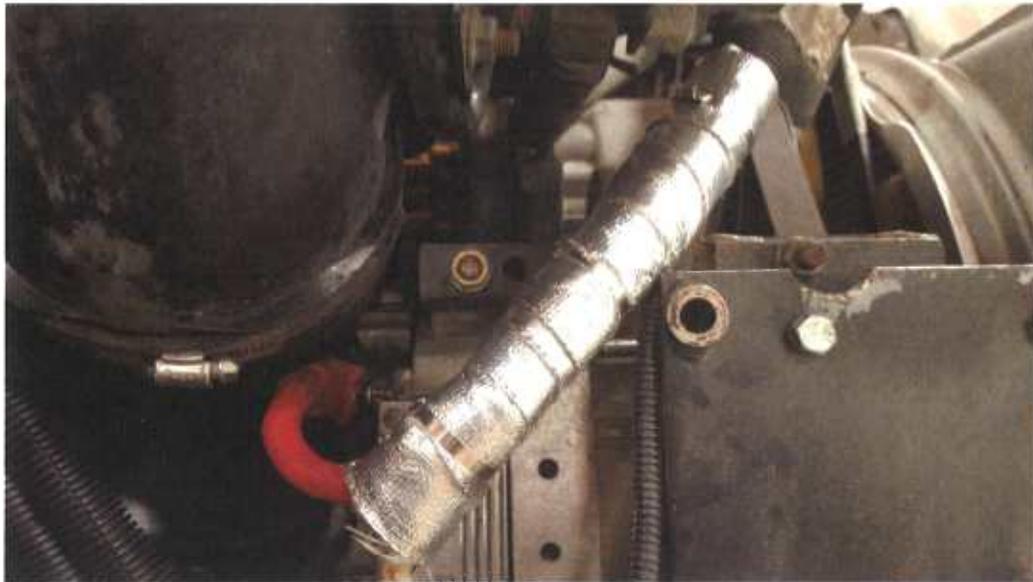
Step 8: Install cloth thermal covering and secure with tie strap provided.

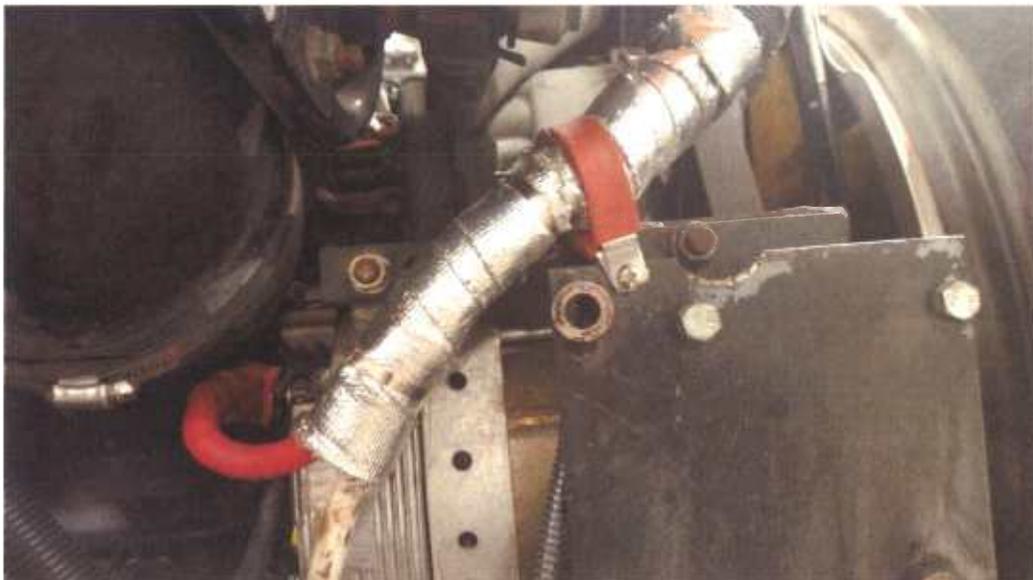
Step 9: Drill hole through A/C bracket.

Step 10: Install insulated clamp around alternator cables and secure to A/C bracket using hole drilled from step 9.

Step 11: Make sure cables are not rubbing and re-install A/C compressor, A/C belt, Charge air cooler hose and fender liner.
