VS/VX/VZ/VL No. 091

June 26, 2015

SAFETY RECALL CAMPAIGN VZR1800 Backrest Mounting Bolts

Affected Models: 2006 - 2015 VZR1800 (Boulevard M109R)

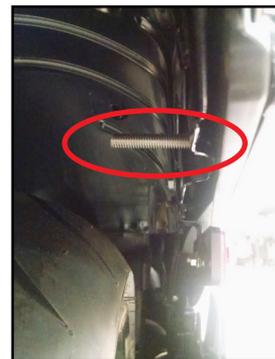
The mounting hardware for installing the Suzuki Genuine Accessory backrest P/N 990A0-75148 and P/N 990A0-75148-BLK on 2006 - 2015 Suzuki VZR1800 (Boulevard M109R) motorcycles may contain 110mm mounting bolts, which is an incorrect length. Under certain loads and riding conditions, it may be possible for the mounting bolts to contact the rear tire, damaging it and/or causing loss of control.

Incorrect mounting bolt

- 1) Replace the mounting bolts.
- 2) Submit a warranty claim.
- 3) If you have unsold inventory of affected backrest mounting hardware kits, please see [Parts & Accessories Bulletin PA15-14](#) for instructions for returning those kits to Suzuki Motor of America, Inc.

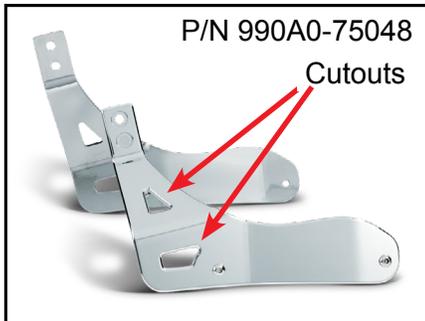
If the motorcycle is equipped with early model backrest mounting brackets with cutouts as shown below, no action is needed.

Early Model Brackets
NO REPAIR NEEDED
Because it is equipped with two 75mm and two 95mm mounting bolts.

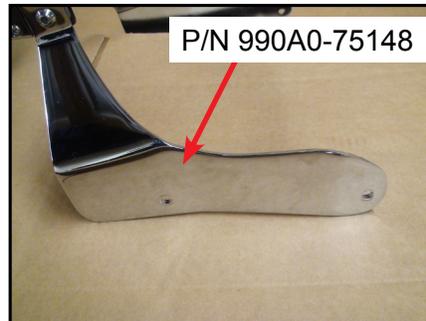
If the motorcycle is equipped with late model backrest mounting brackets without cutouts and it does NOT have saddlebag supports, the mounting bolts must be replaced.

Late Model Bracket without saddlebag supports
NEEDS REPAIR
Because it is equipped with incorrect four 110mm mounting bolts — these bolts must be replaced with correct 75mm (two) and 95mm (two) mounting bolts.

- 1) Use a 5mm hex bit to remove the two left-side rear fender strut mounting bolts. The rear bolt has a separate nut on the inside of the fender — use a 12mm wrench to remove it.
- 2) Verify that the 16mm spacer at the front of the bracket and the 18mm spacer at the back of the bracket are correctly positioned between the bracket and the fender strut mounting holes. **See the illustration below.**
- 3) Insert one front-mount **M8 x 95mm** socket button-head bolt and one rear-mount **M8 x 75mm** socket button-head bolt, then use 5mm hex bit to secure the backrest mounting bracket to the fender strut.

Backrest Bracket Mounting Bolt Tightening Torque: 23N·m (17.0 lbf-ft)

- 6) Inspect the inner fender clearance between the bolts and the rear tire. The bolts must NOT extend so that they can contact the tire during vehicle operation.

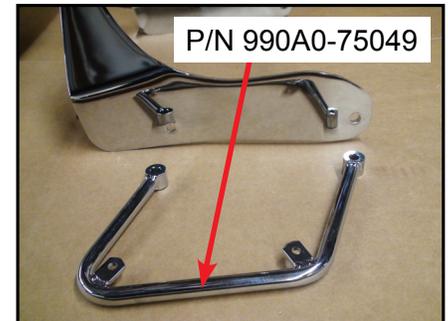
If the motorcycle is equipped with late model backrest mounting brackets without cutouts and it is equipped with Suzuki Genuine saddlebag supports (P/N 990A0-75049), no action is needed.

Late Model Bracket with saddlebag supports
NO REPAIR NEEDED
Because it is equipped with longer four 110mm mounting bolts required for the saddlebag supports. Shorter 75mm (two) and 95mm (two) bolts are not required.
SEE WARNING AND NOTE BELOW.

If the Suzuki Genuine saddlebag supports (P/N 990A0-75049) are removed and the saddlebag support bolts are used to install only the backrest, these bolts are an incorrect length and may come into contact with the rear tire. This may cause the rider to lose control, increasing the risk of a crash.

If the saddlebag supports are removed, the mounting bolts must be replaced using Suzuki bolt kit P/N 990A0-75048-002 or P/N 990A0-75048-003 (black). After installation of the replacement bolts, check the clearance between the bolts and the rear tire. The bolts must NOT extend so that they can contact the tire during vehicle operation.

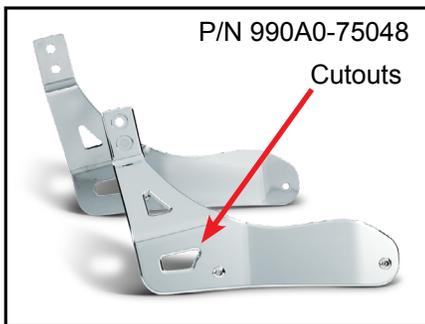
If the motorcycle is equipped with early model backrest mounting brackets with cutouts as shown below, no action is needed.

Early Model Brackets
NO REPAIR NEEDED
Because it is equipped with two 75mm and two 95mm mounting bolts.

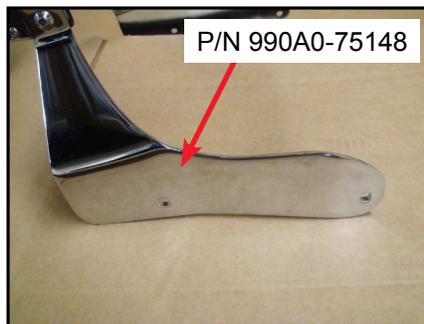
If the motorcycle is equipped with late model backrest mounting brackets without cutouts and it does NOT have saddlebag supports, the mounting bolts must be replaced.

Late Model Bracket
without saddlebag supports
NEEDS REPAIR
Because it is equipped with incorrect four 110mm mounting bolts — these bolts must be replaced with correct 75mm (two) and 95mm (two) mounting bolts.

If your backrest was installed with the incorrect mounting bolts, your Suzuki dealer will replace them with the correct mounting bolts. This procedure will take approximately 10 minutes to complete. Parts are available now, and there will be no charge to you for any recall service-related parts or labor.

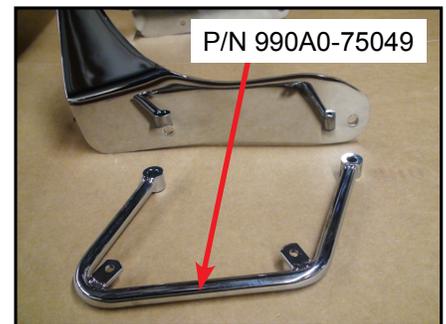
If the motorcycle is equipped with late model backrest mounting brackets without cutouts and it is equipped with Suzuki Genuine saddlebag supports (P/N 990A0-75049), no action is needed.

Late Model Bracket
with saddlebag supports
NO REPAIR NEEDED
Because it is equipped with longer four 110mm mounting bolts required for the saddlebag supports. Shorter 75mm (two) and 95mm (two) bolts are not required.
SEE WARNING ON NEXT PAGE.

If the Suzuki Genuine saddlebag supports (P/N 990A0-75049) are removed and the saddlebag support bolts are used to install only the backrest, these bolts are an incorrect length and may come into contact with the rear tire. This may cause the rider to lose control, increasing the risk of a crash.

If the saddlebag supports are removed, the mounting bolts must be replaced using Suzuki bolt kit P/N 990A0-75048-002 or P/N 990A0-75048-003 (black). Please contact an authorized Suzuki dealer before removing the saddlebag supports. Your Suzuki dealer will remove the saddlebag supports and replace the mounting bolts.
