IMPORTANT SAFETY RECALL

NHTSA File: 15E034

This notice is sent to you in accordance with the National Traffic and Motor Vehicle Safety Act. Idle Free Systems, Inc. (“IFS”) has decided that two defects, which relate to motor vehicle safety, exist in the Idle Free Model BA600 electric Auxiliary Power Units (the “APUs”). According to our records, you purchased a Model BA600 APU as an aftermarket add-on to your truck.

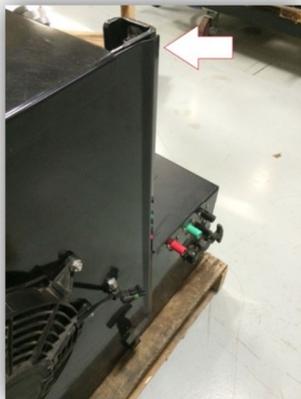
Defect A

Defect A- Defective C-channel Mount: In certain Model BA600 APUs, the C-channels of the metal frame that attach the APU with bolts to the truck frame rail have shown evidence of cracking and tearing. There are no precautions that can be taken to prevent this from happening. The cracking and tearing, if it occurs, would result from the normal operation of the vehicle. If left uncorrected, the APU device could fall off the vehicle frame rail. If this occurs, it could create a safety hazard, including a vehicle crash without prior warning.

Without Gusset (Defective)

Idle Free has developed an APU upgrade kit that will be shipped at no cost to dealers. Instructions for installing the upgrade will be included with each upgrade kit. The dealers shall coordinate and make necessary repairs to your APU at no charge to you.

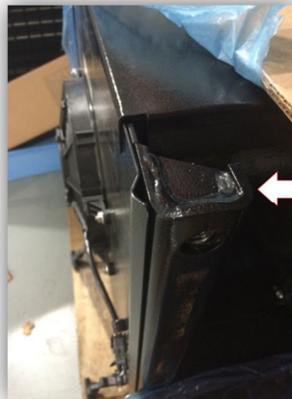
With Gusset (Not Defective)

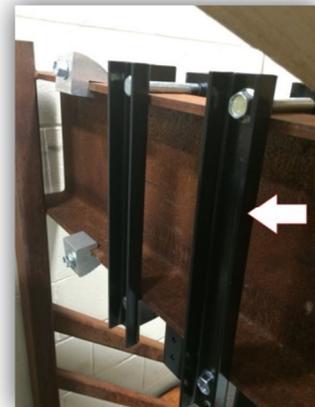
Defect B

Defect B- Defective Mounting Bracket and Bolts: In certain Model BA600 APUs, the back mounting brackets that tighten and secure the APU against the truck’s frame rail can deform, loosen, move freely or fall off, and the mounting bolts used with the back mounting brackets could loosen or fail. There are no precautions that can be taken to prevent this from happening. These malfunctions, if they occur, would result from the normal operation of the vehicle. If left uncorrected, the APU could fall off the vehicle frame rail. If this occurs, it could create a safety hazard, including a vehicle crash without prior warning.
