TSB150060
-----------

New Crankcase Breather Tube Hose Clamps for Part Option BR9277

- ISL G CM2180

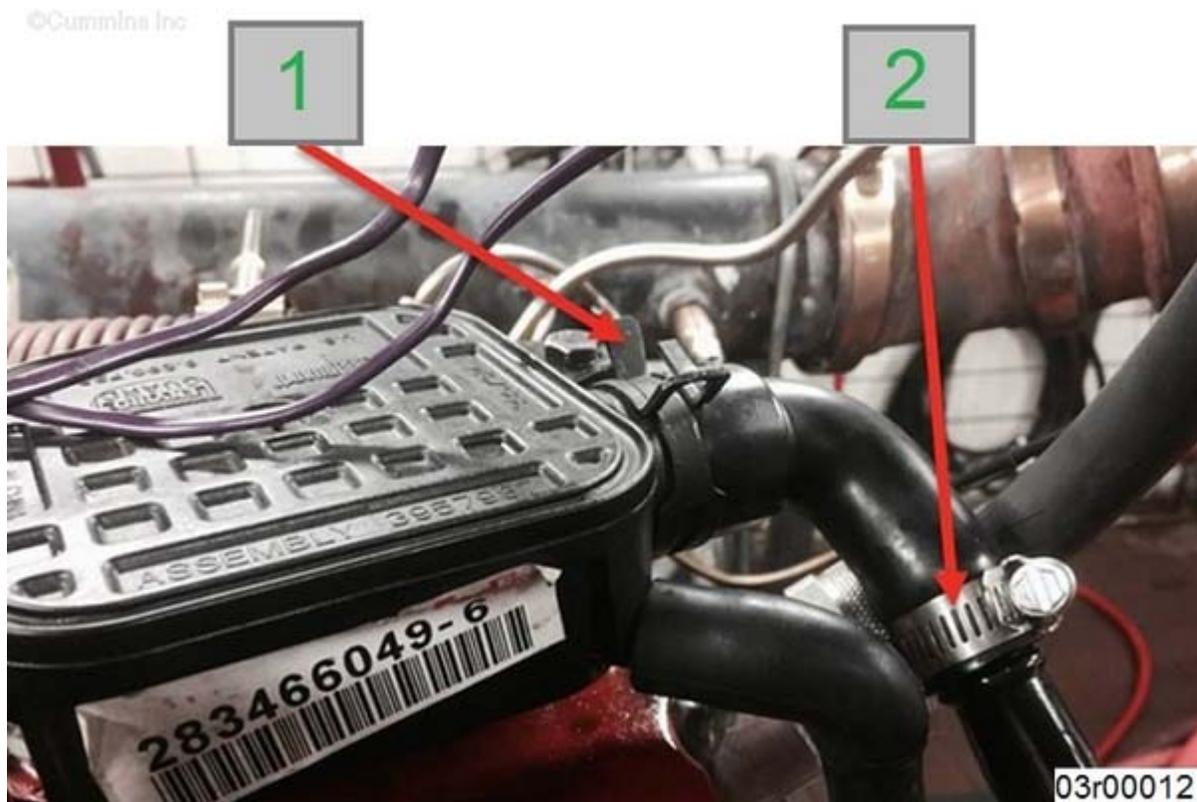
Figure 1, Number 1 Left: Spring Hose Clamp, Part Number 3925089. Number 2 Right: Worm Hose Clamp, Part Number 43828.

A spring loaded hose clamp, Part Number 3925089, has been released for the connection from the crankcase breather assembly to molded elbow.

The worm gear hose clamp, Part Number 0043828, has been released for the connection from the molded elbow to crankcase breather tube.

Cummins Inc. recommends that the new hose clamps, Part Numbers 3925089 and 0043828, be installed on both ends of the molded rubber adapter of the crankcase breather tube to prevent the crankcase breather tube from possibly detaching during high crankcase pressure conditions.

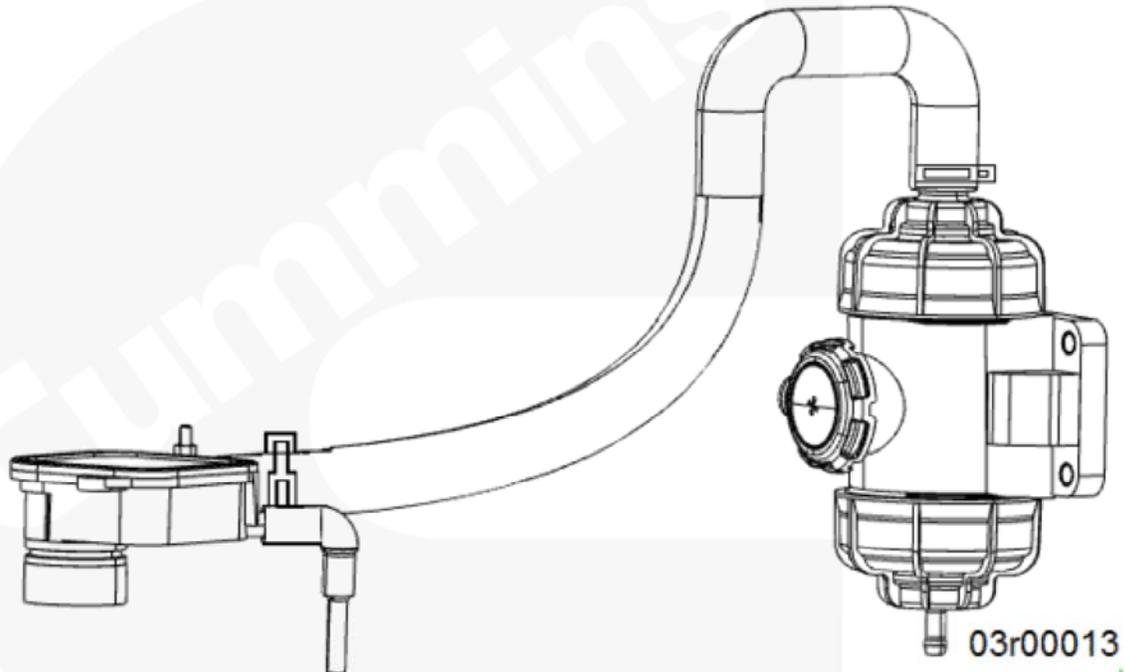
Figure 2, Closed Crankcase Ventilation System with Clamps

**NOTE:** Closed crankcase ventilation systems, Part Options BR9486 and BR9501, are supplied with hose clamps and are not impacted by this change. See Figure 2 below for an illustration of a closed crankcase ventilation system.

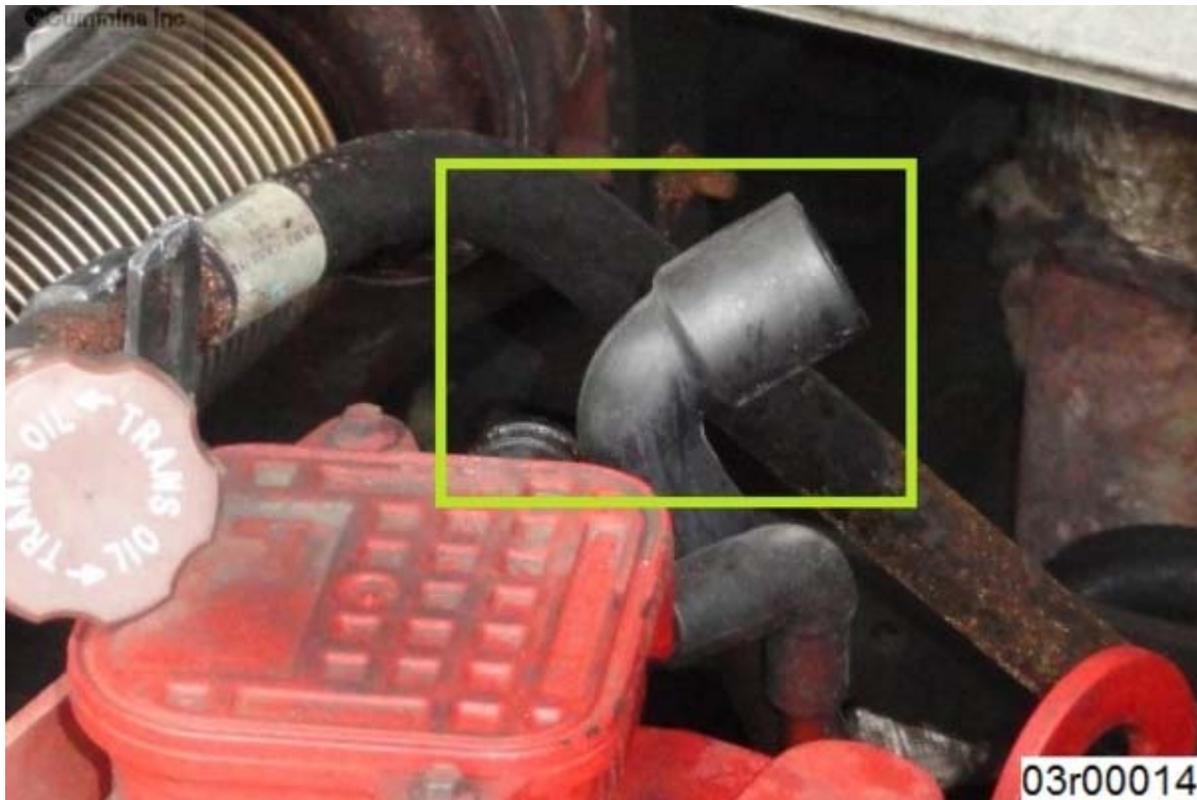
Figure 3

1. Remove molded rubber adapter from the crankcase breather assembly by gently pulling.

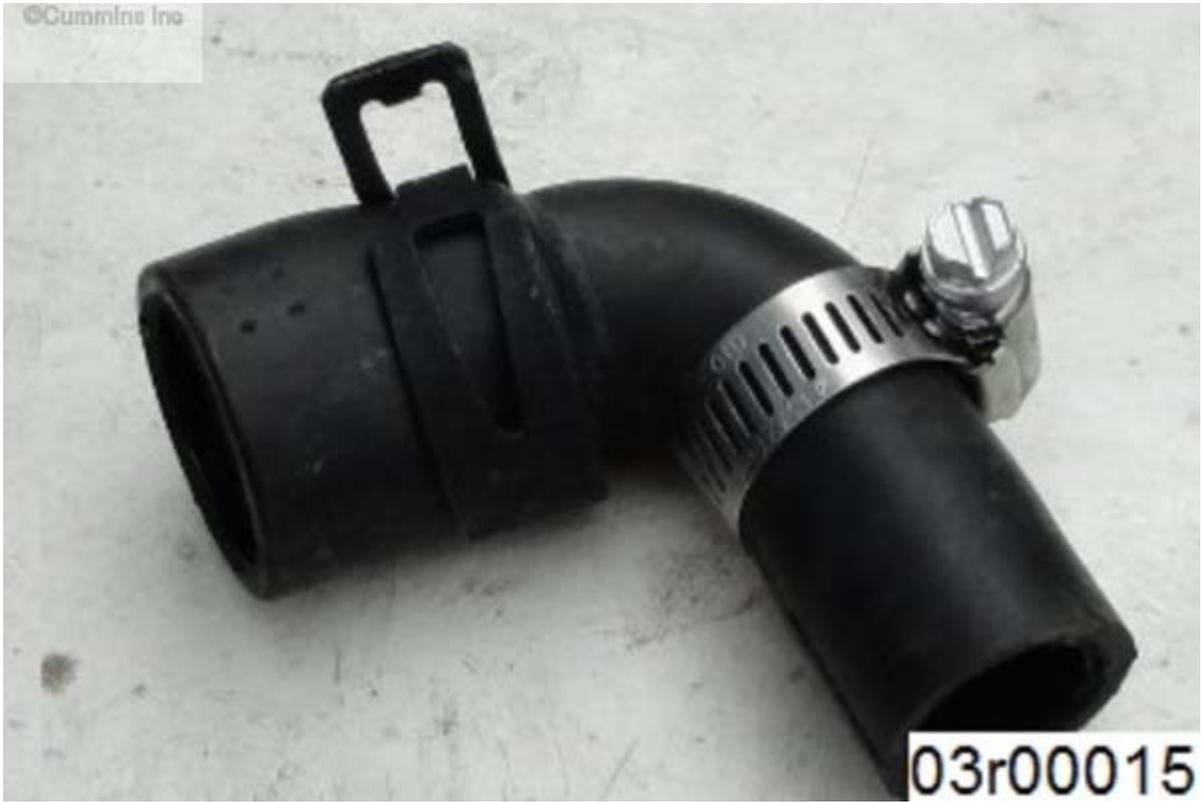
2. Remove molded rubber adapter from crankcase breather tube by gently twisting connection while pulling.
3. Loosely install the hose clamps on the connection. See Figure 4 for 90 degree connection and Figure 5 for straight connection.

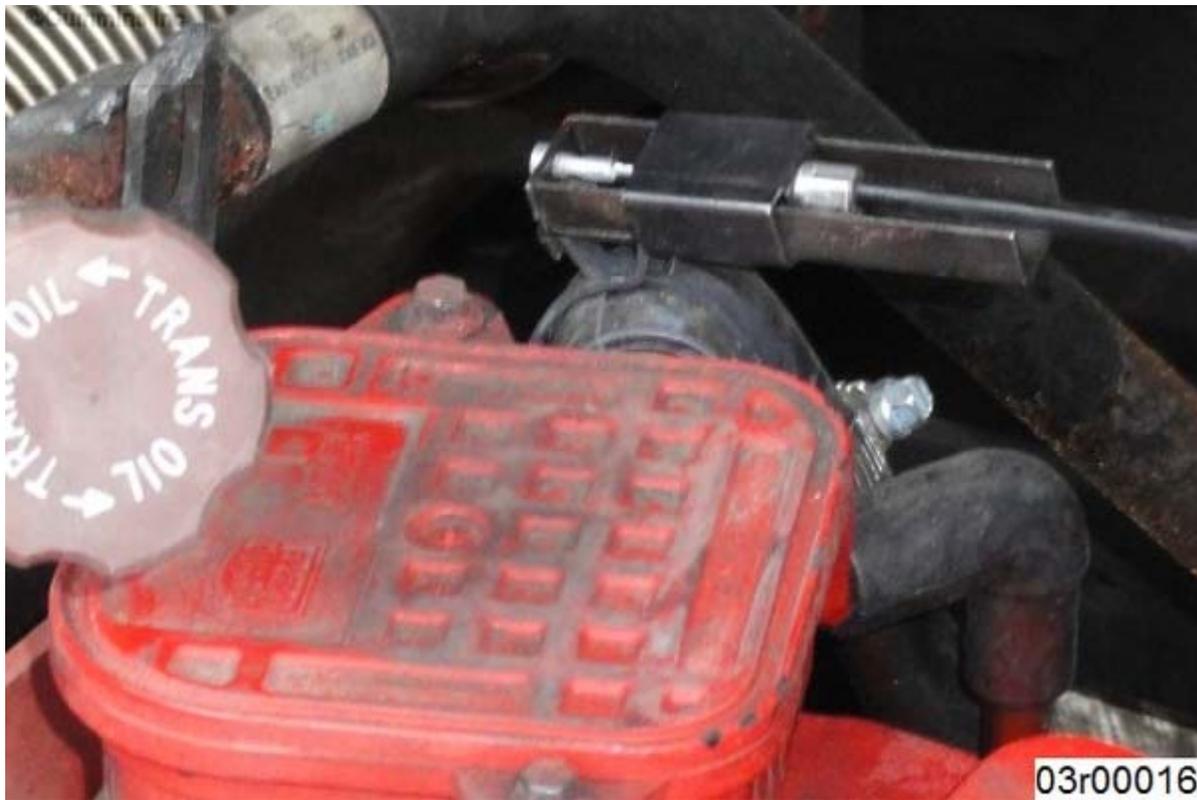
Figure 6

4. Install the molded rubber adapter by pushing the molded rubber adapter onto the crankcase breather tube, then onto the crankcase breather assembly.
5. Move spring loaded hose clamp over the barb on the breather assembly.

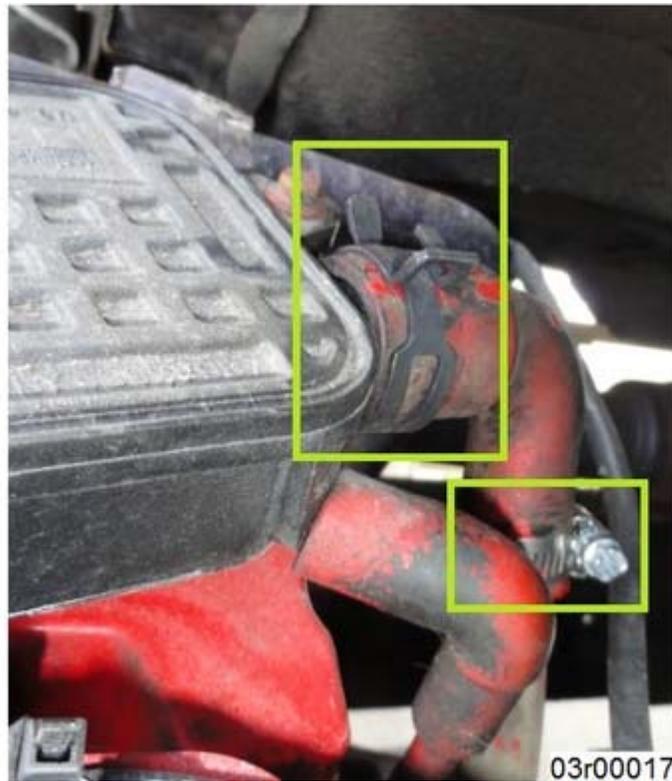
Figure 7

6. Move worm gear hose clamp over barb on crankcase breather tube. Tighten capscrew.

**Torque Value:** to 1.5 N•m [ 13 in-lb ]
