Recall Bulletin 150625ARG

**PRODUCT(S)
AFFECTED:**
Fleetwood
Southwind

**MODEL(S)
AFFECTED:**
32 VS,
with
manufacturing
dates between
April 16, 2014
and
June 19, 2015

SUBJECT:
Providing
Egress for
Driver's Side
Bedroom
Window

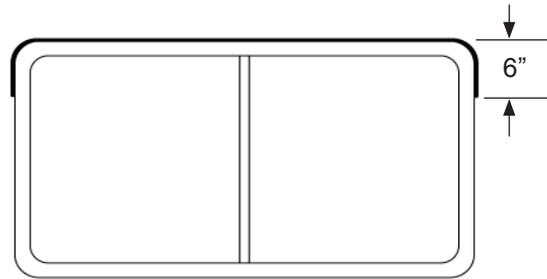
Figure 1

4. Install the new emergency egress window using the compression seal and screws supplied in the Recall kit. Apply a 1/8" bead of clear silicone sealant to the exterior upper six inches of the new window frame after installation. See Figure 1.

Note: Keep the vehicle parked overnight, unmoved, to allow the sealant to cure.
