NHTSA#: 15V-495 TC#: 2015-360

Inspect furnace for proper installation.
Relocate and Secure bracket when required.

Launch Ultra Lite Travel Trailer	2015 2016	24RLS 24RLS	F2JT5171 - 5186 G2JT5051 - 5499
-------------------------------------	--------------	----------------	------------------------------------

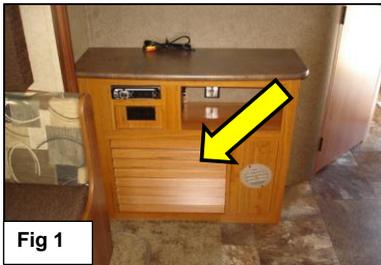
- 1 Fully extend the slideout to gain access to the furnace.
Fig 1 - Furnace is located inside the entertainment center behind the louvered panel (arrow).
- 2 **Fig 2** - Remove 4 screws (one in each corner) from the louvered panel.
Remove the panel from the entertainment center.
Locate the area behind the gas line (indicated with the arrow).
- 3 **Fig 3** - Inspect the area between the gas line and front of the ductwork at the base of the furnace.

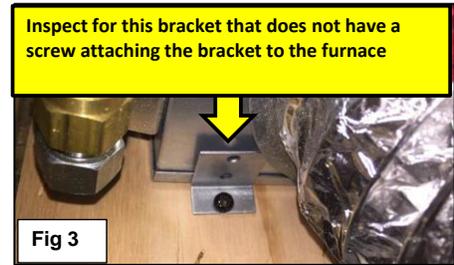
The bracket in Fig 3 is NOT in the correct location and requires the recall repair

If the bracket in this area has a single screw **attaching the bracket to the floor as shown in Fig 3, AND the top hole of the bracket is void of a screw**, the furnace is **NOT** properly secured and requires the recall repair

DO NOT DRILL A HOLE IN THE FURNACE OR ATTEMPT TO PUT A SCREW through the upper hole of the bracket when the bracket is **NOT** properly secured .

Remove the screw that attaches the bracket to the floor, then remove the bracket.

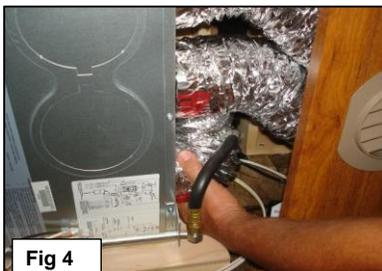
- 4 **Fig 4** - Remove only the lower duct from the furnace.
Grasp the duct close to the furnace and *gently* turn it counter-clockwise about 1/4 turn.
Pull the ducting away from the furnace.

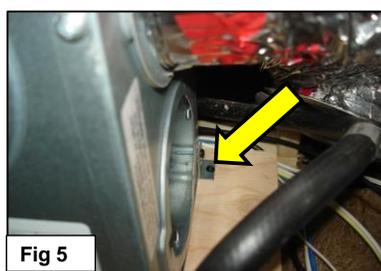
- 5 **Fig 5 & 6** - With the ducting removed from the lower port on the furnace, check to see if there is a secured bracket in the lower back corner.
Arrow in **Fig 5** shows the bracket. If the bracket is present, check to see if there are 2 screws in this bracket.
One screw should attach the bracket to the wood base, the other screw goes into a pre-drilled hole in the furnace.
If this bracket is installed as shown in **Fig 6**, skip down to Step 7.
If there is no bracket in this location, or if there is only a single screw in the bracket continue to **Step 6**.

- 6 If the bracket shown (in **Fig 5 & 6**) is **NOT** there; Install the bracket (removed in Step 3) at the location shown in **Fig 5 & 6**.
The bracket **MUST** be attached with **TWO** screws as shown in **Fig 6**.
The screws are #8 x 3/4" sheet metal screws
One screw is installed in the single hole on the bracket and into the wood base.
A pre-drilled hole in the furnace can be found where this bracket will be located.
Secure the bracket to the furnace by installing a screw through the top hole in the bracket and then into this pre-drilled hole.
DO NOT DRILL ANY HOLES IN THE FURNACE.
