<p> <input checked="" type="checkbox"/> Safety Recall <input type="checkbox"/> Field Campaign <input type="checkbox"/> Service Information <input type="checkbox"/> Product Improvement </p>	<p align="center"> <u>FIELD SERVICE BULLETIN</u> <u>All Models</u> <u>SEAT BELT CORNER CAP</u> <u>Recall 15V-391</u> </p>	<p> FSB_2015-110 Revision: 0 Issue Date: 9/11/2015 Manual Section: 9 Author: SFindley Approval: RPourtney Form Rev. D 11/21/14 </p>
---	---	--

DESCRIPTION: The aisle belt has the potential for fraying on the seat frame.

Recall 15V-391 Aisle Seat Belt Replacement

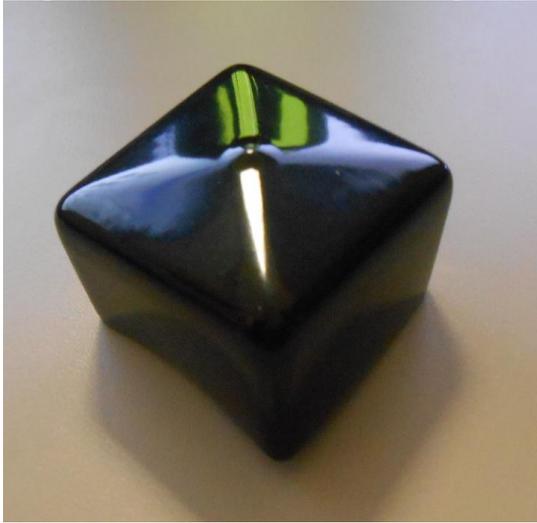
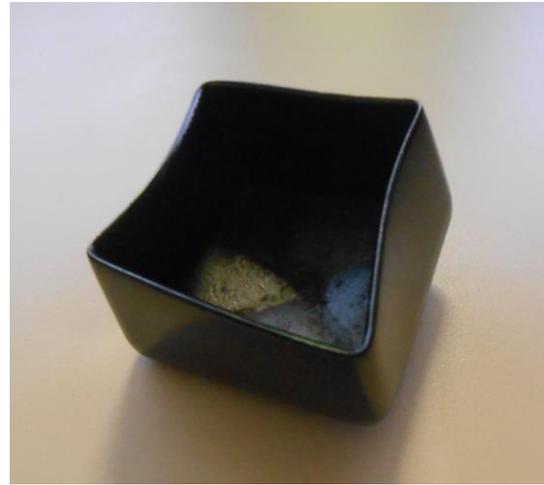
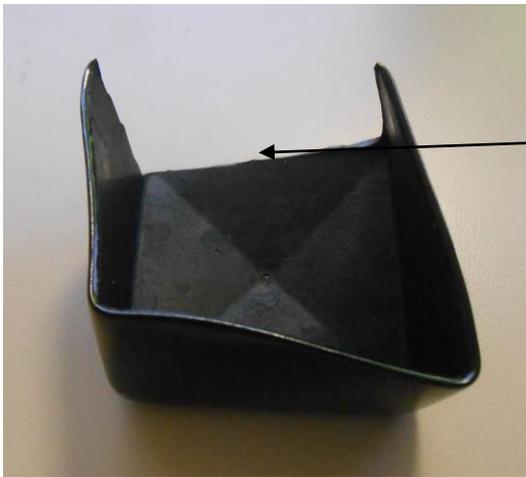
Step 1: cut one side off 6570326 cap

Using the utility knife: cut along the radius of the legs and across the top removing one side

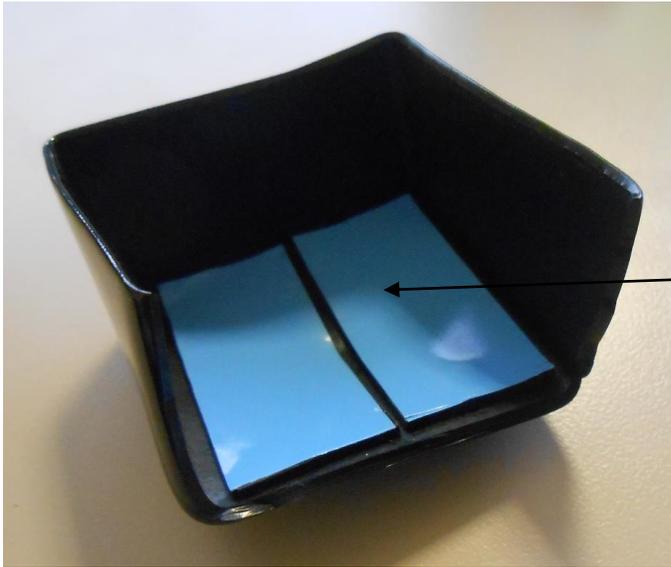
Step 2: apply the double sided tape 8970528

Using the utility knife, cut (2) 1.75" long strips of the double sided tape.
Apply the double sided tape side by side to the underside of the cap. (do not remove protective tape until ready to apply to the base frame.

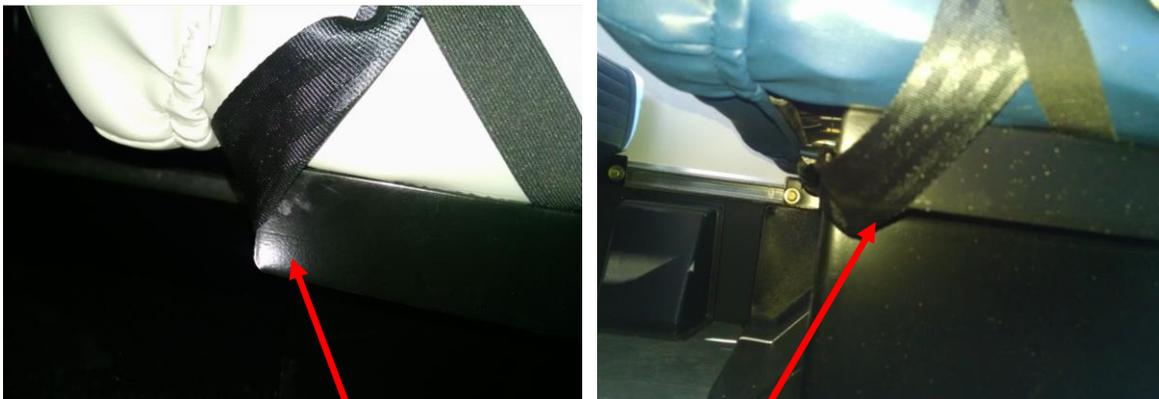
Step 3: locate seat/seat belt issue and apply cap

Seatbelt rubbing base frame is to be fixed

Move the seatbelt away from the base frame and clean the base frame to provide sufficient adhesion of the double sided tape.

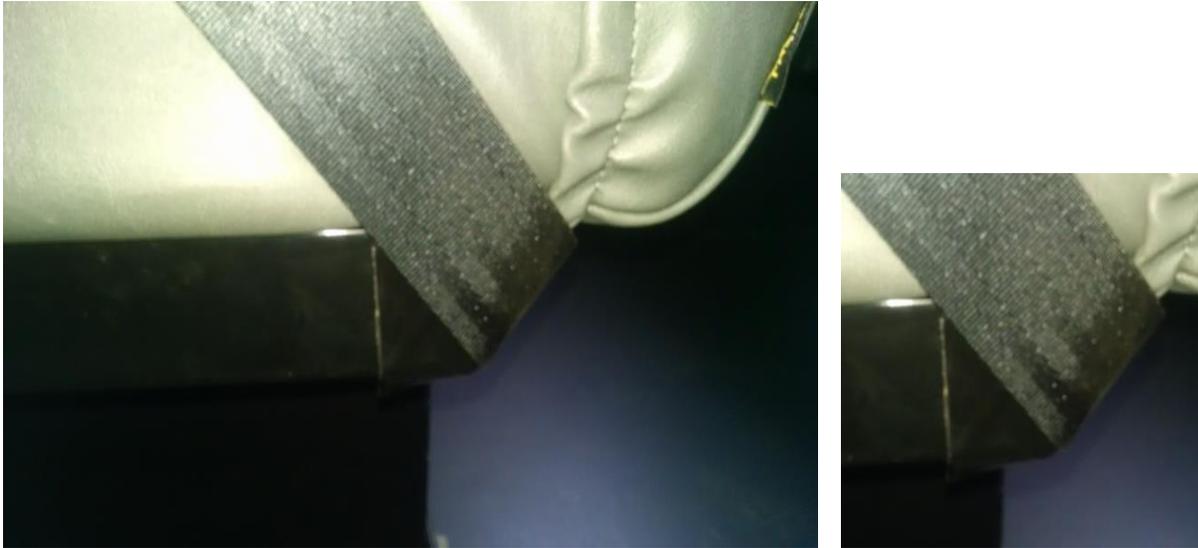
View of frame with cap in place

b: pply cap to back side of the base frame to cover edge of Freedamn plate
