SUBJECT: IFS Ball Joints

CONDITION: For a select group of IFS units, it is possible that the central steering system ball joints were not properly torqued or secured into the relay rod

APPLIES TO: This bulletin applies to ReycoGranning IFS models IFS20-XXXXX and IFS24-XXXXX used on Fire Apparatus.

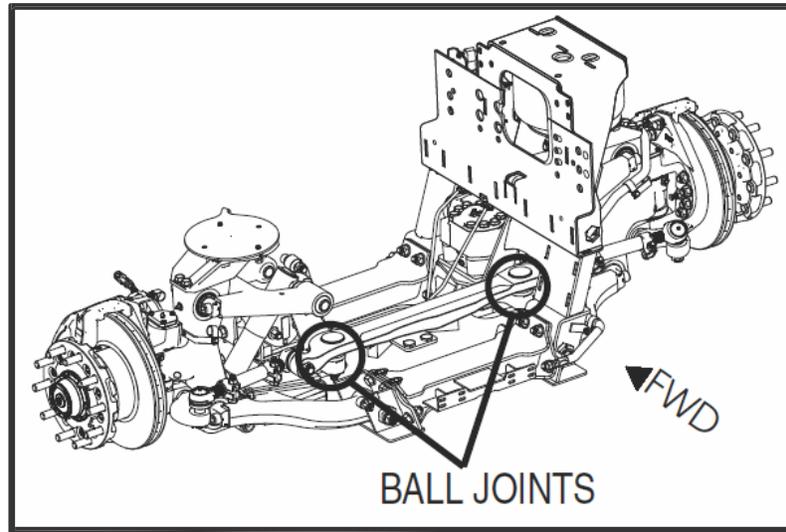
FIG. 2-1

1. Follow normal maintenance and safety procedures to gain access to the pitman arm ball joints. Refer to FIG. 2-1.

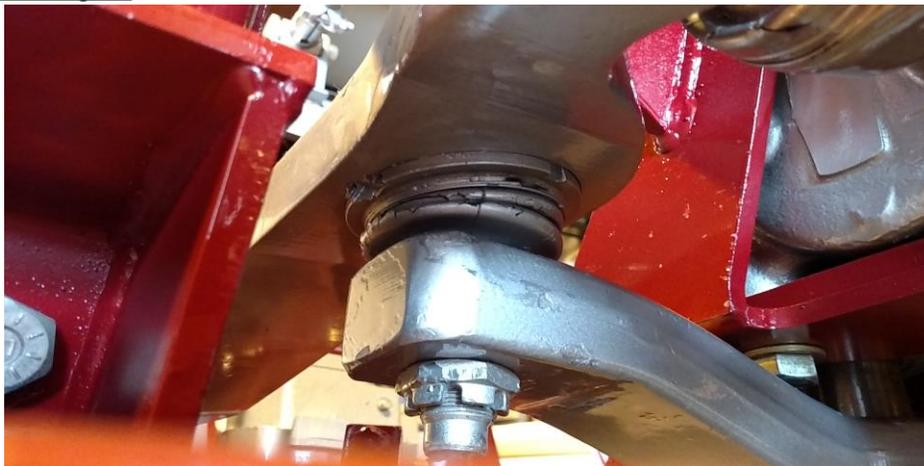
2. Visually inspect the ball joints located in pitman arms, the ball joints will be seated in both pitman arms off of the steering gears. The ball joint shall be fully engaged with the notched flange in contact with the spot face surface of the relay rod. If it is not, please proceed to the repair procedure. Refer to FIG. 2-2 and 3-1 (pictures may not represent suspension you are working on).

3. If the ball joint appears to be seated, using a 0.001 inch feeler gauges to check under the notched flange. If the feeler gauge slides under the flange, please proceed to the step by step instructions.
4. With a punch and hammer use moderate force in an effort to tighten the ball joint in place (clockwise). If it moves proceed to the step by step instructions. If it is tight this will finish the inspection and vehicle can be returned to service.

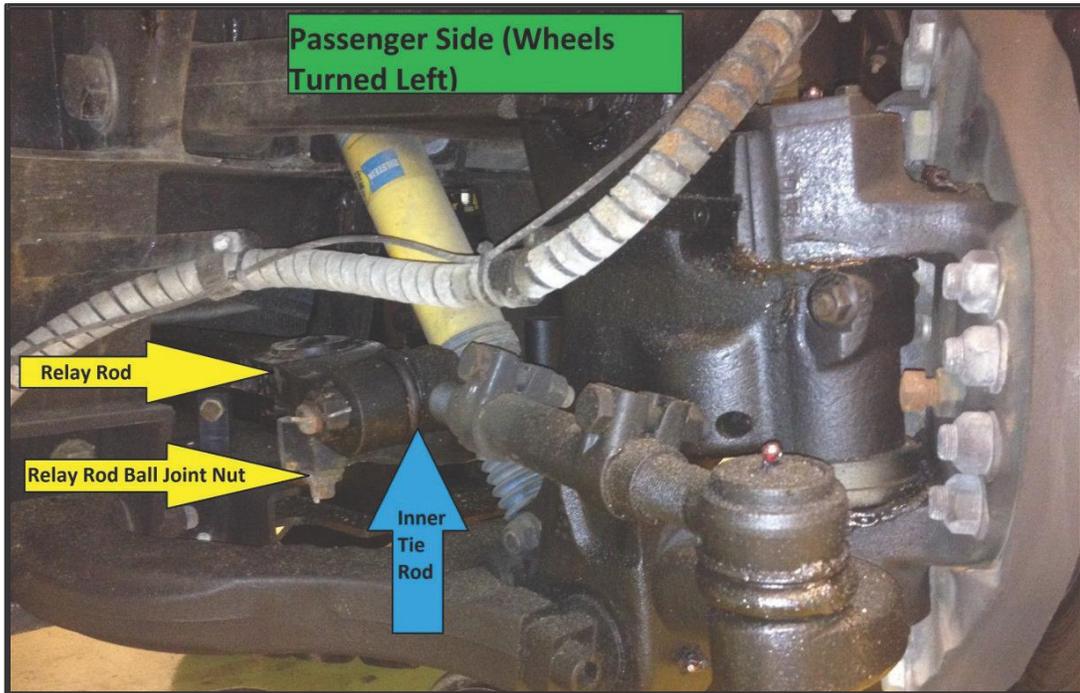
FIG. 4-1

1. If a ball joint is found loose contact Mark Bachman at 765-838-0361 ext. 6 to acquire loaner tools 708116-03, 708116-06. Credit card information will be required for security on tools.
2. Using industry standards means lift the front of the truck high enough to remove the front tires. Secure the truck and remove the front tires.
3. Turn the steering to full left lock to gain access to the relay rod from the passenger side. Starting on the passenger side remove the following from the relay rod. Refer to FIG. 4-1:
 - Inner tie rod joint
 - Relay rod ball joint from the pitman arm.
 - Pitman arm from steering gear (only needed on the passenger side).

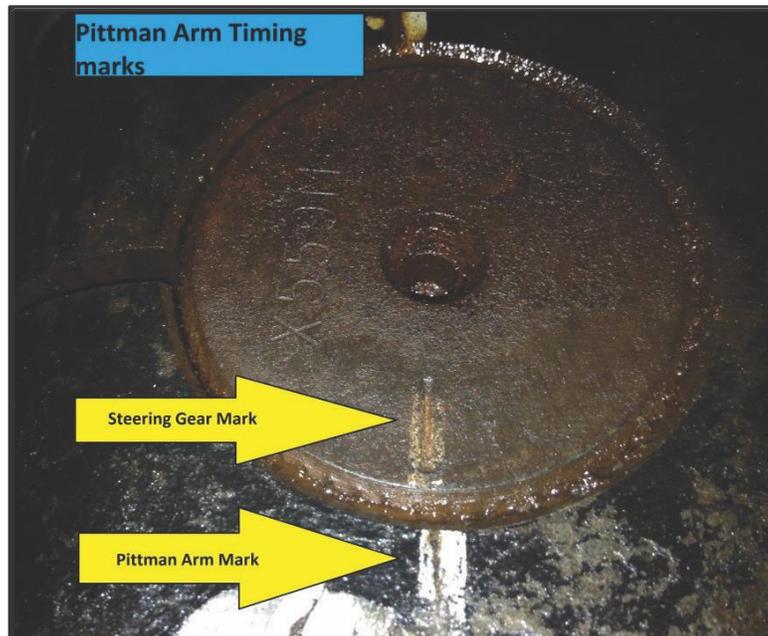
FIG. 4-2

NOTE: Mark the pitman arm to gear timing marks for aid in reinstallation. Refer to FIG. 4-2. There are two sets of marks; you will line up the outward set of marks.

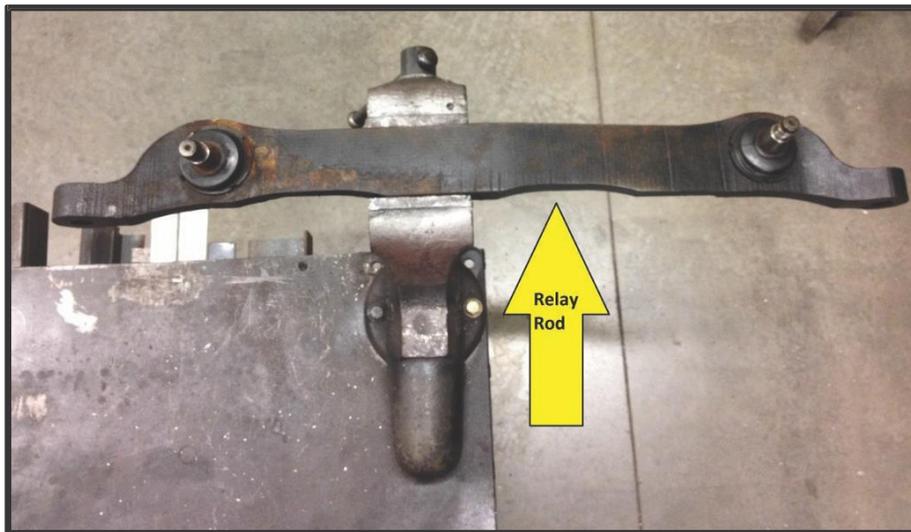
FIG. 5-1

5. Remove the relay rod assembly from the cradle and secure in a vise for repair. Refer to FIG. 5-1.

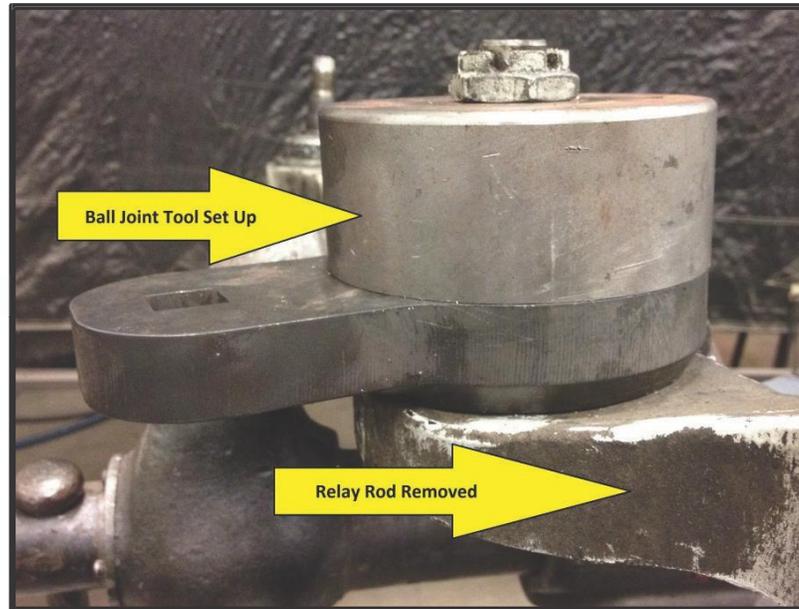
FIG. 6-1

6. Back the ball joints out of the relay rod and clean the threads. Apply Loctite 242 to ball joint threads and thread ball joint back into the relay rod. Set up provided ball joint tooling, using castle nut to loosely secure tooling. Refer to FIG. 6-1. Place a torque wrench 90° to ball joint tool and torque to 425 lbs.-ft. Refer to FIG. 6-2. Be sure that tooling set up is not binding when tightening, castle nut should come off freely after ball joint is torqued.
