### ***Kitchen Range/Cooktop Divider Panel Recall***

In connection with Crossroads RV Recall #15V-582 (USA) and #2015-406 (Canada), Crossroads RV is providing instructions for repair.

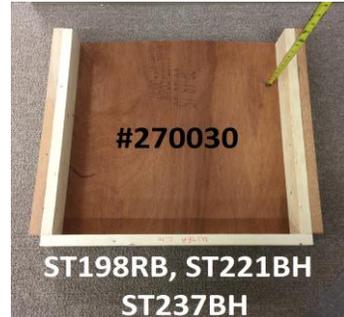
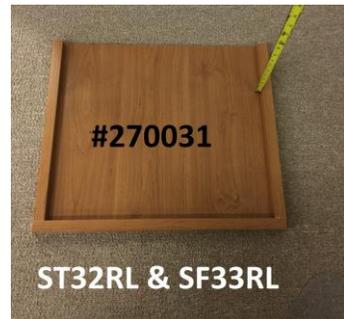
- Open the Outside Kitchen compartment door and extend outside kitchen pullout section.
- Inside the overhead cabinet to the right of the TV is the area with the missing divider wall panel. The exposed side of the kitchen range is visible. (See picture 1)
- Preset four screws to hold divider wall panel in place when installed. (2 screws per side)
- Insert divider wall panel into cabinet. Slide the divider wall panel up into cabinet. Verify that the panel is tight against the top of the opening and that the sides are tight against the range. (See picture 2)
- Tighten the screws so that the panel is secured and cannot move.
- Close pullout section and compartment door.
- The recall is complete.

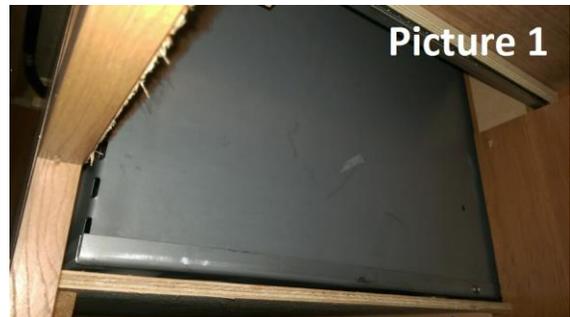
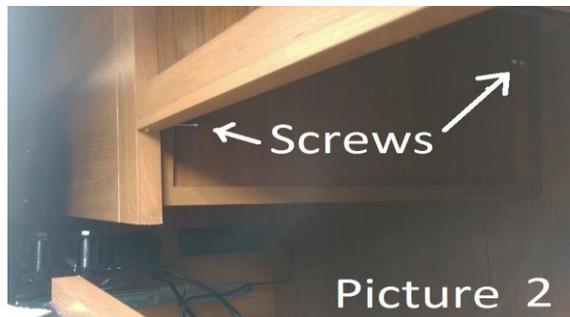
- Open the cabinet door under the kitchen cooktop.
- For easier installation, remove vertical access panel inside the cabinet if necessary. (See picture 3)
- Inside the cabinet at the top is the area with the missing divider bottom panel. The exposed bottom of the cooktop is visible. (See picture 4)
- Preset four screws to hold divider bottom panel in place when installed. (2 screws per side)
- Insert divider bottom panel into cabinet. The open end of the divider bottom panel goes in first. Slide the divider bottom panel up into cabinet. Verify that the panel is tight against the top of the opening and the cooktop. (See picture 5)
- Tighten the screws so that the divider bottom panel is secured and cannot move.
- Re-install vertical access panel (if removed).
- Close the cabinet door.
- The recall is complete.
