Bulletin No.: 01320A
Date: October 2015

PRODUCT SAFETY RECALL

SUBJECT: Front Seat Side Impact Airbag Module

MODELS: 2015 Buick LaCrosse
2015 Cadillac XTS, XTS Professional
2015 Chevrolet Camaro, Equinox, Malibu
2015 GMC Terrain

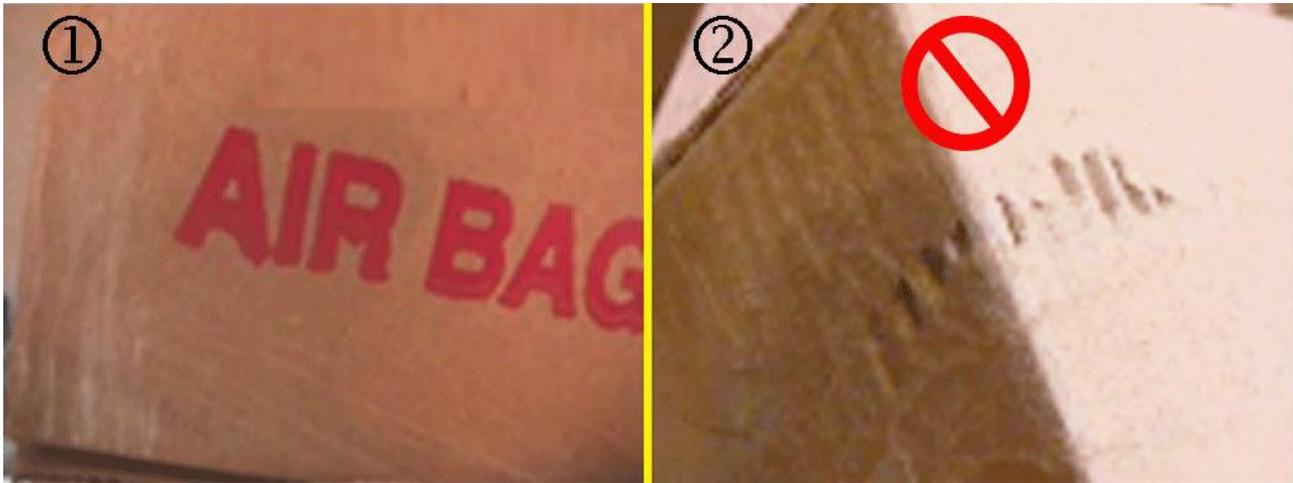
3961561

- **Abrasions:** Abrasions result from sliding the package against a rough surface (e.g. concrete floors). Major abrasions (2) are NOT acceptable. Note the flutes are visible.

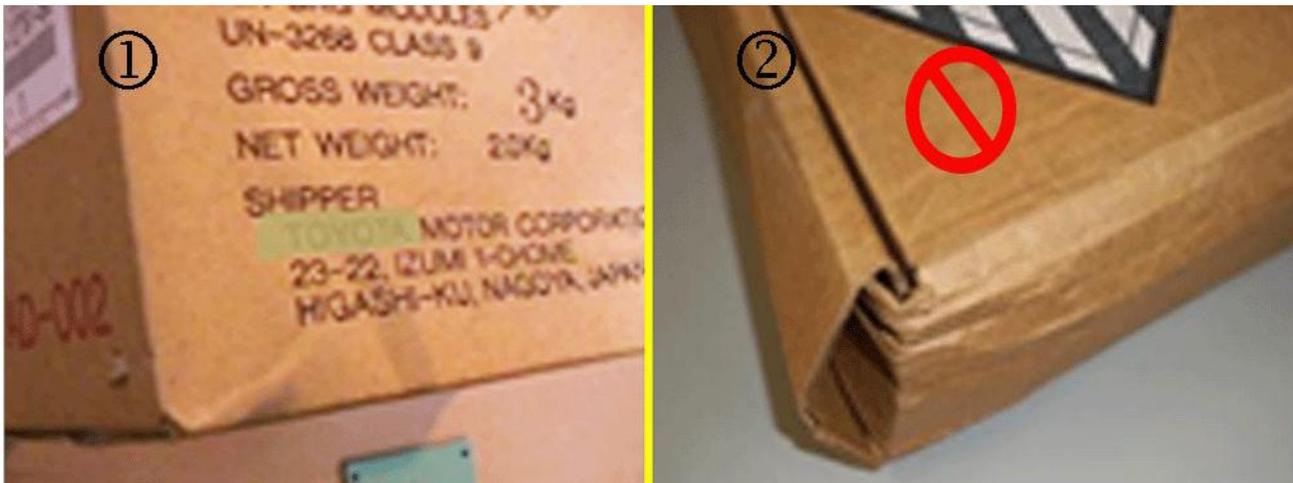
3961563

- **Compressions:** Compressions result from superimposed weights (e.g. stacked too high) or from dropping the packages. Small dimples (1) are acceptable.

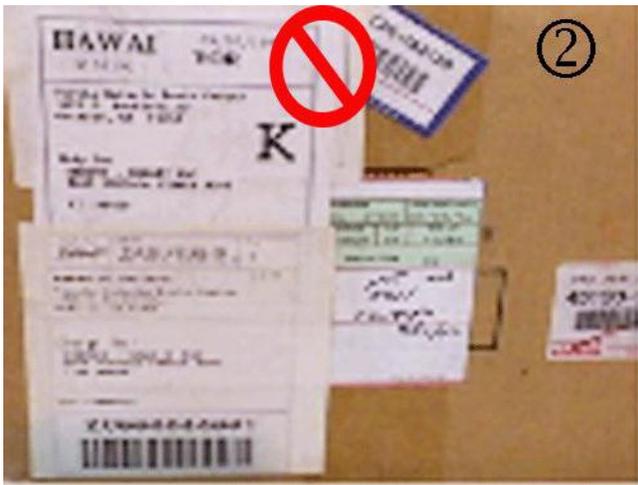
3961566

- **Labeling:** Packages with excessive labeling are NOT acceptable, particularly if the labels obscure other required marks and labels.

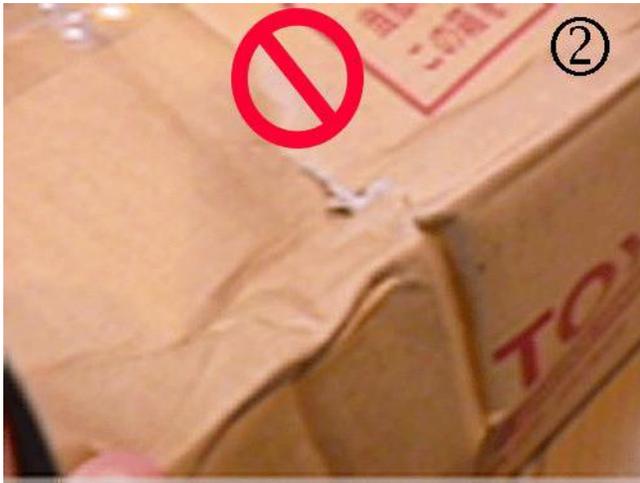
3961567

- **Other Damages:** Multiple damages, such as those shown above, may affect the integrity of the packages, and are NOT acceptable. Others that are not as severe may be acceptable. If questionable, repackage the material.

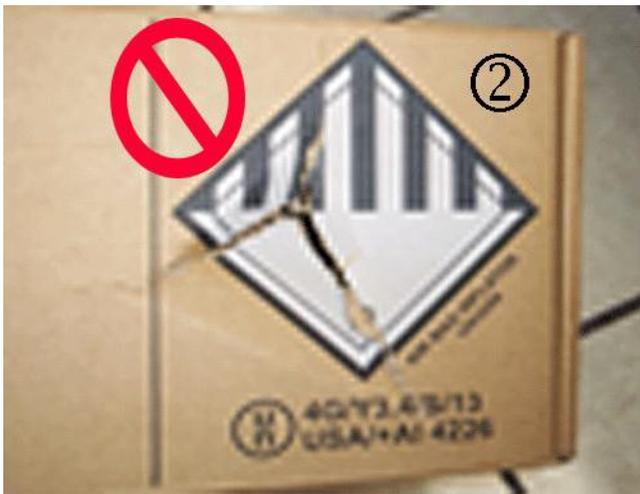
3961568

- **Punctures:** Any punctures, even minor ones, are NOT acceptable.

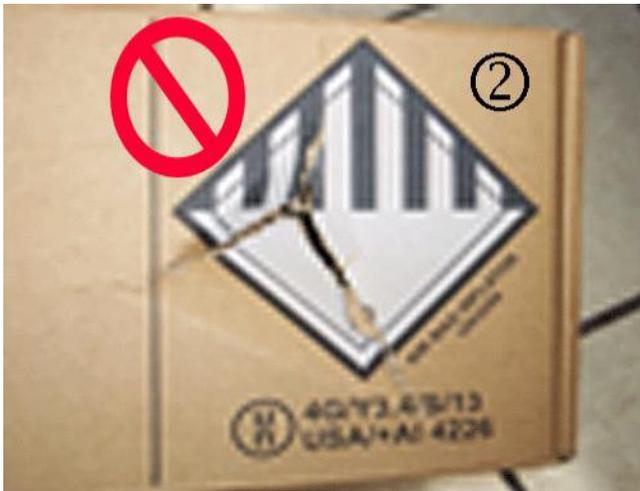
3961568

- **Tears:** Minor tears will not generally affect the structural integrity of the packaging and are considered to be normal "wear and tear", however, large tears or rips are NOT acceptable.

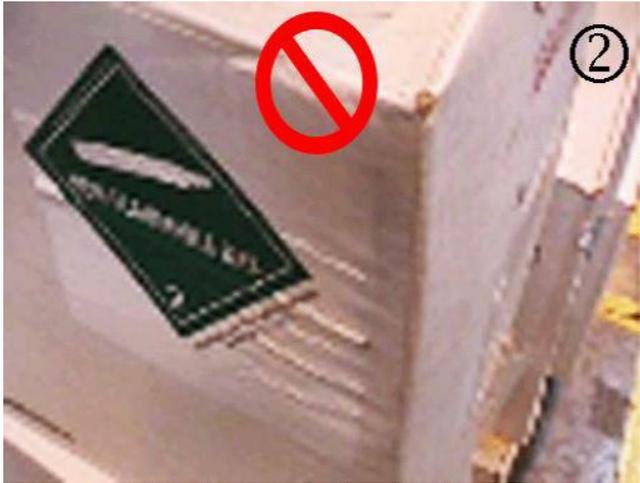
3961569

- **Water Damages:** Water Damages, such as the example shown above, are NOT acceptable. Water damages will affect the structural integrity of the packaging. These packages should be repacked in appropriate specification packages.
1. **DO NOT DEPLOY THE AIRBAG.** Ensure that the box the replacement airbag arrived in is not damaged and place the Front Seat Side Impact Airbag Module in the box. Also, make sure to include a copy of the repair order in the box. (Generic packaging shown)

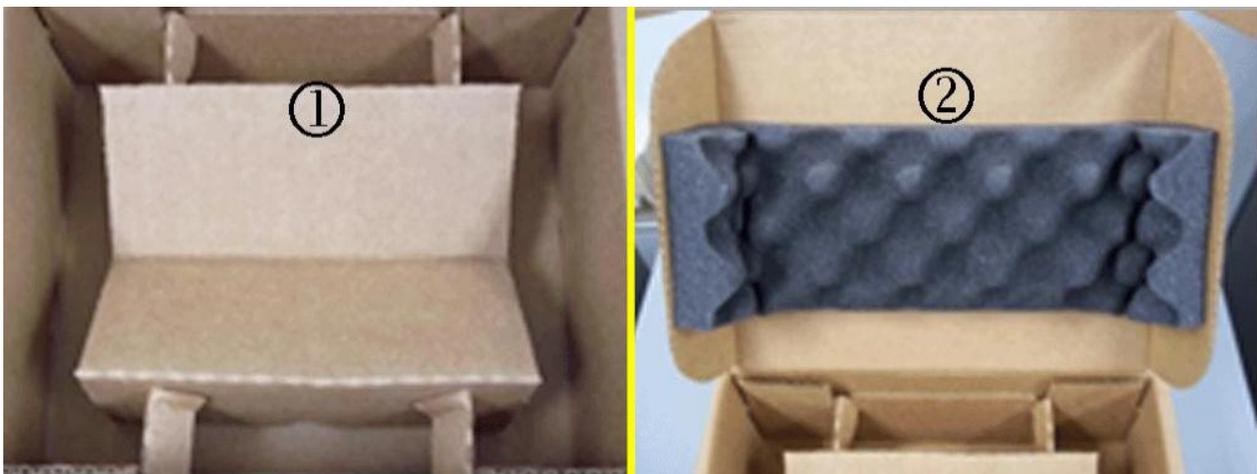
3961570

Important: The components required for the completed return package are dunnage (1) and foam (2), as shown in the graphic above.

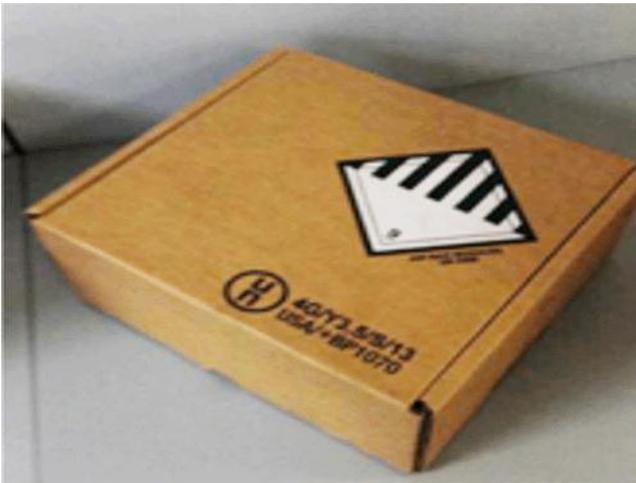
3955264

2. Close and secure any rollover tucks / flaps following the closing instructions below:

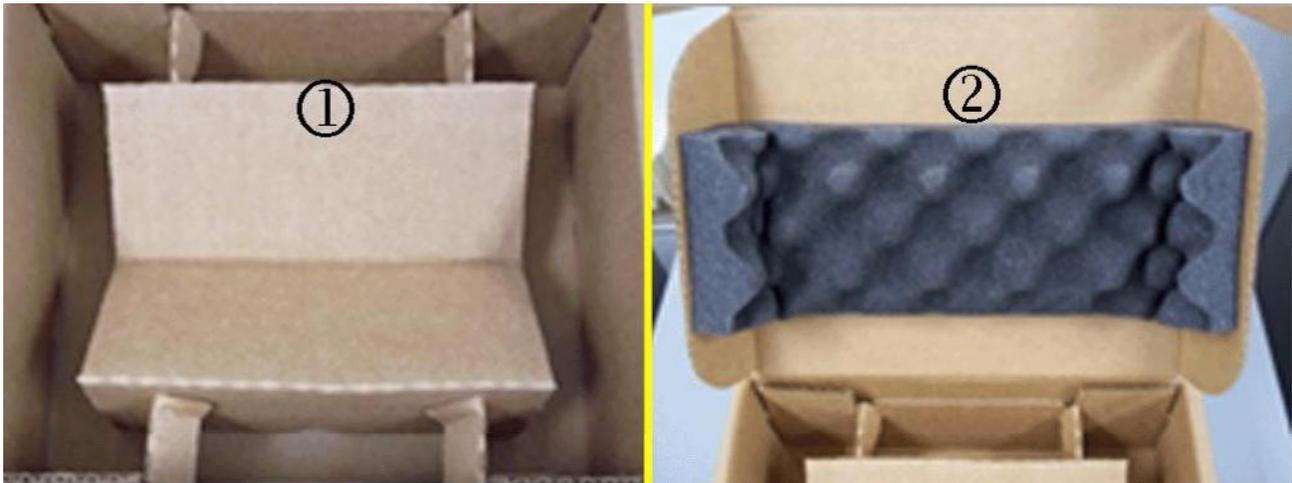
3961570

Important: The components required for the completed return package are dunnage (1) and foam (2), as shown in the graphic above.

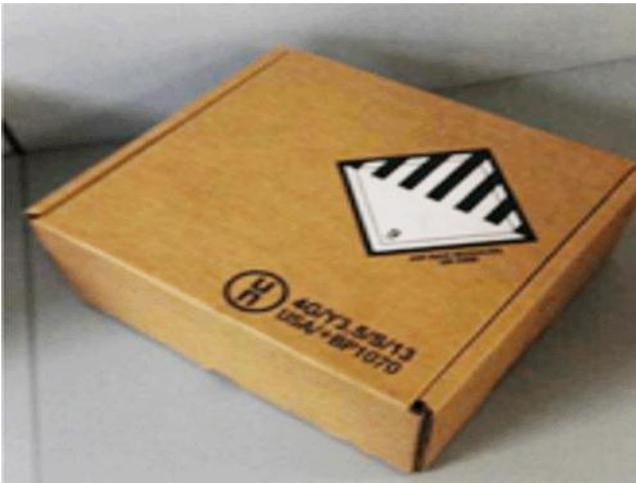
3955264

2. Close and secure any rollover tucks or flaps on the box following the closing instructions below:
