RECALL CAMPAIGN BULLETIN

NTB15-065

VOLUNTARY SAFETY RECALL CAMPAIGN DOOR LOCK INSPECTION 2015 SENTRA, VERSA NOTE, AND ROGUE

CAMPAIGN ID #: PC383 for Sentra/Versa Note
PC382 for Rogue

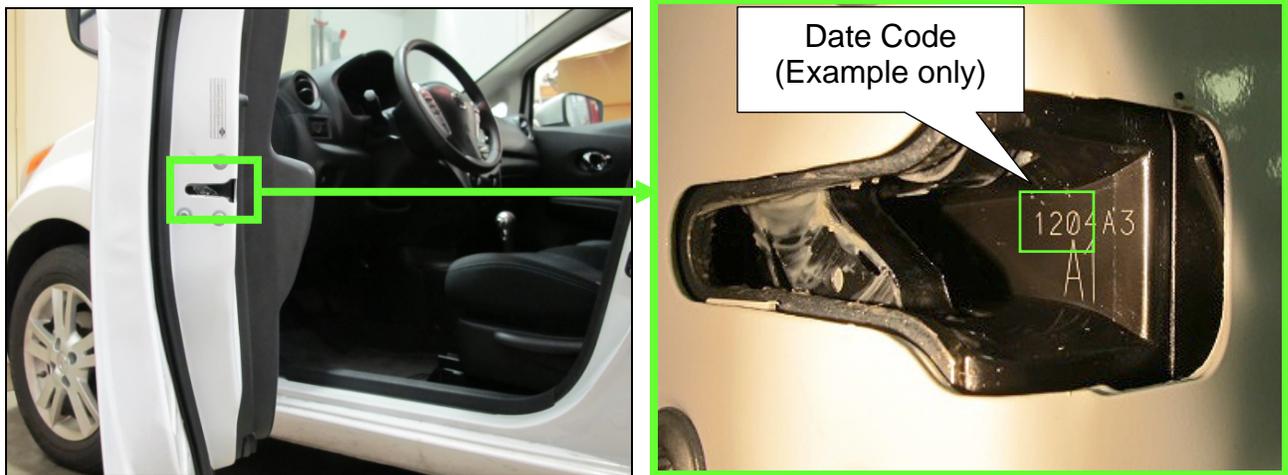
Figure A

In the Service Procedure starting on page 4, the Date Code on the driver's side door locks (Figure A) will first be inspected.

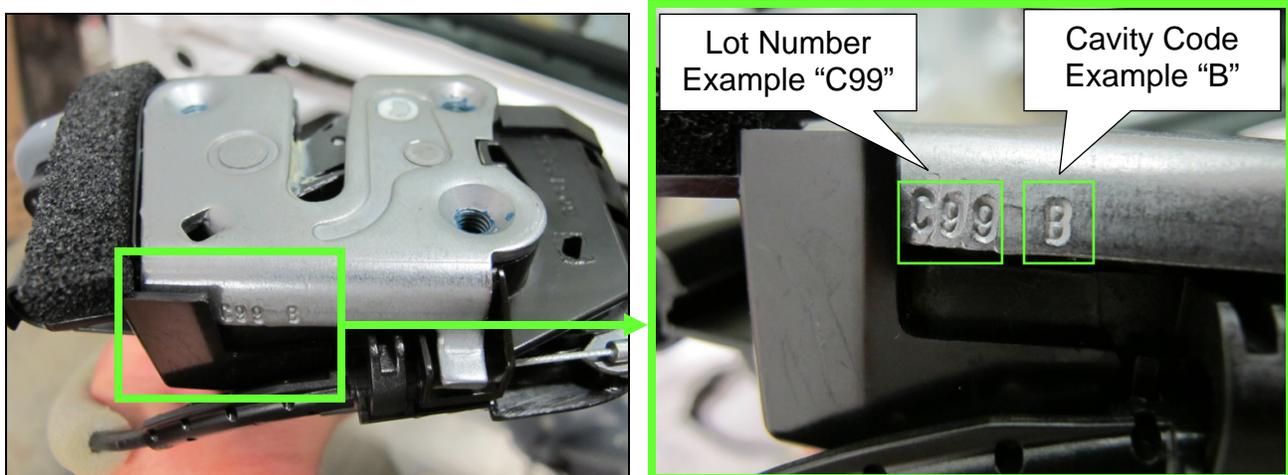
If a door lock has a Date Code within the number range provided, the Cavity Code and the Lot Number (Figure B) will also be inspected on that lock.

NOTE: Figure B is shown with the the door lock assembly removed for inspection of the Cavity Code and Lot Number.

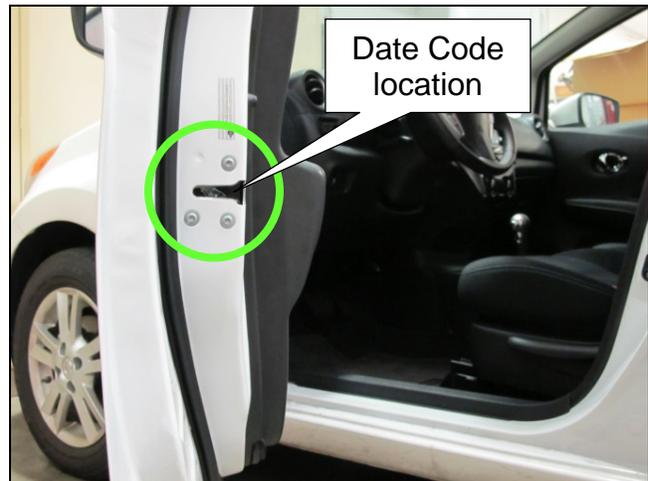
Figure 1

1. Locate door lock Date Code (Figure 1 and Figure 2) on applicable vehicle door(s) listed below.

Inspect the Date Code on the left front and left rear doors.

Inspect the Date Code on the left rear door ONLY.

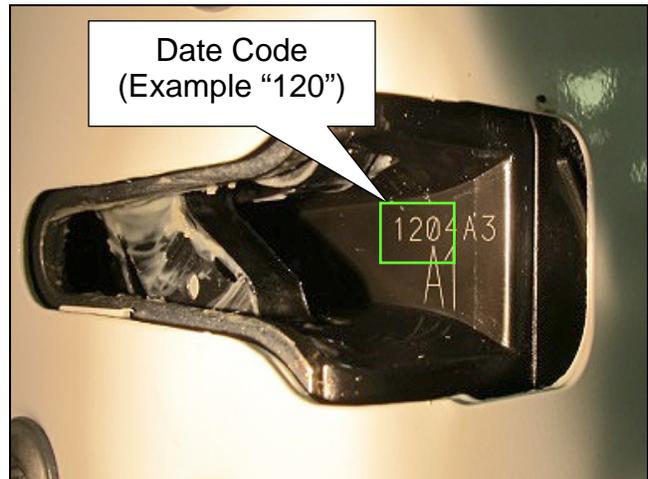
Figure 2

2. Inspect first three digits of the above model specified door lock(s) Date Code (Figure 2).

- If the first three Date Code digits are **154, 155, 156, 157, 158, 159** or **160** or are **unreadable**, continue to step 3.
- If the first three Date Code digits do not match one of those above, submit a claim and release the vehicle.

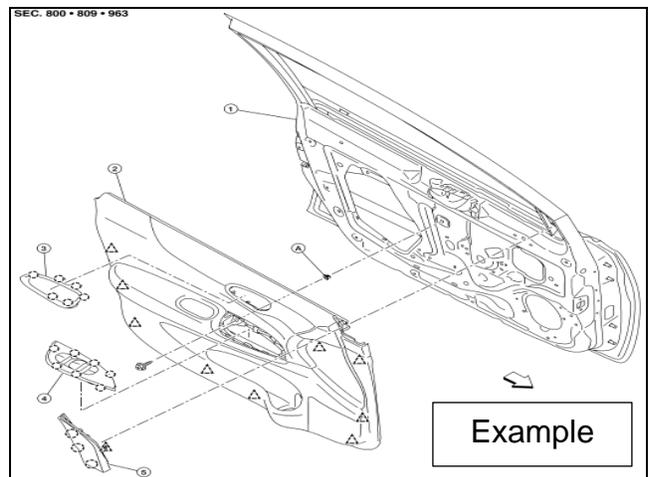
Figure 3

3. Remove the door finisher of the door or doors with the confirmed or unreadable Date Code digits identified in step 2 (example in Figure 3).

IMPORTANT: Only the doors with confirmed or unreadable Date Code will have the door finisher removed.

- Verify the door window is in the full up position.

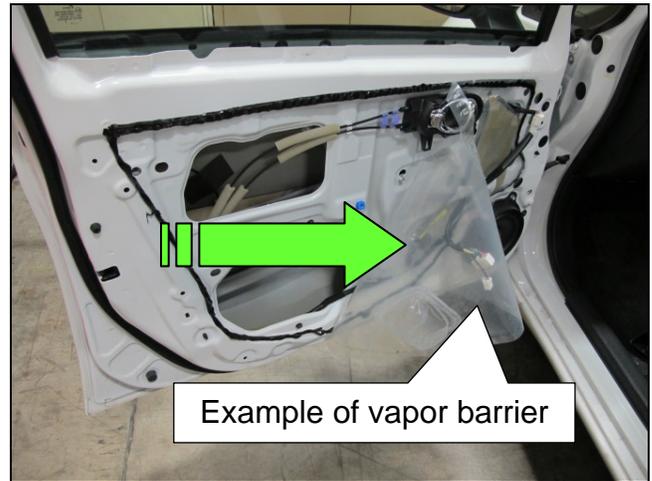
Figure 4

4. Working from the rear of the door, partially peel back the vapor barrier from the front or rear door panel (Figure 4).

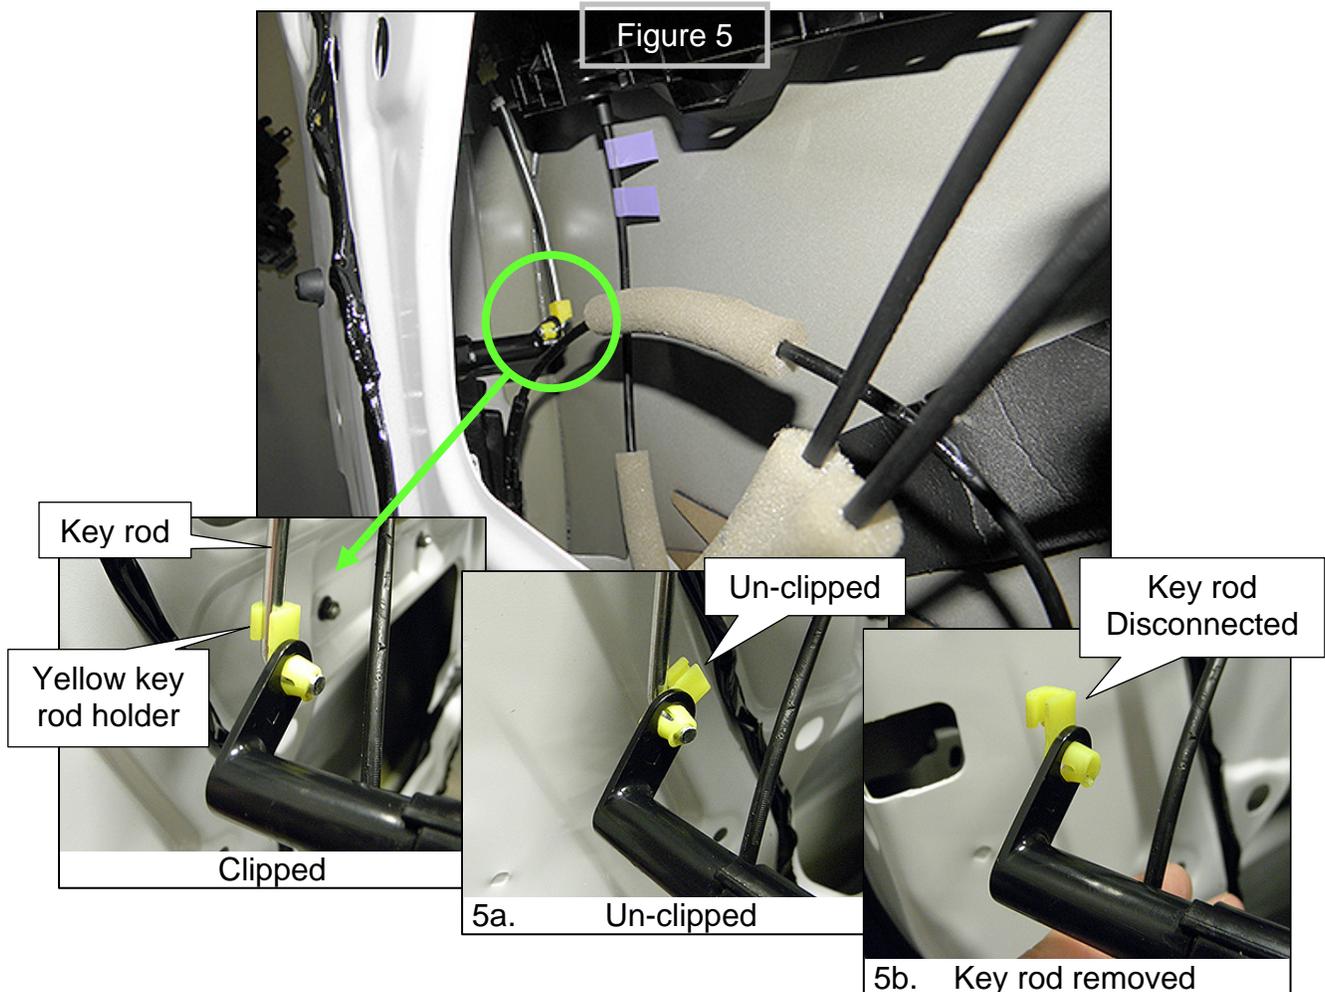
5. If a front door lock is being removed disconnect the key rod at the door lock assembly (Figure 5). If only a rear door lock is being removed, proceed to step 6.
 - a. Unclip the key rod holder (yellow plastic “clip”) by pulling the clip away from the metal key rod.
 - b. Separate the key rod from the clip and door lock assembly.

NOTE: Use care to not damage yellow key rod holder as it must be reused.

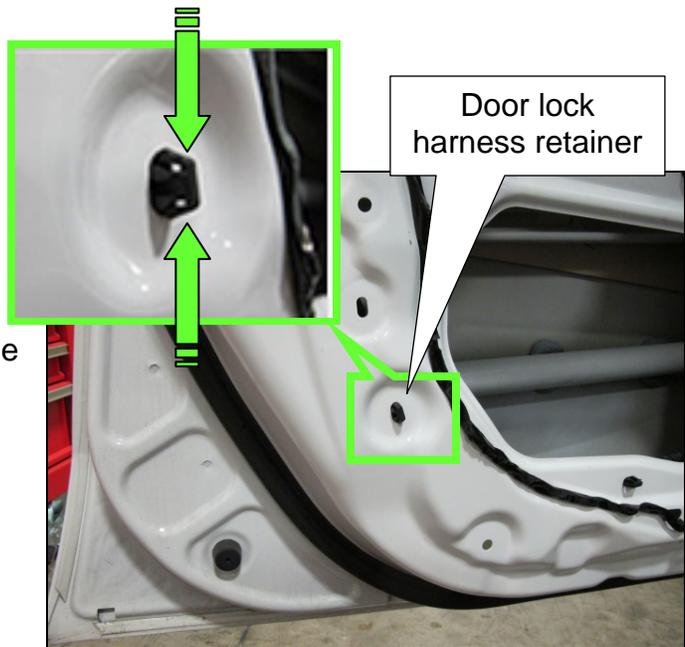
Figure 6

- **YES:** Disconnect the door lock harness retainer from the door being inspected (Figure 6).

NOTE: Pinch clips on both sides of the harness retainer while pushing the retainer into the door.

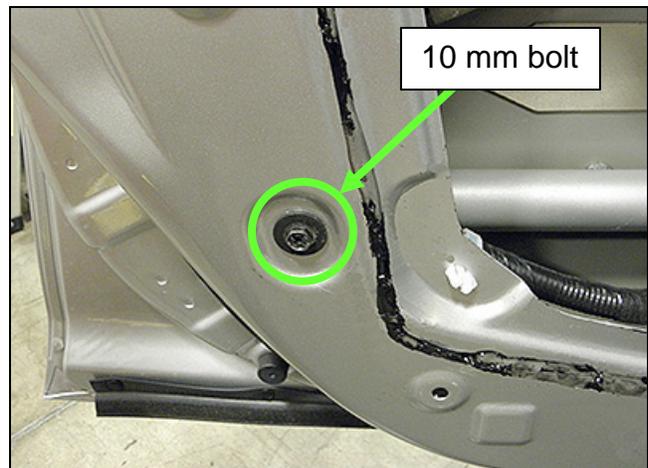
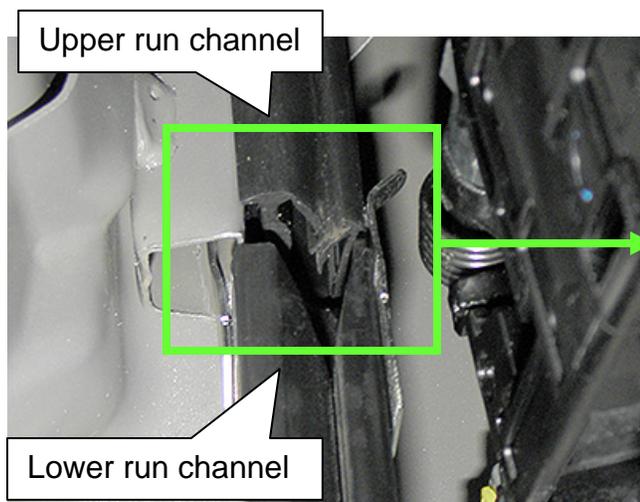
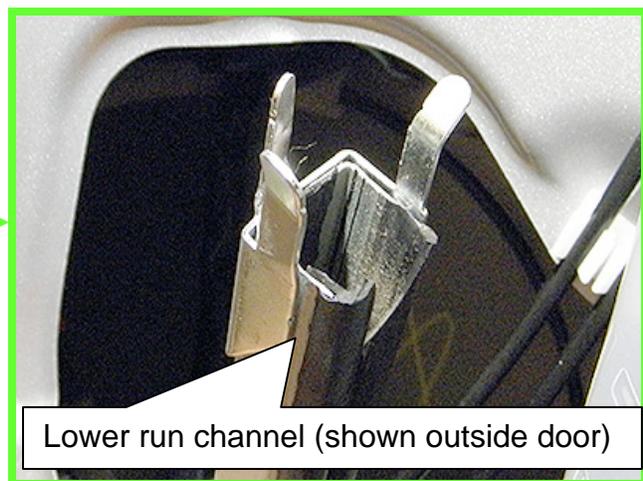
For Sentra left front door (refer to Figure 7, Figure 8 and Figure 9).

- Remove the 10 mm lower run channel retaining bolt.
- Move the lower run channel aside to allow the door lock to be removed.

- The top of the lower run channel is only clipped to the upper run channel and may detach.
- Refer to Figure 8 and Figure 9 for the correct orientation of the lower run channel.

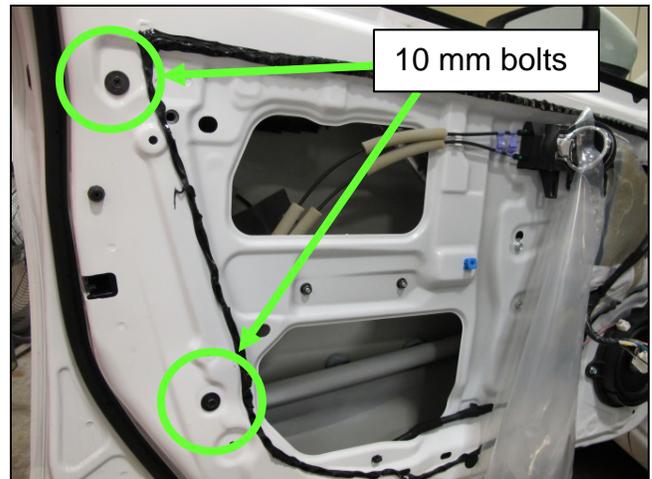
Figure 10

For Versa Note left front door (refer to Figure 10).

- a. Remove the two 10 mm run channel retaining bolts.
- b. Slide rear window run channel down and remove it from the door.

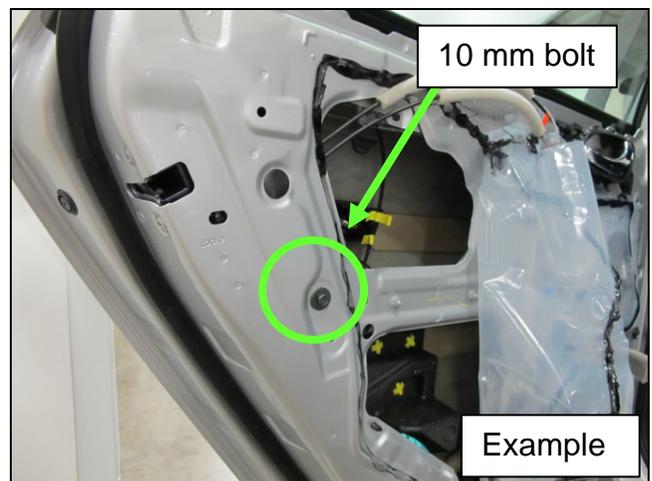
Figure 11

For Sentra, Versa Note and Rogue left rear door (refer to Figure 11).

- a. Remove the one 10 mm run channel retaining bolt.
- b. Push the bottom of rear window run channel back providing clearance to remove the door lock assembly.
 - Do NOT attempt to remove the window run channel as it is attached to the door at the top and could cause run channel damage.

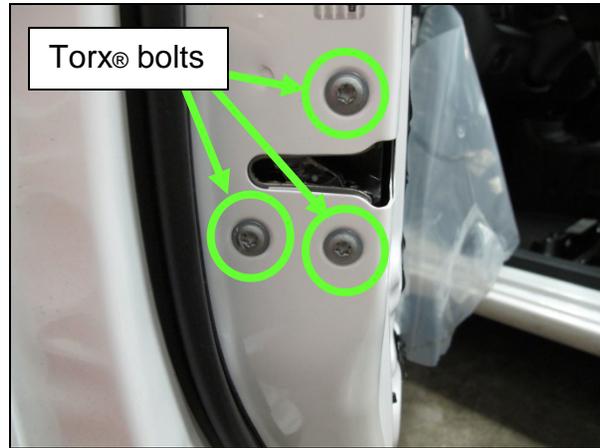
Figure 12

8. Remove door lock assembly retaining bolts.

- Remove the three T-30 Torx® bolts (Figure 12) and discard.

Reassembly Torque: 5.8 N•m (0.59 kg-m, 51 in-lb)

NOTE: Do NOT reuse bolts.

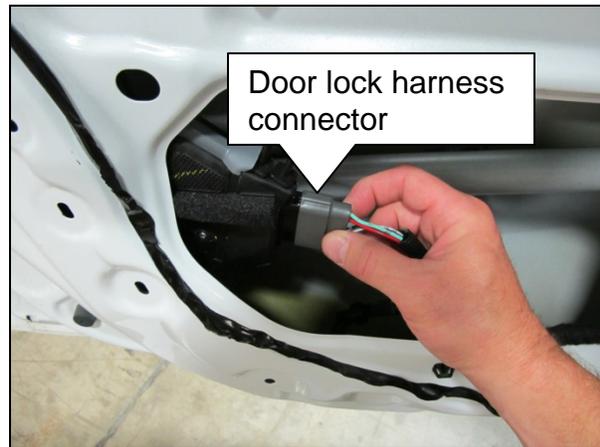
Figure 13

- **YES:** Disconnect the door lock harness connector(s).
- **NO:** Proceed to step 10.

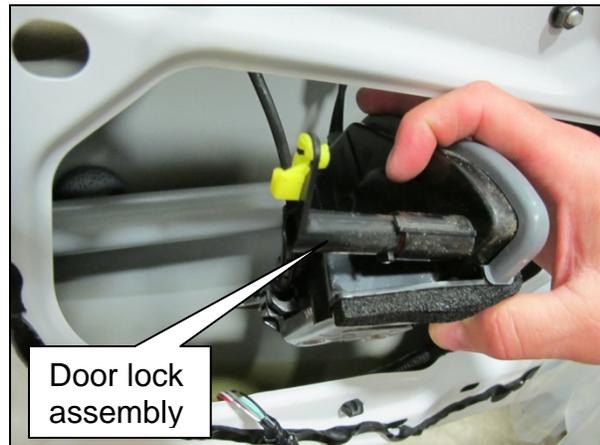
Figure 14

10. Pull the door lock assembly out of the door.

- Do not kink the door lock cables or disconnect them from the door handles.

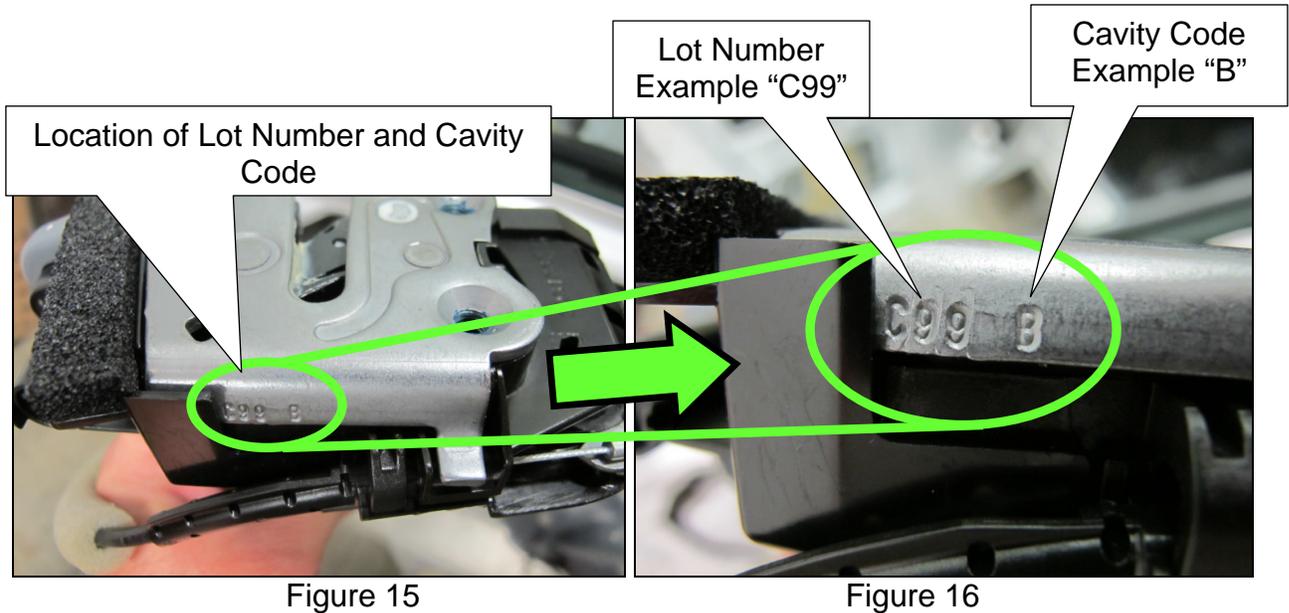
11. Inspect door lock assembly for the Cavity Code stamped on plate edge (Figures 15 and 16).

- If the Cavity Code stamped on the plate edge **IS NOT** a “B” reassemble the vehicle, submit a claim and release the vehicle.

- If the Cavity Code stamped on the plate edge **IS** a “B” proceed to Step 12.
- If the Cavity Code **cannot be determined** proceed to Step 12.

12. Inspect the door lock assembly for the Lot Number stamped on the plate edge. (Figures 15 and 16).

- If the Lot Number stamped on the plate edge **IS** an “E88”, reassemble the vehicle, submit a claim and release the vehicle.
- If the Lot Number stamped on the plate edge **IS NOT** an “E88”, replace the affected door latch assembly.
- If the Lot Number stamped on the plate edge **cannot be determined**, replace the affected door lock assembly.
