IMPORTANT SAFETY RECALL 15V-607

Fontaine Fifth Wheel has decided that a defect which relates to motor vehicle safety exists in Ultra LT model fifth wheels manufactured between 2009 and 2013.

Subject: Service Bulletin - Ultra LT Fifth Wheel Damage Caused by Improper Coupling

How do I identify if I have an Ultra LT Fifth Wheel?

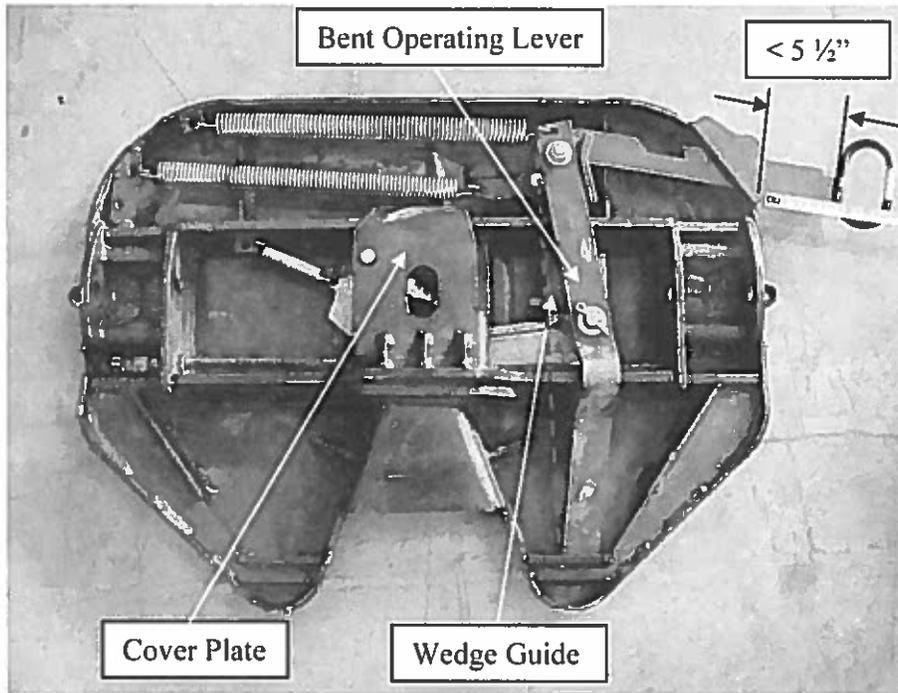
Bent Operating Lever – Pull Handle Dimension <math>< 5 \frac{1}{2}"</math>
Figure 1

1) Perform a thorough visual inspection of the fifth wheel, including underneath, looking for bent or damaged components. Pay particular attention to the operating lever (Figures 1 & 2), the rotating jaw and cover plate (Figures 3, 4, & 5), and the wedge guide (Figure 6). If any components are bent or damaged replace the fifth wheel.

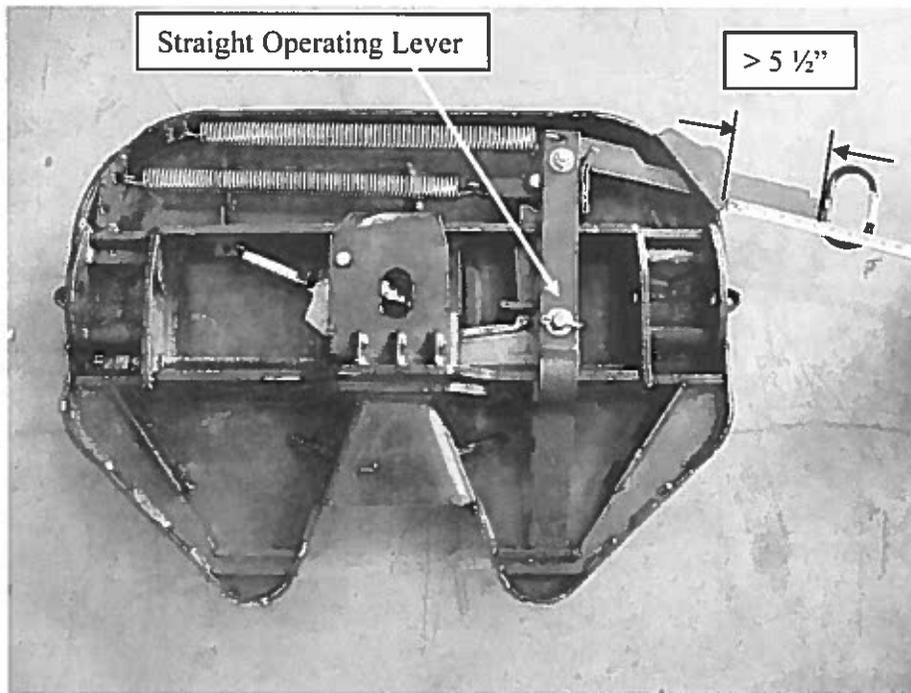
Undamaged Operating Lever – Pull Handle Dimension $> 5 \frac{1}{2}"$
Figure 2

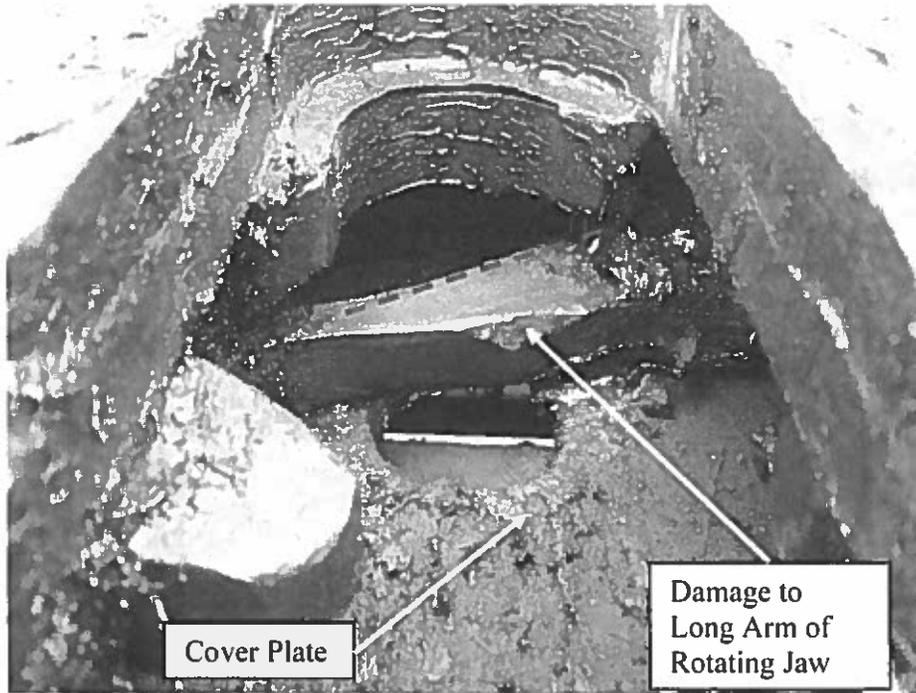
Damage to Rotating Jaw Caused By High Coupling, Resulting in a Bent Cover Plate
Figure 3

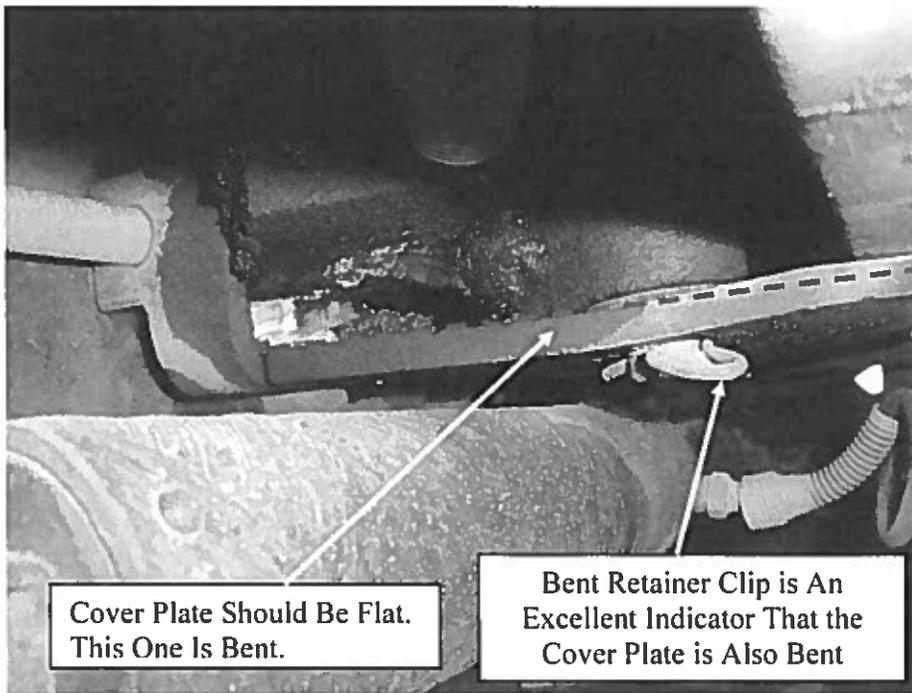
Bent Cover Plate
Figure 4

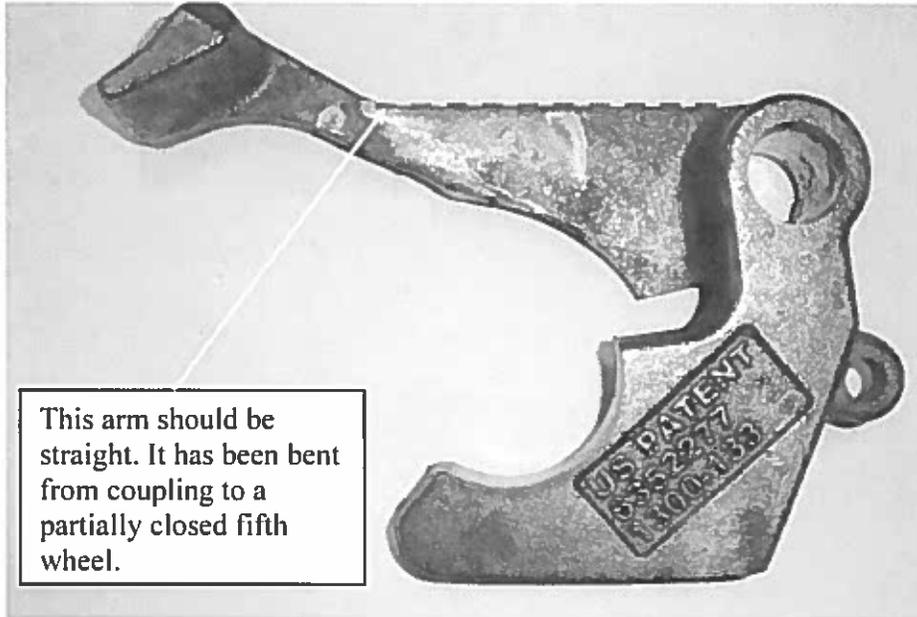
Damaged Rotating Jaw Caused By Improper Coupling
Figure 5

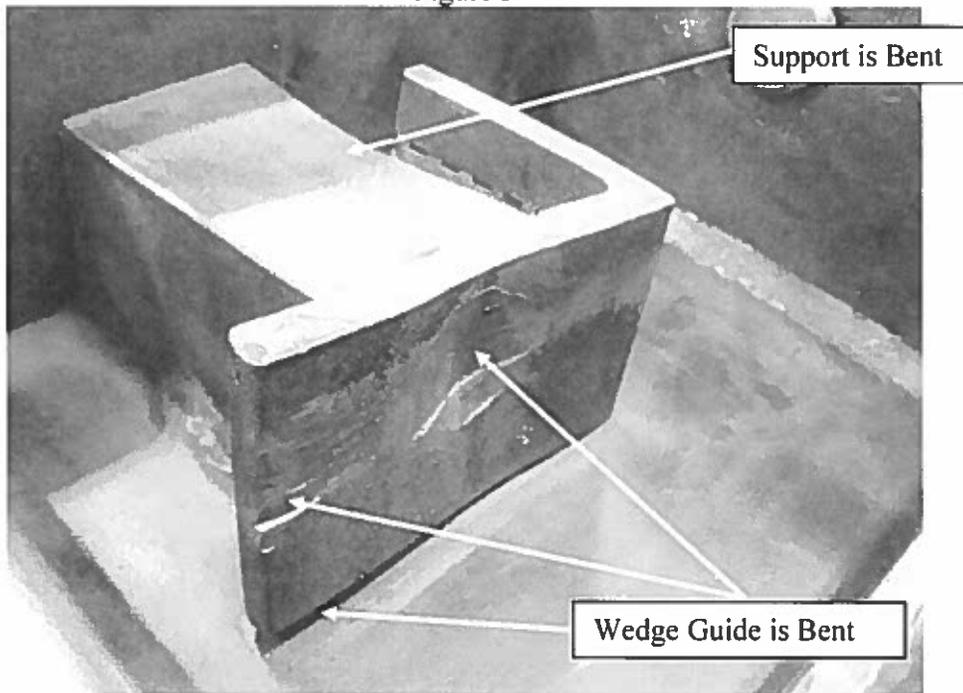
Wedge Guide Damage
Figure 6

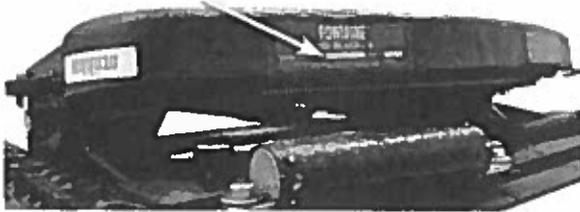
Model number location

Method 1: Identify the Model Number
