## Inspect Front Seat Belt Pre-Tensioners for Correct Installation

<b>Classification</b>	Recall Bulletin	<b>Section/Group</b>	20 - Safety and Restraint	<b>Country/Region</b>	All
<b>Year</b>	2012-2015	<b>Model</b>	Model S	<b>Version</b>	All

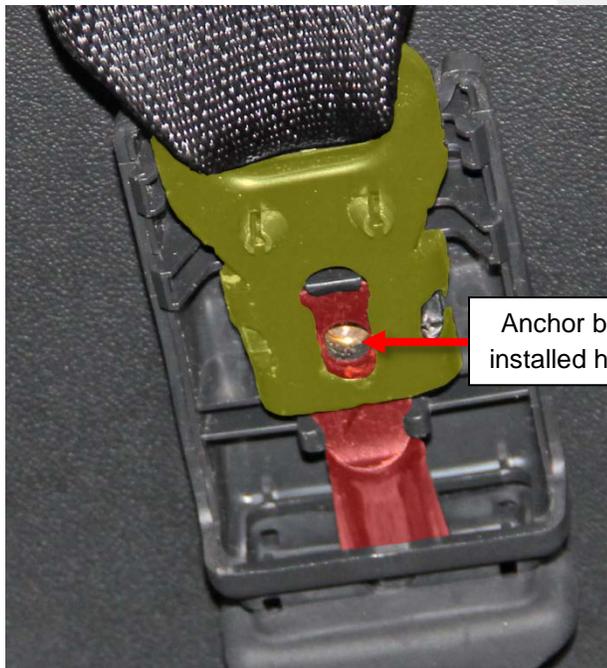
Some Model S vehicles might have been manufactured with the pre-tensioner(s) for the 1<sup>st</sup> row seat belts installed incorrectly. The pre-tensioner(s) might be secured to a plastic tab inside the upper pre-tensioner cover (Figure 2) instead of being secured to the seat belt by an anchor bolt (Figure 1).

✓ **Figure 1 (Correct; pre-tensioner highlighted in red, seat belt highlighted in yellow)**

- Resecure the seat belt assembly to the pre-tensioner (Figure 1).

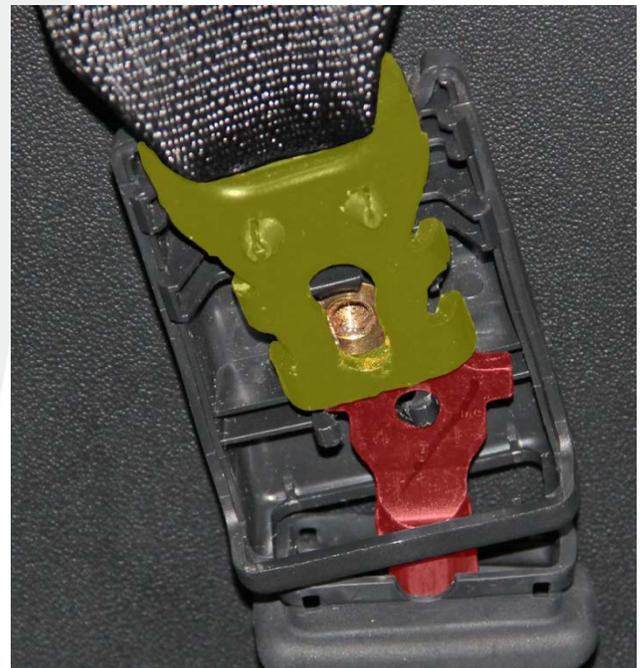
✗ **Figure 2 (Incorrect; pre-tensioner highlighted in red, seat belt highlighted in yellow)**

Inspect both front seat belt pre-tensioners to ensure that they are installed correctly. If either pre-tensioner is installed incorrectly, resecure the pre-tensioner.

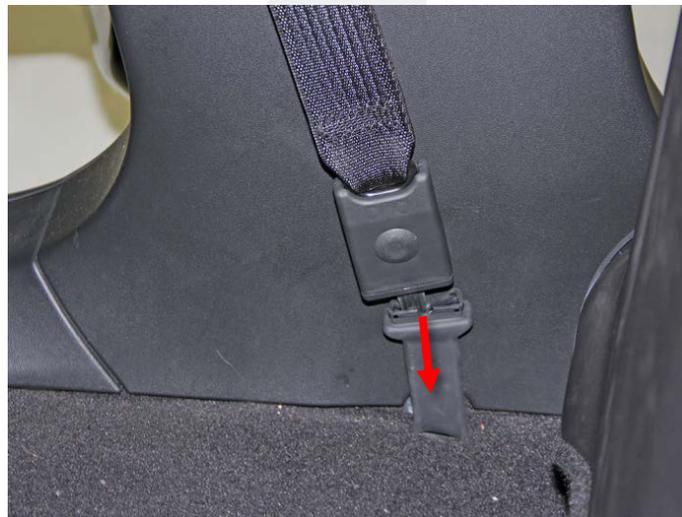
Figure 3

1. Move both front seats fully forward for access.
2. Pull the rubber pre-tensioner cover down (Figure 3).

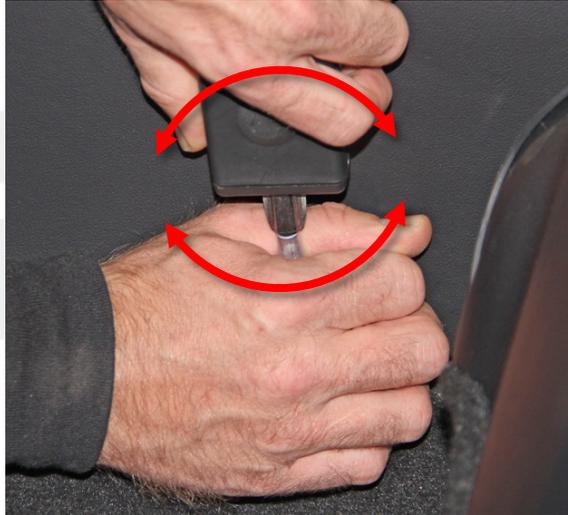
**Figure 4**

3. While holding the upper pre-tensioner cover with one hand and the pre-tensioner crimp with the other, firmly pivot the upper pre-tensioner cover and pre-tensioner back and forth to test if the pre-tensioner moves freely (Figure 4).
  - If the pre-tensioner feels firm and moves in unison with the upper pre-tensioner cover and seat belt, continue to the next step.
  - If the pre-tensioner feels loose or moves freely or with little resistance, skip to the “Resecure the Pre-tensioner” section of this document.

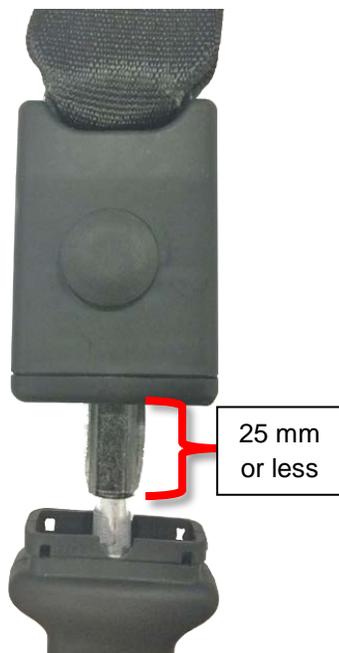
**✓ Figure 5**

4. Measure the distance between the bottom of the upper pre-tensioner cover and the bottom of the exposed crimp:
  - If the distance is 25 mm (1 in) or less (Figure 5), continue to the next step.
  - If the distance is more than 25 mm (1 in) (Figure 6), skip to the “Resecure the Pre-tensioner” section of this document.

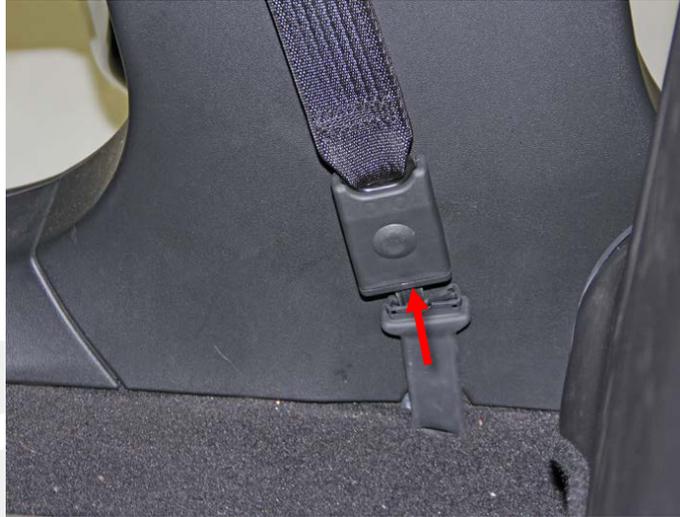
**Figure 7**

5. Reinstall the rubber pre-tensioner cover (Figure 7).

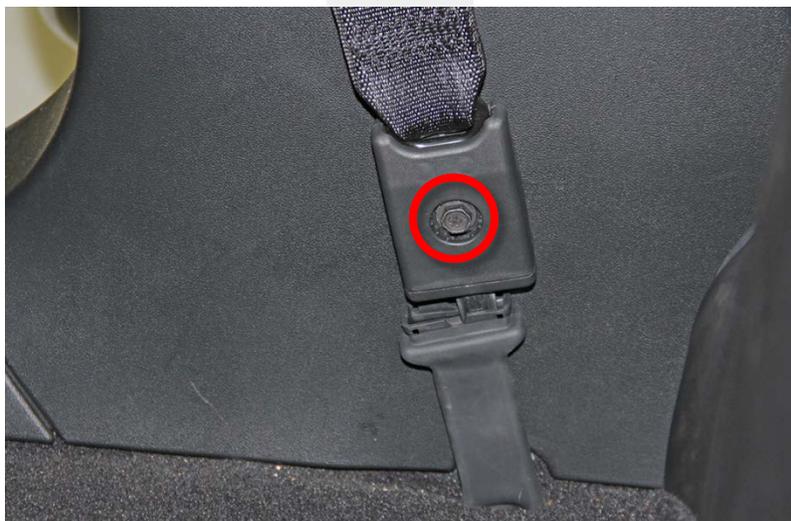
**Figure 8**

1. Use a trim tool to carefully release the anchor bolt cap from the inboard upper pre-tensioner cover.
2. Remove and discard the anchor bolt that secures the seat belt to the pre-tensioner (Figure 8).

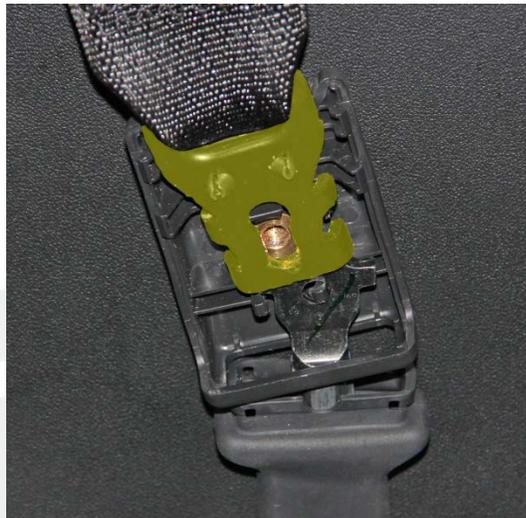
- Carefully release the seat belt assembly from the upper pre-tensioner cover (Figure 9). Temporarily move the seat belt away from the working area.

**Figure 9 (Seat belt assembly highlighted)**

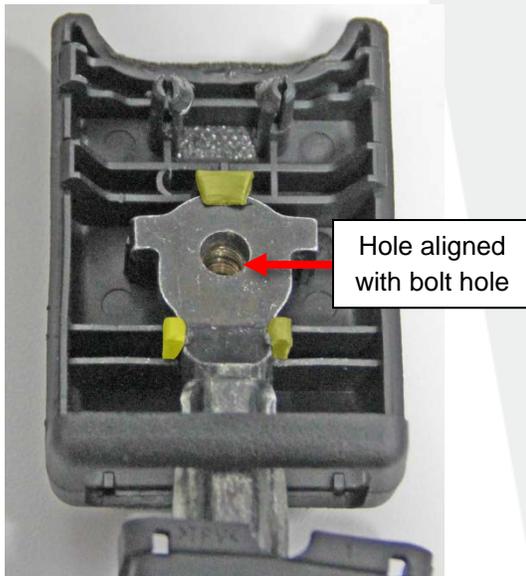
- Release the pre-tensioner from the plastic retaining tab in the upper pre-tensioner cover (Figure 11). Reposition the pre-tensioner so that it is centered between the 3 plastic retaining tabs with the hole aligned with the bolt hole (Figure 10).

**✓ Figure 10 (Retaining tabs highlighted)**

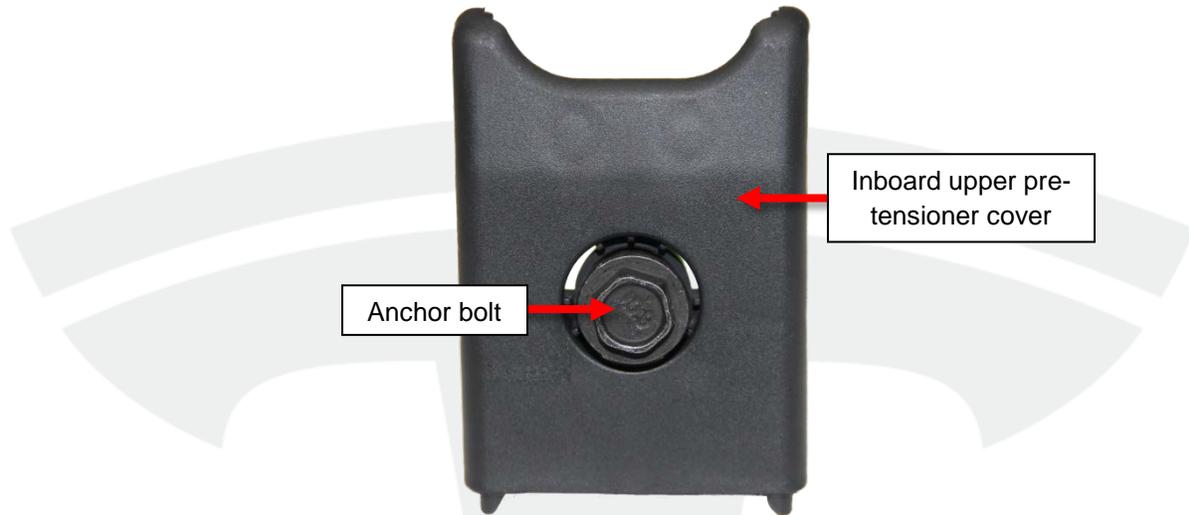
**Figure 12**

7. Install the new inboard upper pre-tensioner cover (Figure 12).

8. Use the anchor bolt that is included with the new inboard upper pre-tensioner cover to secure the seat belt to the pre-tensioner (torque 9 Nm) (Figure 12).
