RECALL CAMPAIGN BULLETIN

NTB15-109

VOLUNTARY RECALL CAMPAIGN 2015-2016 GTR SOLD IN PUERTO RICO CERTIFICATION LABEL

CAMPAIGN ID #: P5334
APPLIED VEHICLE: 2015-2016 GTR (R35)

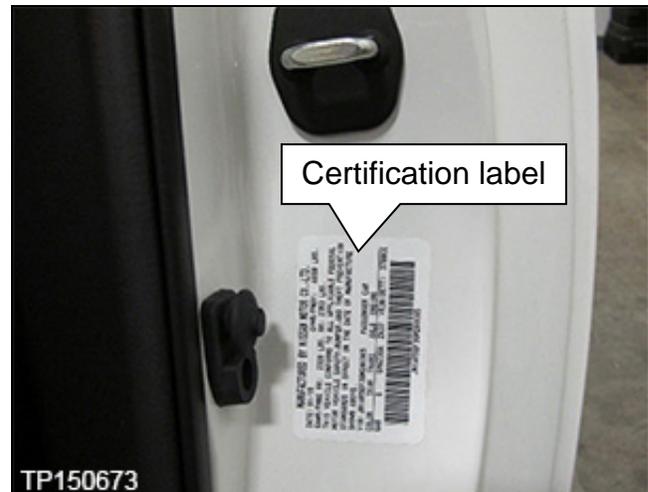
Figure 1

3. Locate the certification label (Figure 1).

NOTE: The certification label has the VIN on it.

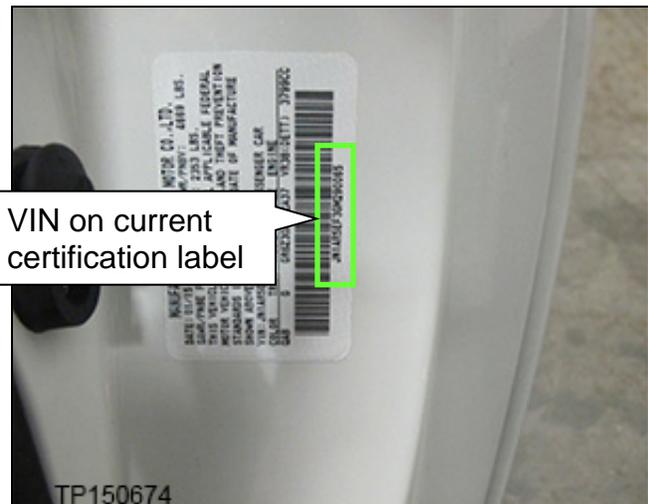
Figure 2

4. Confirm the VIN on the new certification label matches the VIN on the certification label that is currently attached to the vehicle (Figure 2).

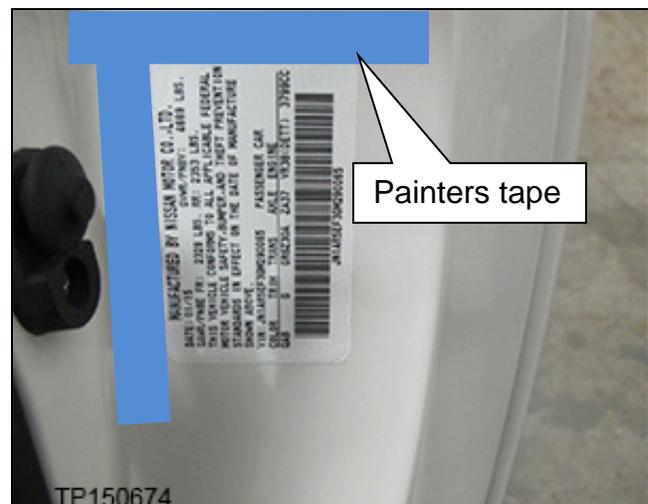
Figure 3

5. Clean the area around the current certification label (Figure 3).

- Use 50/50 solution of isopropyl alcohol and water, allow the area to dry.

NOTE: Do not use harsh chemicals that may damage the painted surface.

6. Mark the location of the current certification label with painters tape.

NOTE: Apply tape along one vertical and one horizontal edge.

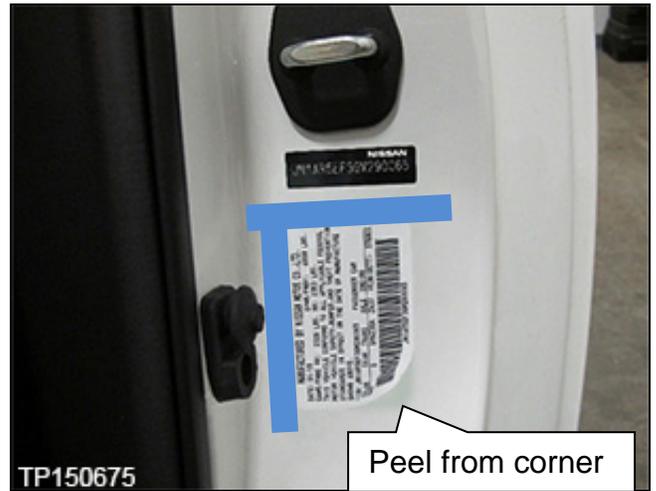
Figure 4

7. Use a plastic trim tool to peel and remove the current certification label (Figure 4).
 - Take great care not to damage the paint.

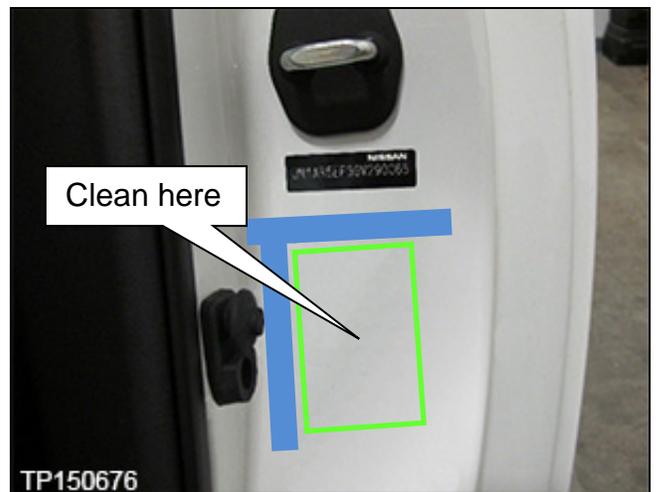
Figure 5

8. Clean the area where the old certification label was attached (Figure 5).
 - Use 50/50 solution of isopropyl alcohol and water; allow the area to dry.

- Do not use harsh chemicals that may damage the painted surface.
- It is important that the surface is free of any dirt and oil to ensure proper adhesion of the new label.

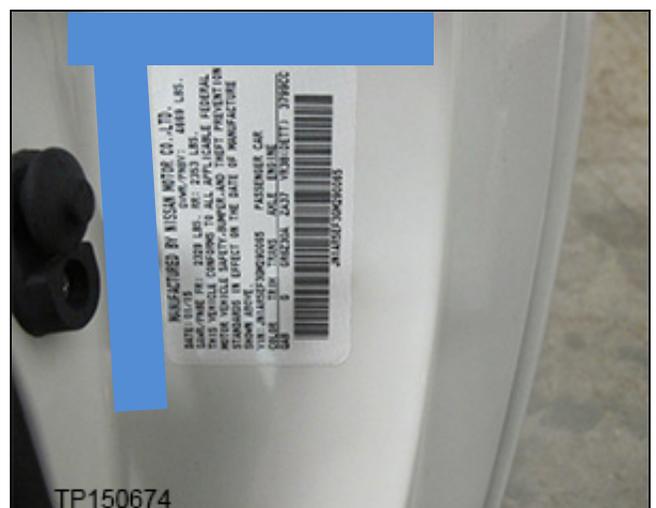
Figure 6

9. Attach the new certification label:
 - a. Peel the new certification label from its backing sheet.
 - b. Line up the new certification label with the painters tape (Figure 6).
 - c. Attach the new certification label from the top down.

- The adhesive on the label is permanent.
- Extra care should be taken when applying the new label since it cannot be moved once it is attached.
