FL685AB

Subject: TBB Emergency Door Handles

Models Affected: Specific Thomas Built Buses Vista, TL-960, Saf-T-Liner Conventional, ER, MVP-EF, EFX, MVP-ER, FS65, C2, and HDX Buses manufactured February 5, 2001, through May 29, 2012.

Recall Campaign

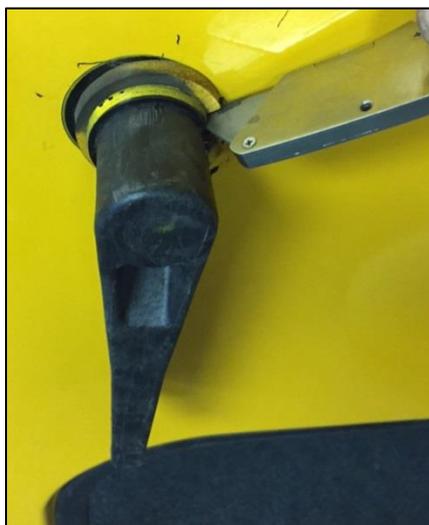
Figure 1, Cutting Washers

1. Chock the wheels, set the parking brake, make sure the shifter is in Park or Neutral. Disconnect the battery and the ignition switch is off.
2. Remove the washers between the external door handle and the door facing. Use a razor knife to slice through the large washer and then the smaller diameter plastic washer. Slide something under the washers to keep from damaging the paint on the door. See **Figure 1**.

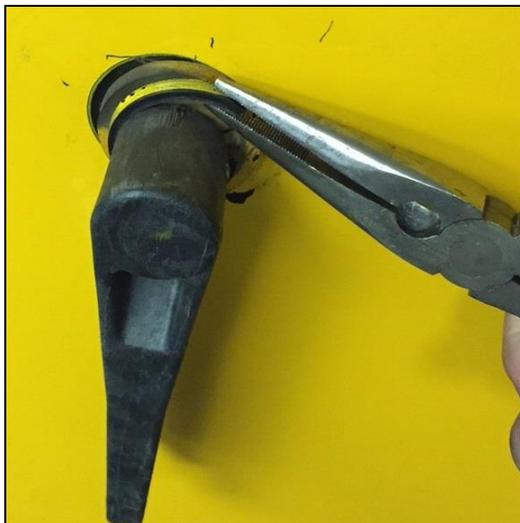
Figure 2, Removing Washers

3. Pull the washers off with needle nose pliers and discard the washers. See **Figure 2**.

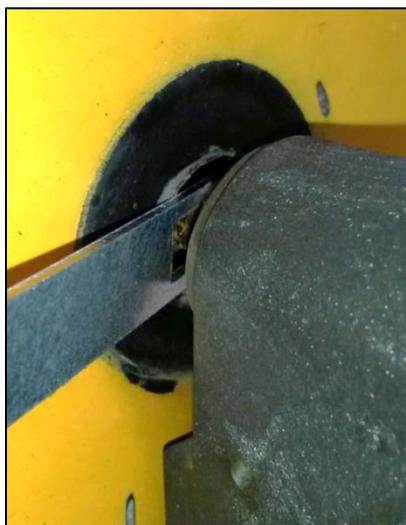
Figure 3, Using the Go/No Go Gauge

4. Once the washers are removed, use the go/no go gauge (TBB 204666 from kit TBB 204971) to verify the stem material is of sufficient thickness for operation. Try to slide the gauge over the smallest thickness of the stem on each of the four sides. See **Figure 3**. If the gauge is able to slide completely on at any point of the stem, go to “Replacement of Interior and Exterior Door Handles.” See **Figure 3** for use of the gauge.

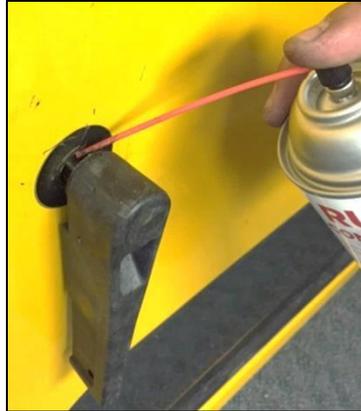
Figure 4, Applying Protectant

5. After verifying the gauge will not slide over the stem, apply a liberal amount of protectant over the entire stem (inside and outside the door cavity). Use an approved corrosion protectant such as WD-40 purchased locally. If any of the protectant liquid gets on the paint or exterior handle, remove it as quickly as possible with an alcohol based wipe. See **Figure 4**.

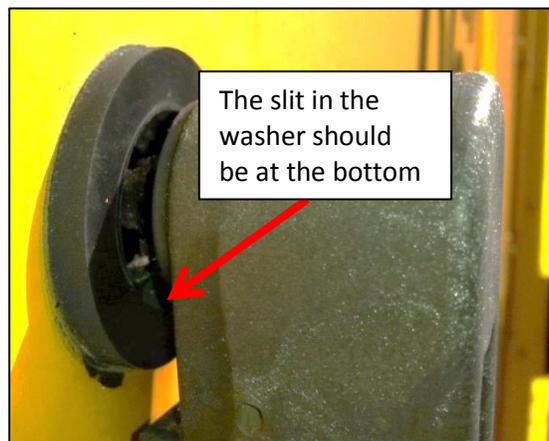
Figure 5, Position of Slit in Washer

6. After spraying the stem, install a new external washer (TBB 204677 from kit TBB 204971).
7. Make sure the painted surface around the stem opening is clean and dry. Remove the paper backing from the washer and place the adhesive side on the door around the external handle. Make sure the washer slit is installed on the bottom side of the opening. There will be an opening between the exterior washer and the door handle. See **Figure 5**.

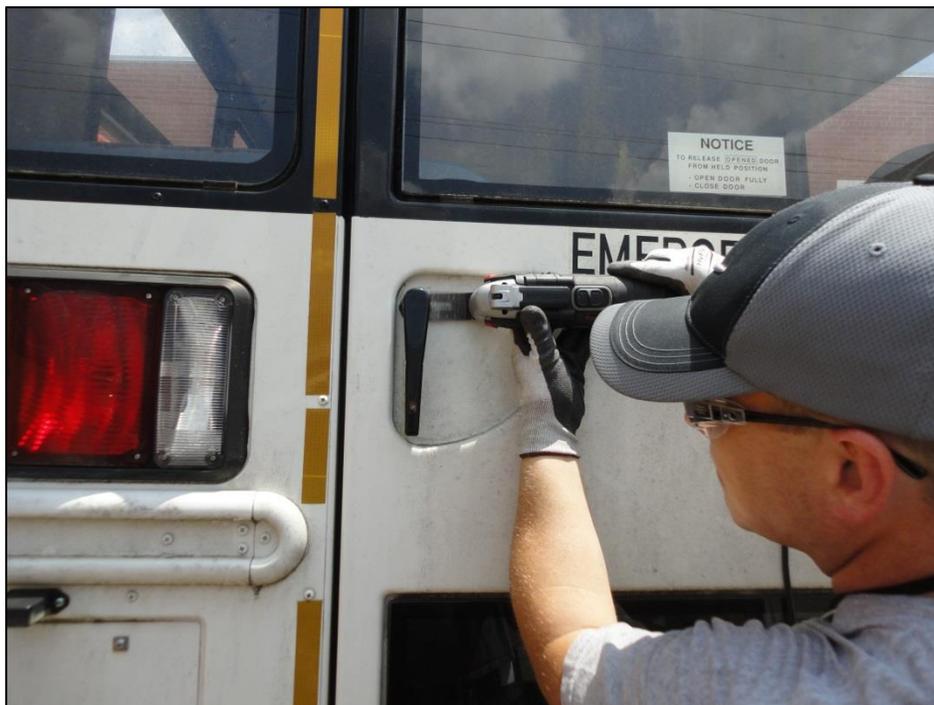
Figure 6, Cutting Off the Stem and Exterior Door Handle

1. Close and lock the door to keep it steady while performing next step.
2. Cut the stem and exterior door handle off. This can be performed with an oscillating tool or similar. See **Figure 6**.

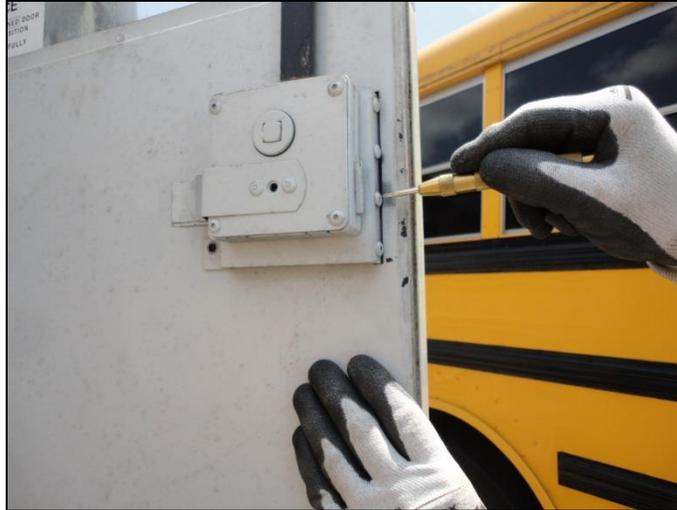
Figure 7, C2 mounting

C2 rear emergency doors will have four (4) rivets used for mounting the mechanism to the door bracket. Included in kit TBB 204987 are four (4) #12 screws to be used as replacement fasteners for the rivets. See **Figure 7**.

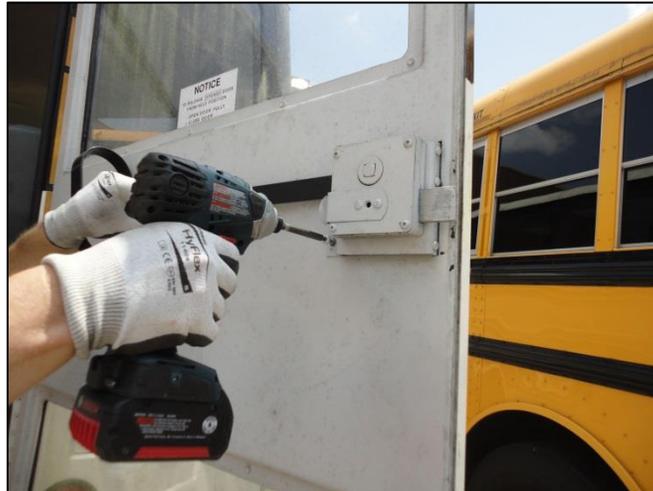
Figure 8, Legacy Mounting

Legacy products will have screws used for mounting the mechanism to the door. Remove and retain these screws for replacement. See **Figure 8**.

5. Remove the two screws on the left side of the locking mechanism and retain them for replacement. See **Figure 8**

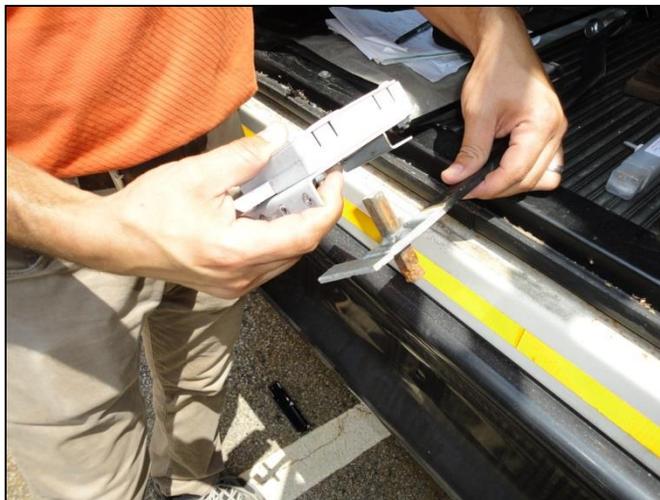
Figure 9, Removing the Locking Mechanism

6. Pull the locking mechanism and handle off the door. Lay the locking mechanism on the side the handle is not on and pull the handle shaft out of the locking mechanism. See **Figure 9**.

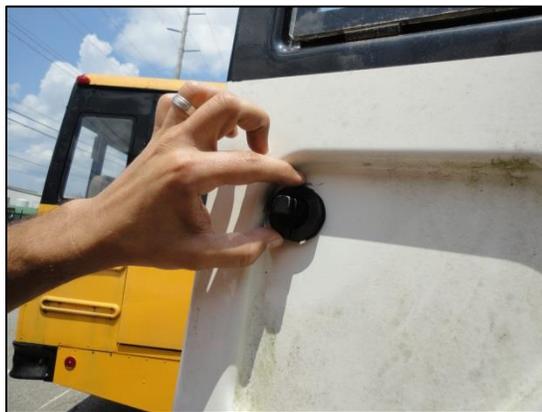
Figure 10, Installing the New Washer

7. Install the new handle with the locking mechanism and new washers from the kit (TBB 204987), using #12 screws in all fastener locations (Two (2) that were already used for mounting and four (4) used to replace the rivets).
8. Wipe the surface clean around the new stem where it exits the door.
9. Remove the paper covering the adhesive off back of the new washer and install it around stem. Make sure the washer slit is installed on the bottom side of opening. See **Figure 10**.

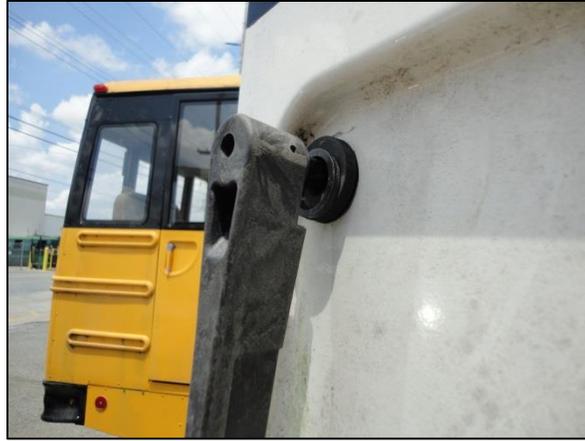
Figure 11, Position of Newly Installed Exterior Handle

10. Close the emergency door using the interior door handle. Make sure the interior handle is in the closed position. The closed position is when the interior handle is pushed all the way down to a horizontal position.
11. The exterior door handle must be installed in a vertical orientation. See **Figure 11**.

12. Using a rubber mallet, hammer the exterior handle (kit TBB 204988) onto the stem. The exterior handle must properly fit on the door stem for installation of the locking pin.
13. Insert the locking pin (TBB151501 from kit TBB 204987) into the side of the exterior handle.
14. Check door operation.
15. Unchock wheels.
