TECHNICAL INSTRUCTIONS
FOR
SAFETY RECALL GLA
DRIVER'S KNEE AIRBAG INSPECTION & REPLACEMENT
CERTAIN 2016 MODEL YEAR RX 350 & RX 450h

The subject vehicles are equipped with a driver's knee airbag module that may not have been properly manufactured. This could affect the performance of the airbag and increase the risk of injury in a crash.

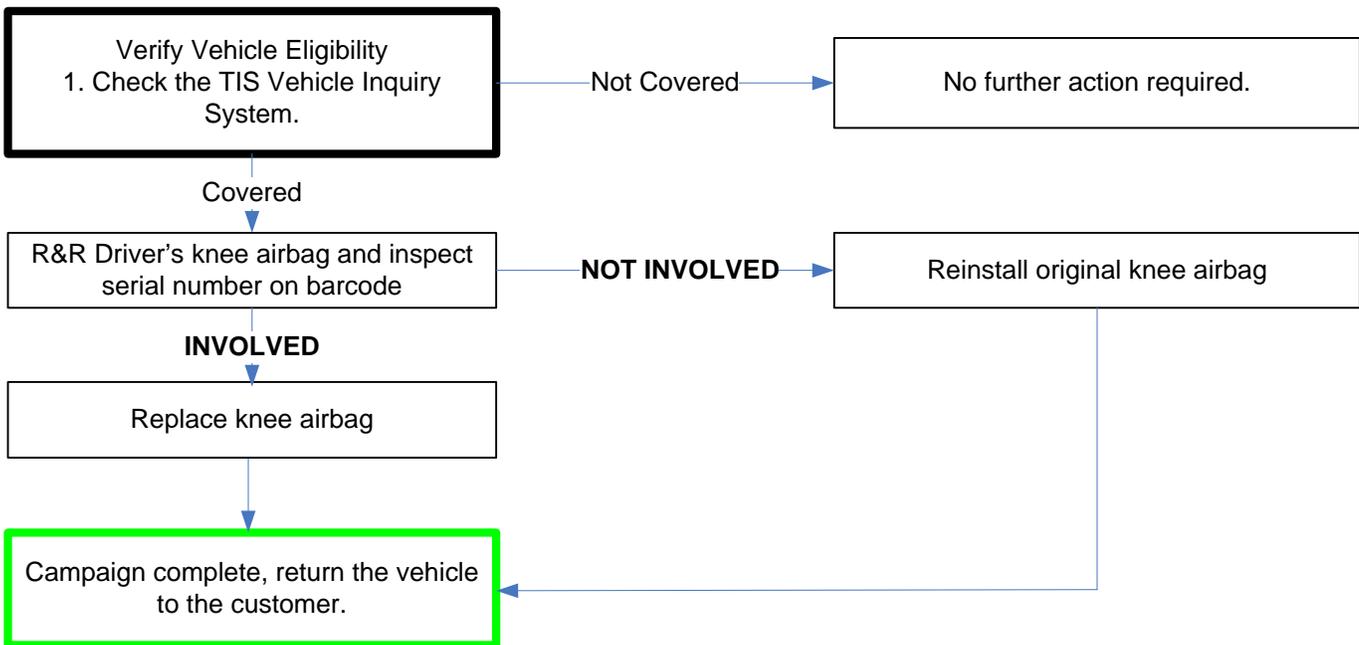
I. OPERATION FLOW CHART

The flow chart is for reference only. **DO NOT** use it in place of the full technical instructions. Follow **ALL** steps as outlined in the full technical instructions to confirm the campaign is completed correctly.

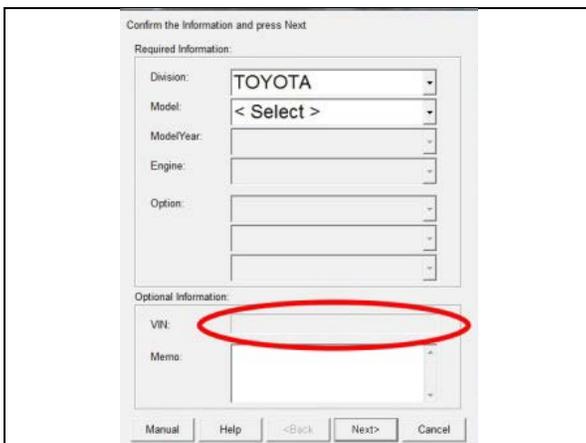
Confirm the information and press Next

- a) Confirm the Techstream is connected to the dealership's internet.

- b) Perform a health check.

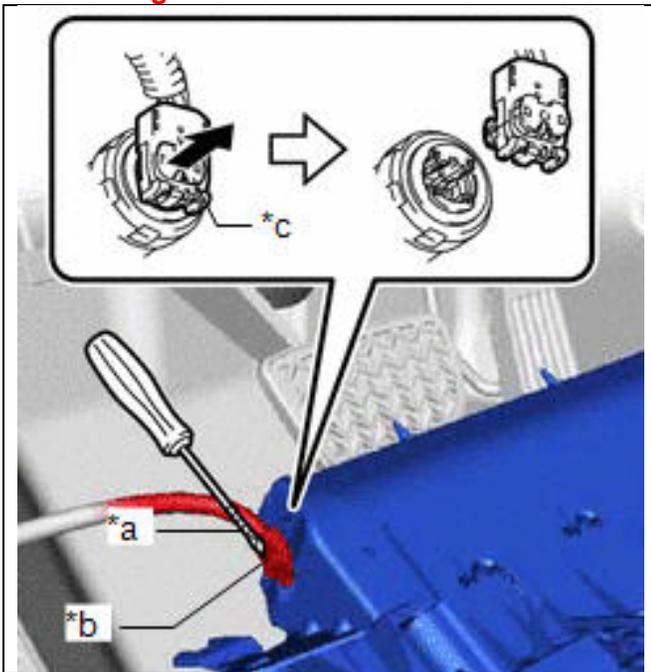
Knee Airbag Connector

The knee airbag connector can be easily damaged. Using a small screwdriver or pick release the secondary lock first, then remove the connector from the airbag.

- a) Small screwdriver or pick
b) Airbag connector
c) Secondary lock

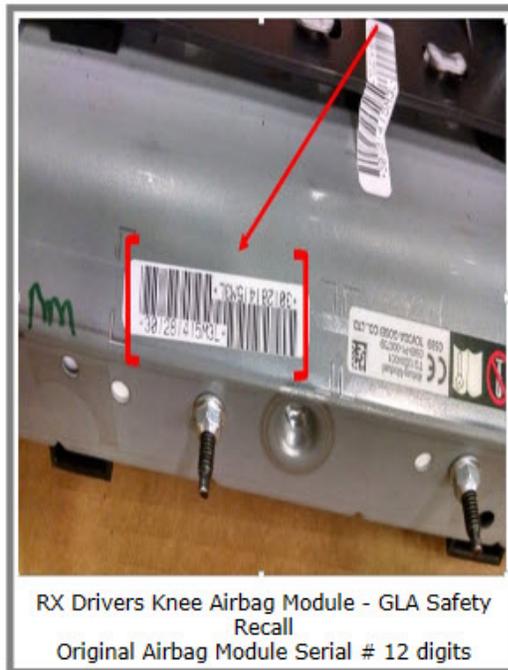
Airbag Serial Number Label Example

- The airbag serial number is **ALWAYS** the **12 DIGITS**.

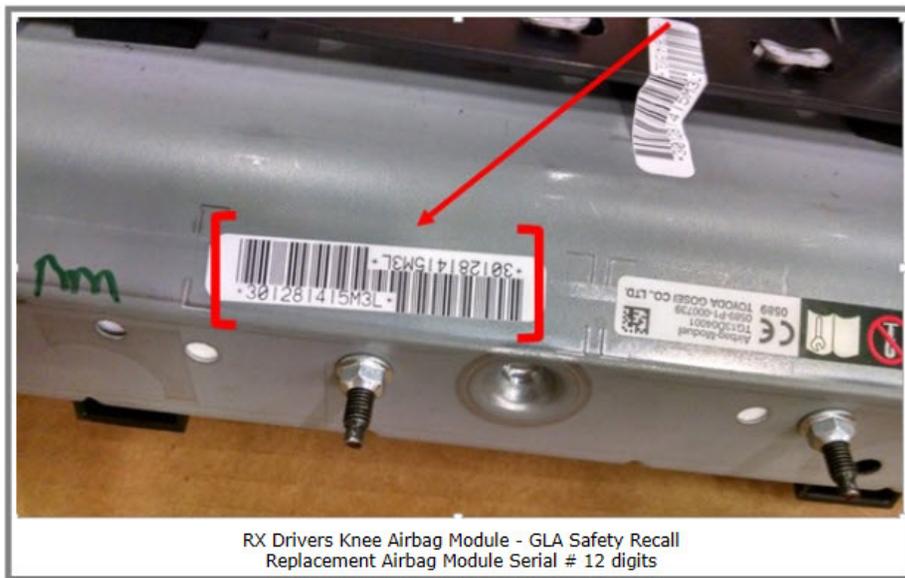
RX Drivers Knee Airbag Module - GLA Safety Recall
Replacement Airbag Module Serial # 12 digits

Prior to scanning the new knee airbag serial number ensure you have the correct interior color for the vehicle

The new **KNEE AIRBAG** serial number **MUST** be recorded prior to installation to track the airbag to the vehicle.
