NHTSA #15V-432 (School Bus)

REVISED NOTICE

## Subject: TBB Emergency Door Handles

**Models Affected: Specific Thomas Built Buses Vista, TL960, Saf-T-Liner Conventional, ER, MVPEF, EFX, MVPER, FS65, and C2, and HDX Buses manufactured February 5, 2001, through May 29, 2012.**

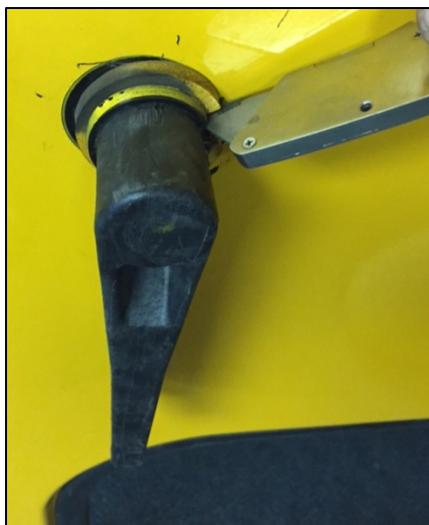
**Figure 1, Cutting Washers**

1. Chock the wheels, set the parking brake, make sure the shifter is in Park or Neutral. Disconnect the battery and turn the ignition switch to off.
2. Remove the washers between the external door handle and the door facing. Use a razor knife to slice through the large washer and then the smaller diameter plastic washer. Slide something under the washers to keep from damaging the paint on the door. See **Figure 1**.

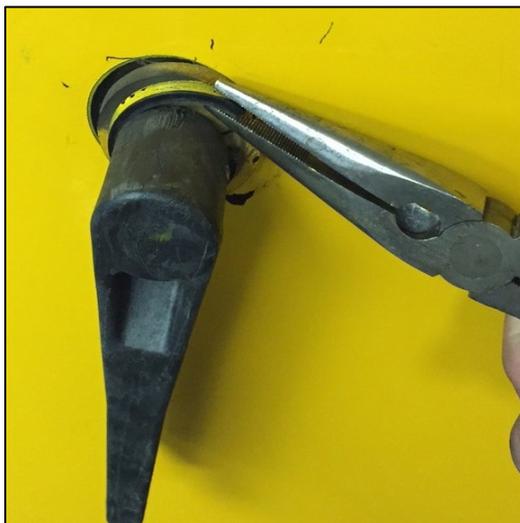
Figure 2, Removing Washers

3. Pull the washers off with needle nose pliers and discard the washers. See **Figure 2**.

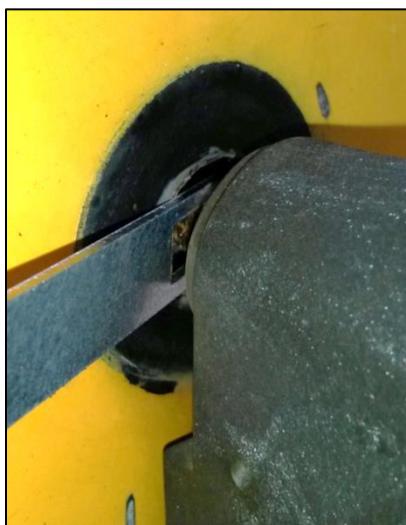
Figure 3, Using the Go/No Go Gauge

4. Once the washers are removed, use the go/no go gauge (TBB 204666 from kit TBB 204971) to verify the stem material is of sufficient thickness for operation. Try to slide the gauge over the smallest thickness of the stem on each of the four sides. See **Figure 3**. If the gauge is able to slide completely on at any point of the stem, go to "Replacement of Interior and Exterior Door Handles." See **Figure 3** for use of the gauge.

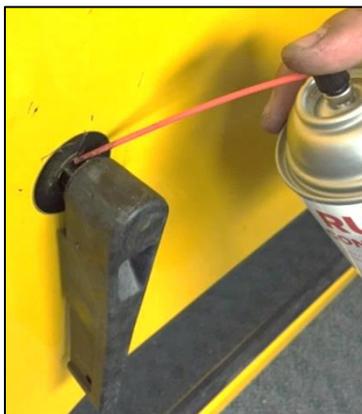
Figure 4, Applying Protectant

5. After verifying the gauge will not slide over the stem, apply a liberal amount of protectant over the entire stem (inside and outside the door cavity). Use an approved corrosion protectant such as WD-40 purchased locally. If any of the protectant liquid gets on the paint or exterior handle, remove it as quickly as possible with an alcohol based wipe. See **Figure 4**.

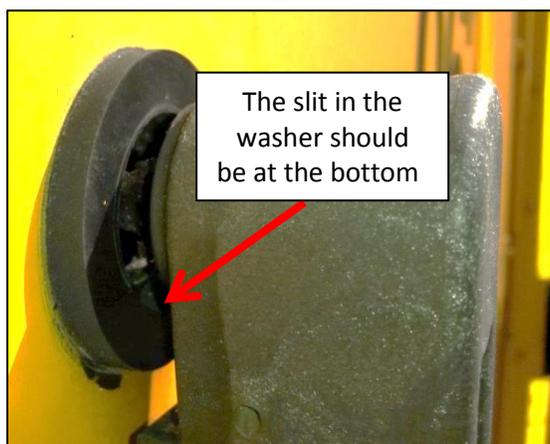
Figure 5, Position of Slit in Washer

6. After spraying the stem, install a new external washer (TBB 204677 from kit TBB 204971).
7. Make sure the painted surface around the stem opening is clean and dry. Remove the paper backing from the washer and place the adhesive side on the door around the external handle. Make sure the washer slit is installed on the bottom side of the opening. There will be an opening between the exterior washer and the door handle. See **Figure 5**.

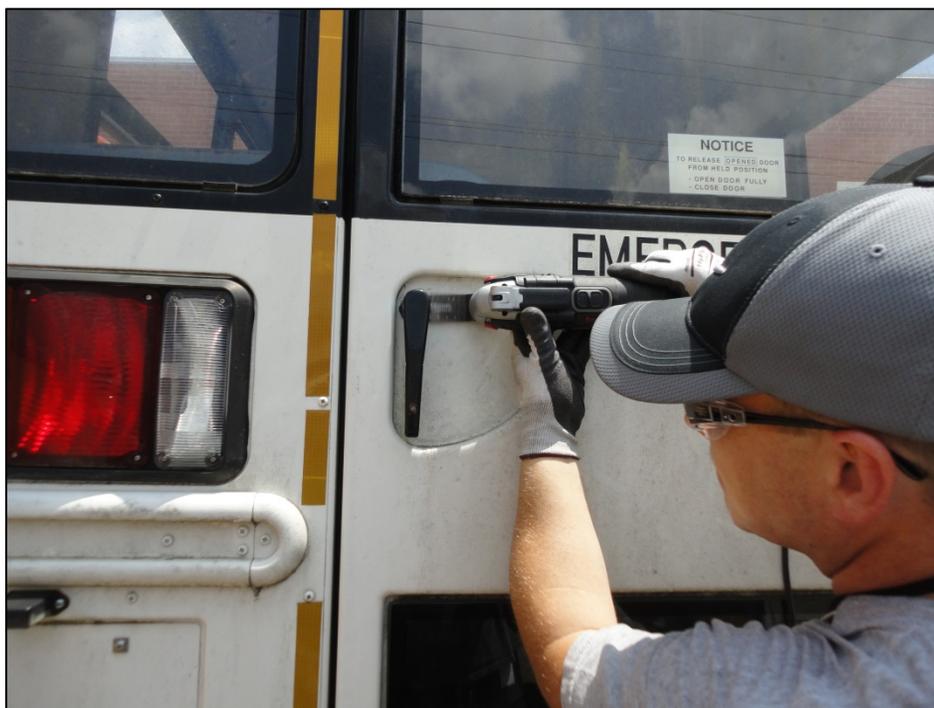
Figure 6, Cutting Off the Stem and Exterior Door Handle

1. Close and lock the door to keep it steady while performing next step.
2. Cut the stem and exterior door handle off. This can be performed with an oscillating tool or similar tool. See **Figure 6**.

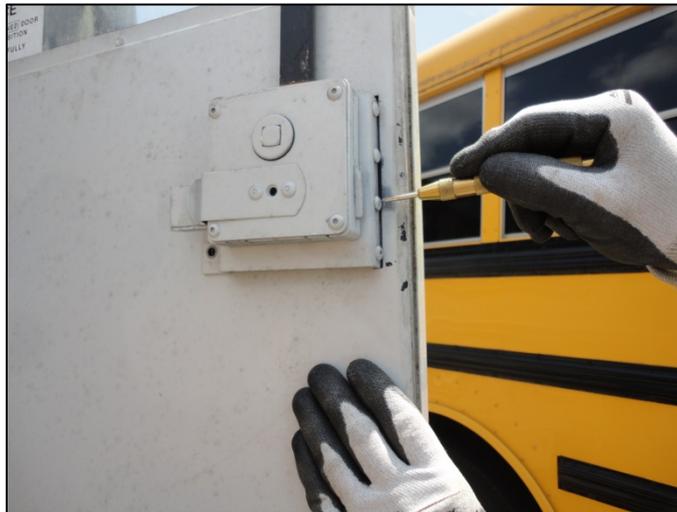
Figure 7, C2 Mounting

C2 rear emergency doors will have four (4) rivets used for mounting the mechanism to the door bracket. Included in kit TBB 204987 are four (4) #12 screws to be used as replacement fasteners for the rivets. See **Figure 7**.

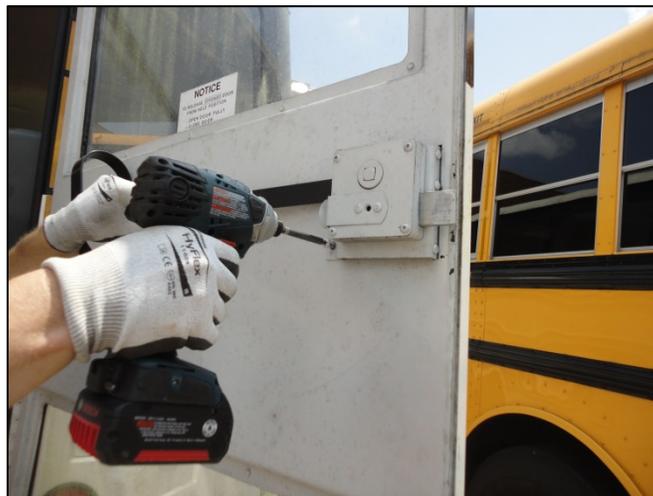
Figure 8, Legacy Mounting

Legacy products will have screws used for mounting the mechanism to the door. Remove and retain these screws for replacement. See **Figure 8**.

5. Remove the two screws on the left side of the locking mechanism and retain them for replacement. See **Figure 8**

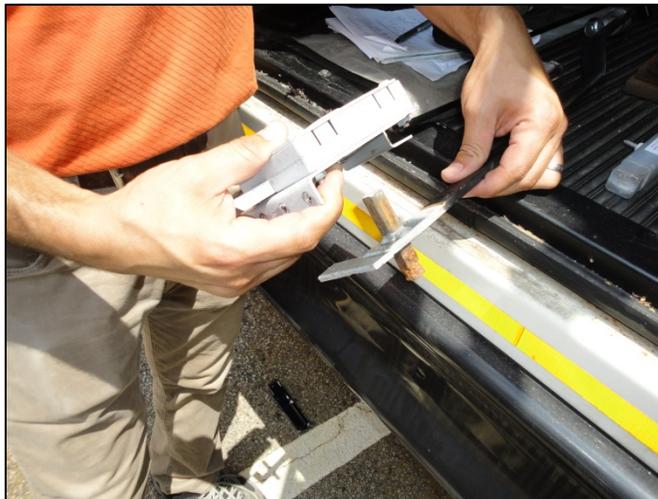
**Figure 9, Removing the Locking Mechanism**

6. Pull the locking mechanism and handle off the door. Lay the locking mechanism on the side the handle is not on and pull the handle shaft out of the locking mechanism. See **Figure 9**.

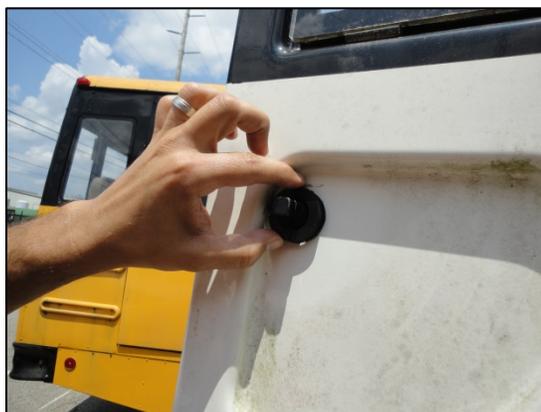
**Figure 10, Installing the New Washer**

7. Install the new handle with the locking mechanism and new washers from the kit (TBB 204987), using #12 screws in all fastener locations (Two (2) that were already used for mounting and four (4) used to replace the rivets).
8. Wipe the surface clean around the new stem where it exits the door.
9. Remove the paper covering the adhesive off back of the new washer and install it around stem. Make sure the washer slit is installed on the bottom side of opening. See **Figure 10**.

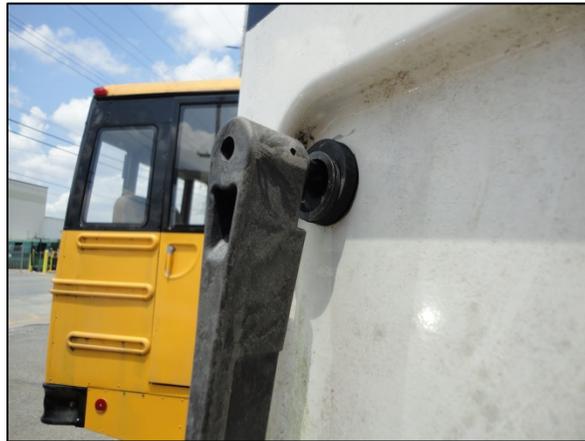
**Figure 11, Position of Newly Installed Exterior Handle**

11. The exterior door handle must be installed in a vertical orientation. See **Figure 11**.

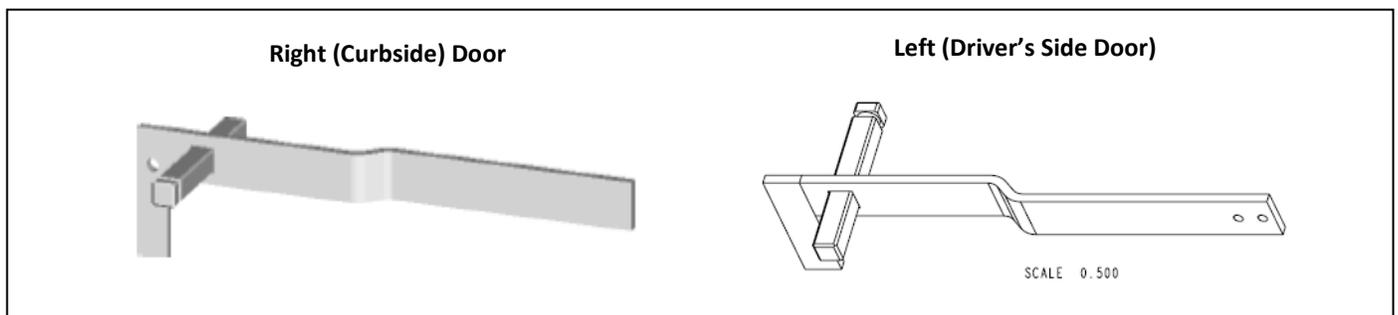
**Figure 12, Right and Left Interior Door Handles**

To determine if the door stem handle is for a right side or left side door, note:

- The groove in the stem is always toward the outside of the bus door.
- The handle stopper is always pointed down.
- Doors always open to the rear.
