Audi

Safety Recall

Code: 74C9

Subject	Side Airbag Cover(s)
Release Date	February 24, 2016
Affected Vehicles	U.S.A. & CANADA: 2015 MY Audi A3 Cabriolet <i>Check Campaigns/Actions screen in Elsa on the day of repair to verify that a VIN qualifies for repair under this action. Elsa is the <u>only</u> valid campaign inquiry & verification source.</i> <ul style="list-style-type: none">✓ Campaign status must show "open."✓ If Elsa shows other open action(s), inform your customer so that the work can also be completed at the same time the vehicle is in the workshop for this campaign.
Problem Description	Certain vehicles may have been manufactured with an incorrect or out of specification stitching in the driver and/or front passenger seat cover. In the event of a crash, this could prevent the side impact airbag from deploying correctly which could increase the risk of injury.
Corrective Action	Replace the driver and/or passenger seat back covers as necessary.

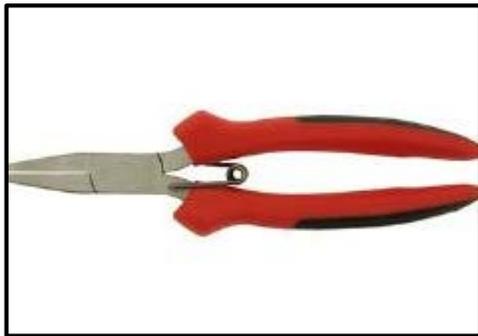
- VAG1634 – Upholstery Clip Pliers (or equivalent)

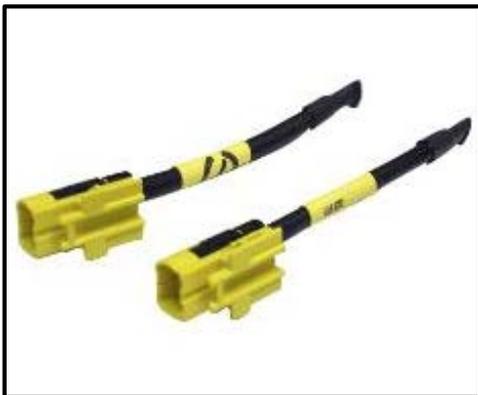
- VAS6282 – Airbag Lockout Adapter

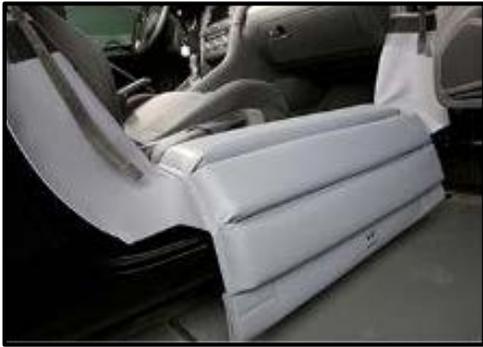
- VAS871 001 – Universal Vehicle Protector (or equivalent)

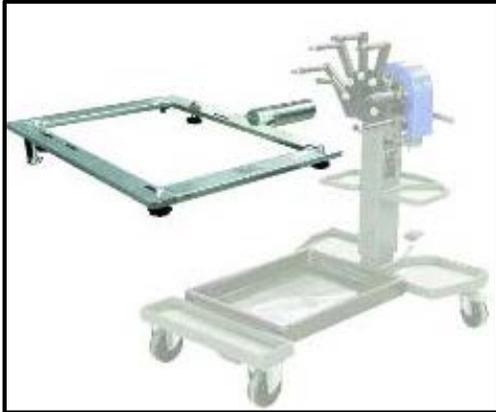
- VAS6095 – Engine and Transmission Holder (or equivalent)

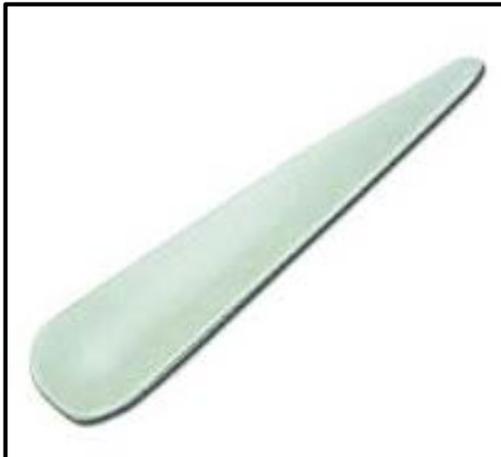
- 3409 – Trim Removal Wedge (or equivalent)

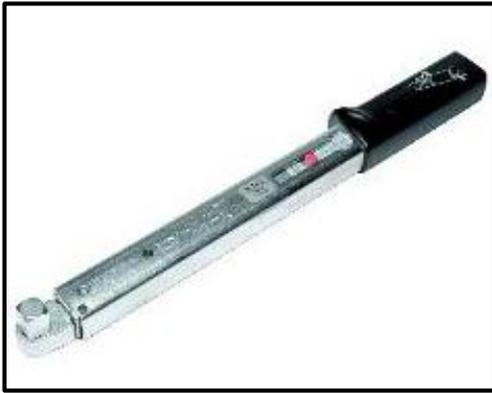
- VAG1331 – 5-50 Nm torque wrench (or equivalent)

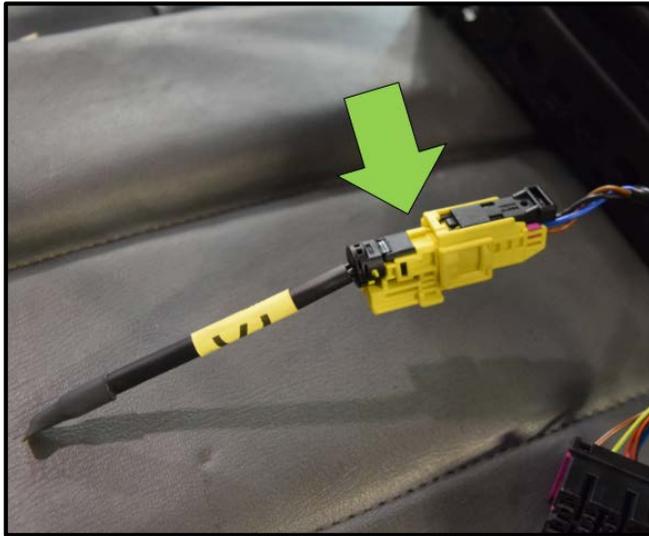
- Connect the Airbag Lockout Adapter VAS6282 to the side airbag wiring harness connector <arrow>.

The Airbag Lockout Adapter VAS6282 **MUST** stay connected to the seat wiring harness until the seat is reinstalled in the vehicle.

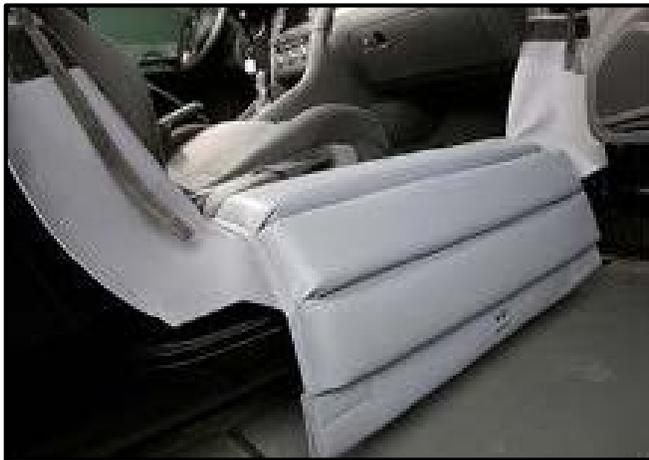
- To protect the sill panel before removing the front seat, install the Universal Vehicle Protector VAS871 001 <as shown>.
- Carefully remove the front seat from the vehicle.

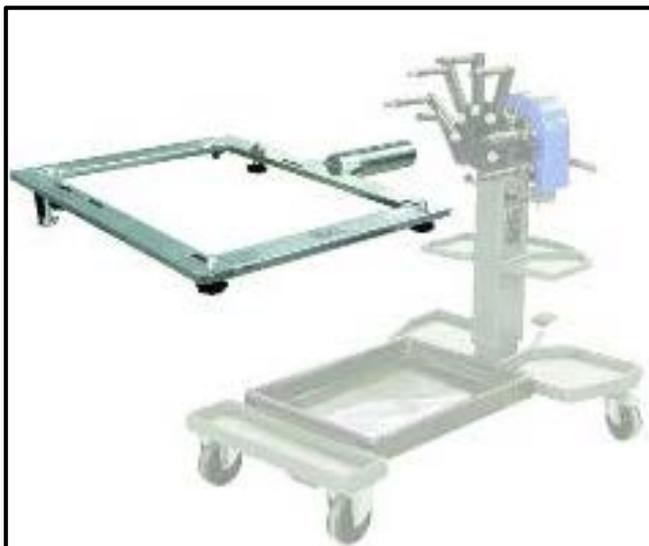
- Attach the Seat Repair Fixture VAS6136 to the Engine and Transmission Holder VAS6095.
- Fasten the affected seat onto the Seat Repair Fixture VAS6136.

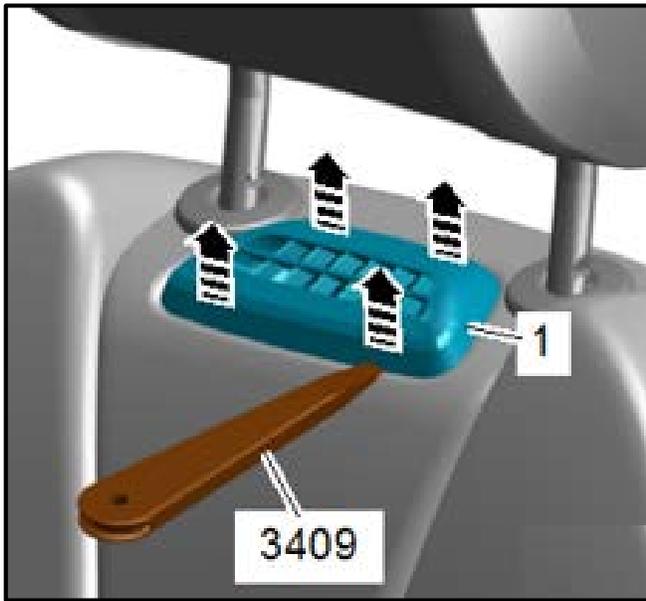
- If the seat is equipped with a head heater vent, unclip and remove the vent <1> using the Trim Removal Wedge 3409 (or equivalent) as shown <direction of arrows>.

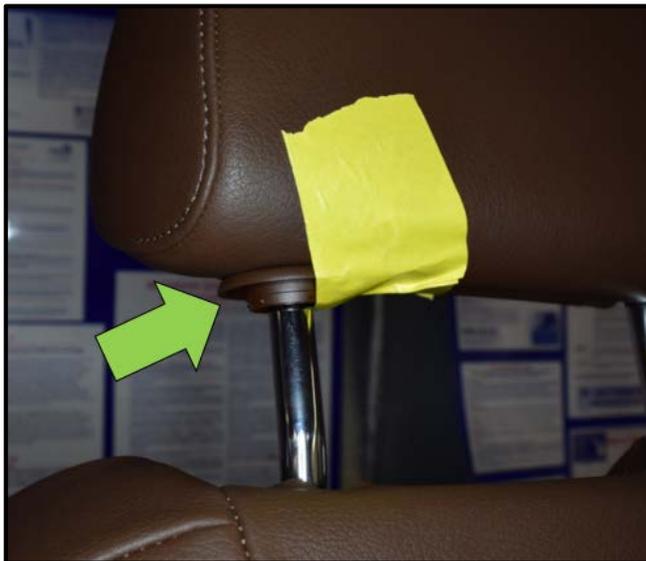
- Lift the headrest to the fully raised position
- Carefully remove the trim ring <arrow> and tape it to the head rest as shown.

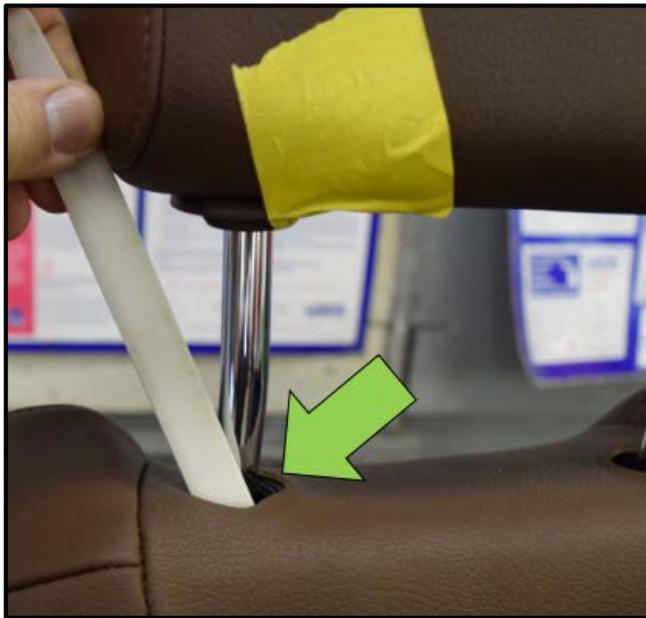
- Carefully insert a trim removal tool into the seat back, behind the LEFT side headrest post as shown <arrow>.

On both front seats, this step is performed on the LEFT side headrest post while looking at the REAR of the seat.

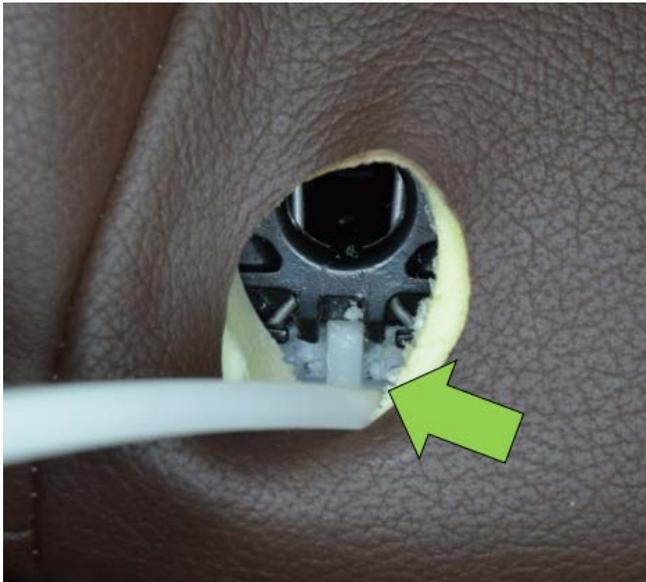
- Position the trim removal tool behind the white plastic headrest release mechanism as shown <arrow>.
- Carefully press the release toward the headrest post while simultaneously lifting upward on the headrest.
- Once released, fully remove the headrest from the seat.
- Remove and discard the trim ring and tape from the headrest.

For picture clarity, this photo was taken with the headrest already removed.

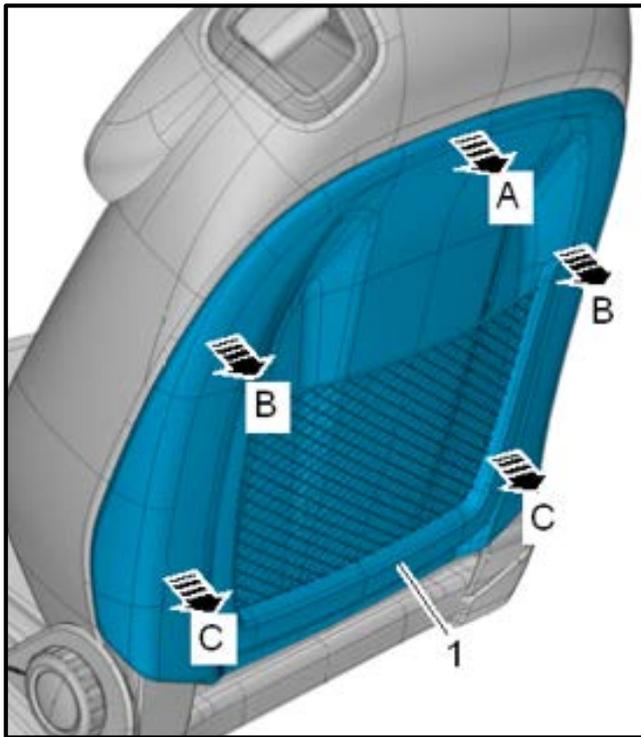
- Using Pry Lever 80-200 (or equivalent), carefully remove the backrest cover <1> from the seat backrest <direction of arrow A>.
- Loosen the side retaining tabs <direction of arrows B and C> then lift the backrest cover upward and outward to remove it from the seat.

- Use caution when removing the seat backrest cover <1>. Forcefully removing the cover, or removing the cover while it is cold can result in damage to the fastening tabs and/or seat backrest cover itself.
- Damage to the seat backrest cover is NOT covered under this action.

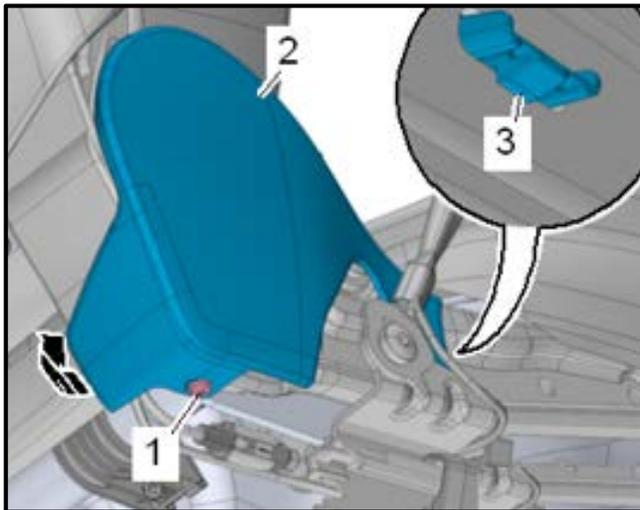
- Remove the expanding rivet <1> from the inboard side seat trim <2>.
- Release the retaining tab <3>.
- Disengage the trim <2> from the backrest hinge <arrow> and remove the trim from the seat.

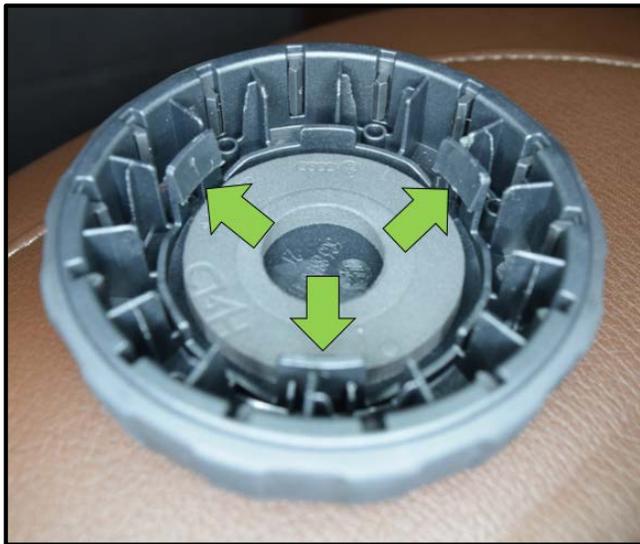
- Release one of the locking tabs <arrows> on the back side of the recliner adjustment knob <left> with a pocket screw driver (or equivalent) and remove the recliner knob from the seat.
- On seats with an electric reclining mechanism, this step is not necessary.

For picture clarity, this photo was taken with the recliner adjustment knob already removed.

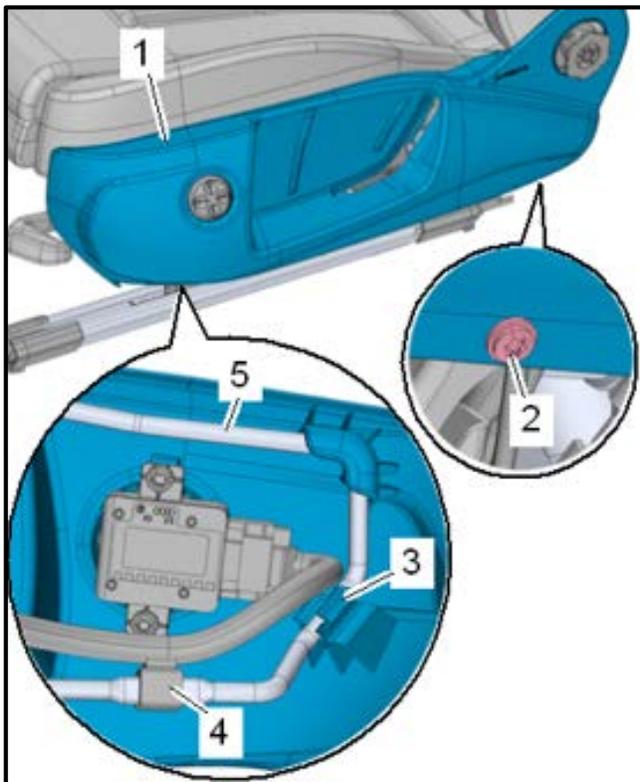
- Remove the expanding rivet <2> from the outboard seat trim panel.
- Open the clip <3> using a pocket screwdriver (or equivalent).
- Disengage the rear of the trim panel <1> from the backrest hinge and the seat pan.
- Lift the trim panel slightly, release from the bracket <5> and remove the panel in a forward direction.
- If equipped with lumbar support, Release the cable holder <4> and disconnect the connector from the lumbar support adjustment switch.
- Disconnect any remaining connectors between the trim panel and the seat.

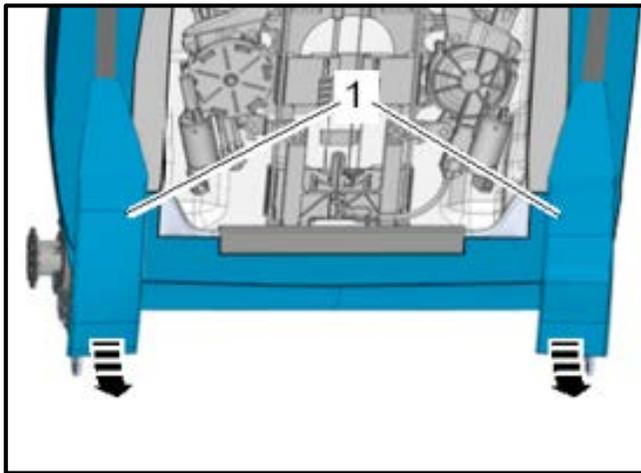
- Disengage the lower cover <1> from the backrest hinge trim <arrows>.

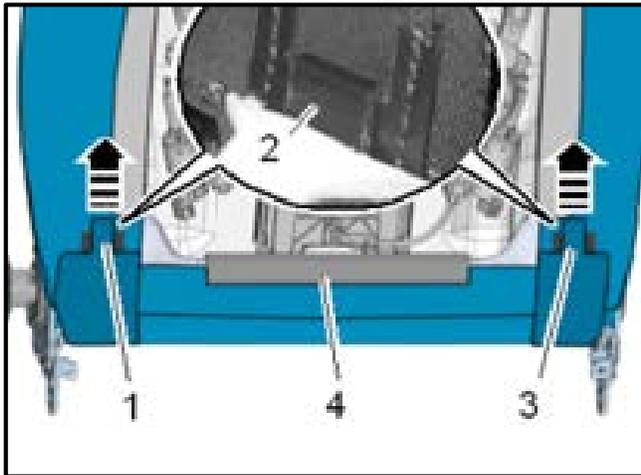
- Pull the cover tabs <1 and 3> upward <direction of arrows> and disengage the beading <2> on the cover.
- Detach the lower molding <4> from the backrest frame.

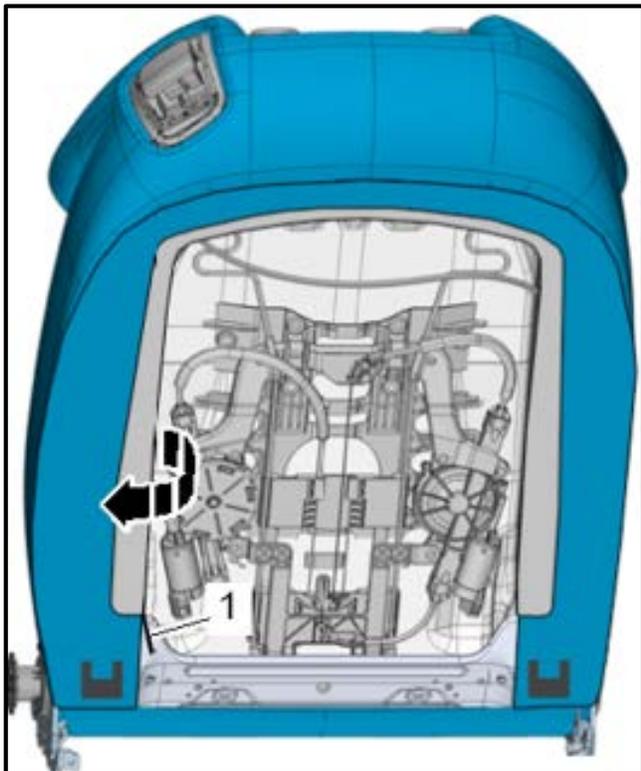
- Disengage the cover clamping strip <1> from the backrest frame as shown <direction of arrow>.

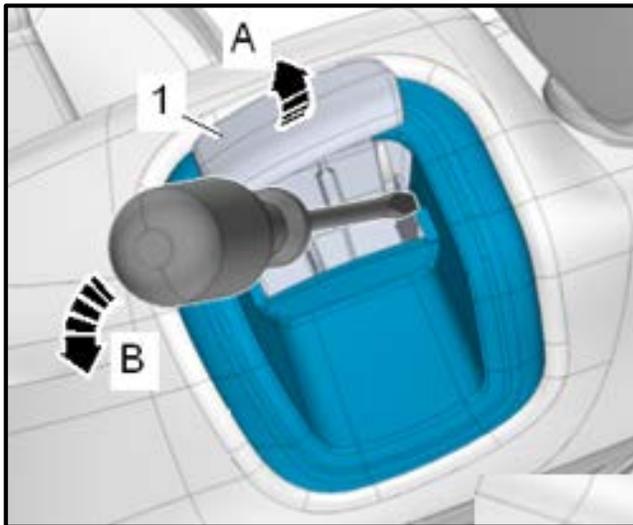
- Pull the backrest release lever <1> upward <direction of arrow A>.
- Insert a flat-head screwdriver between the trim and operating lever <as shown>.
- Release the right side catches <direction of arrow B>.

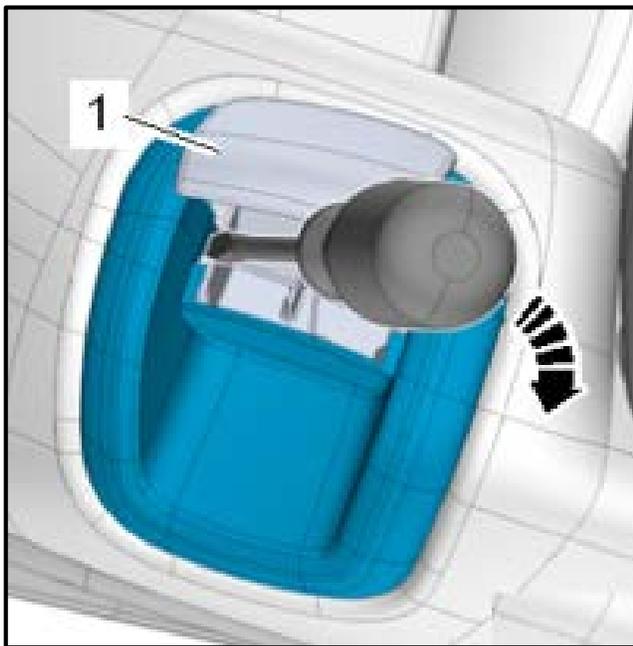
- Continue holding the backrest release lever <1> in the upward position.
- Release the left side catches <direction of arrow>.

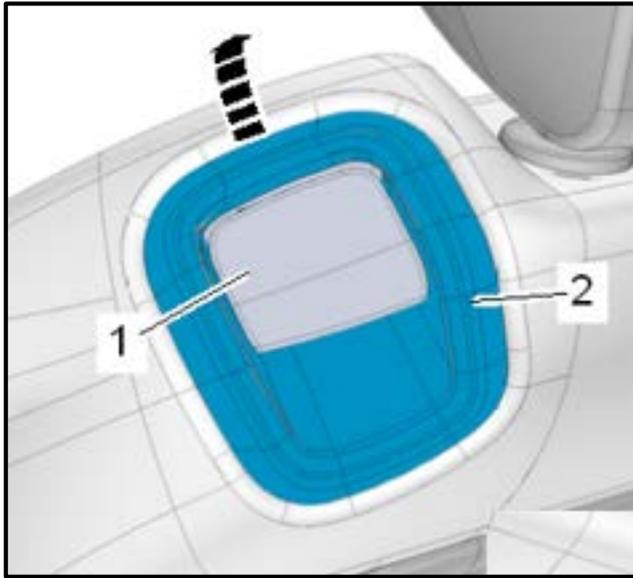
- Return the backrest release lever <1> to the resting position.
- Disengage the trim <2> by hand <direction of arrow>.
- Remove the trim <2> from the seat.

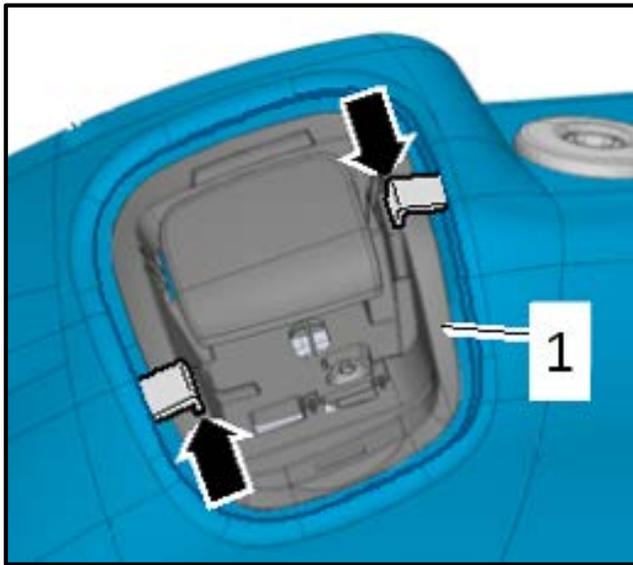
- Release the seat cover fastening hooks <arrows> from the backrest release <1>.

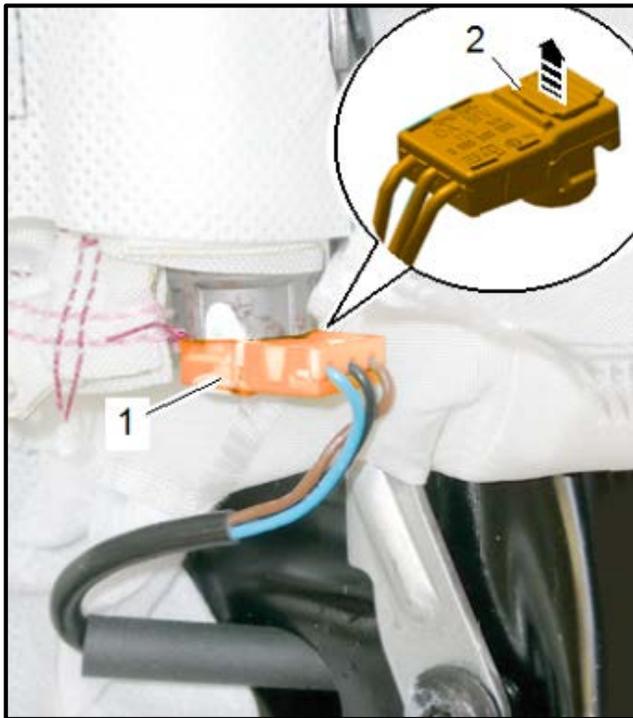
- Locate the side airbag and wiring harness on the outboard side of the seat.
- Release the connector lock <2> with a pocket screwdriver (or equivalent) as shown <direction of arrow>.
- Disconnect the connector <1> from the side airbag igniter.

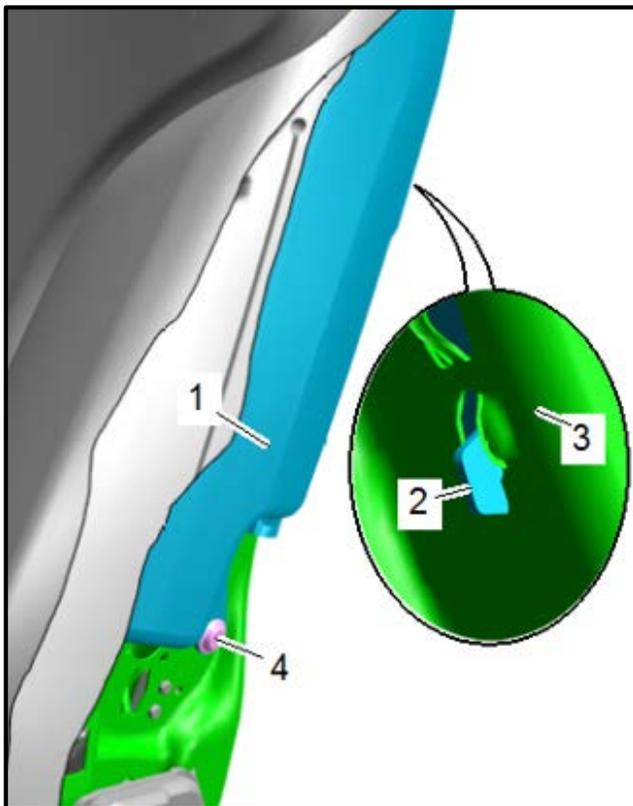
- Carefully push the seat cover with the cushion in the area of the side airbag as far forward as possible.
- Remove and discard the bolt <4>.
- Lift upward on the side airbag <1> to disengage the hook <2> from the seat back frame <3>.
- Remove the side airbag from the seat.
- Place the airbag in a clean, dry location with the igniter on the BOTTOM.

The airbag unit **MUST** be placed with the bag itself facing upward. Placing the airbag with the igniter facing upward can result in injury in the event of an accidental airbag deployment.

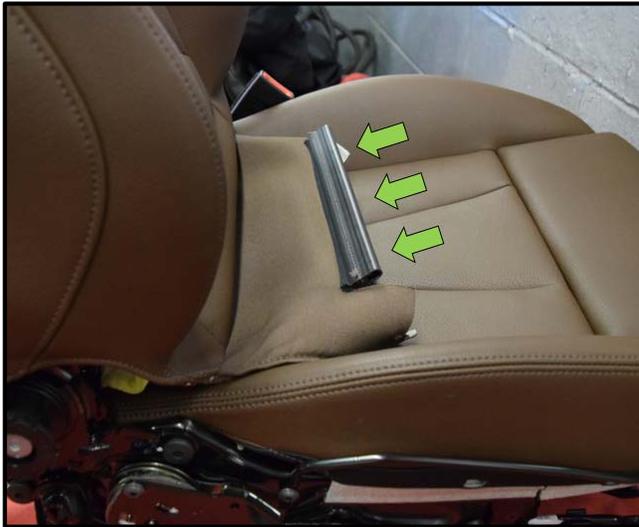
- Carefully pull the bottom of the seat cover through the opening between the seat base and the seat back as shown <arrows>.

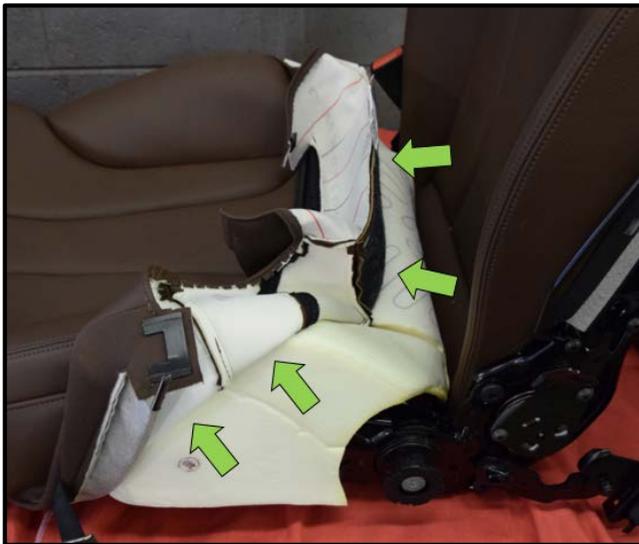
- Continue to peel the seat cover toward the top of the seat back as shown <arrows>.

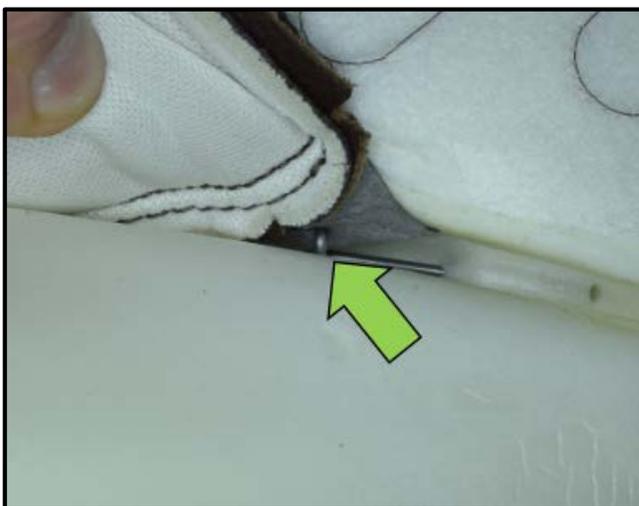
- The seat cover is fastened to the seat cushion using wire upholstery clips <arrow>.

! NOTE	
The seat cover will have approximately 30 upholstery clips installed. While cutting these clips, some fragments may remain attached to the seat cushion. ALL fragments of the old clips MUST be removed from the seat cushion prior to reassembling the seat.

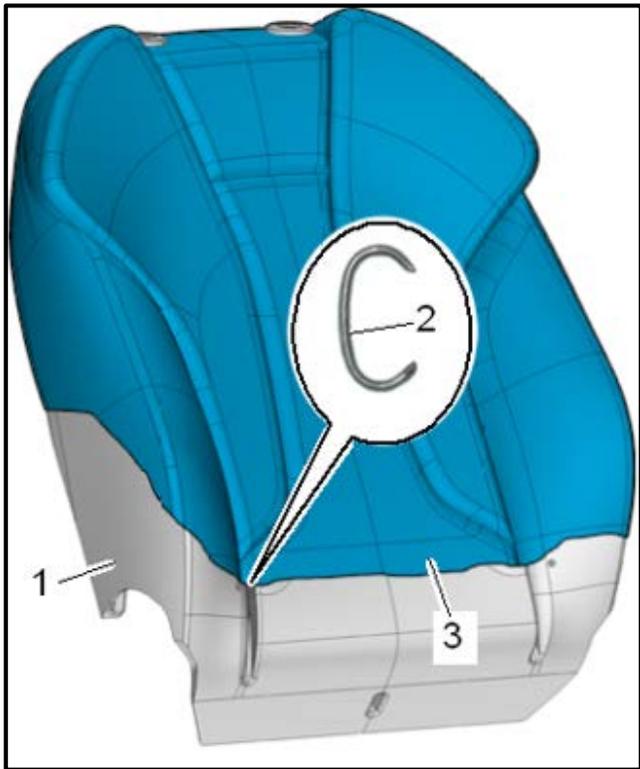
- Pull the edges of the cover <3> from the cushion <1> as far as possible.
- Starting along the bottom edge, cut the upholstery clips <2> using appropriate side cutting pliers.
- Once all of the upholstery clips have been cut, fully remove the cover <3> from the cushion <1>.

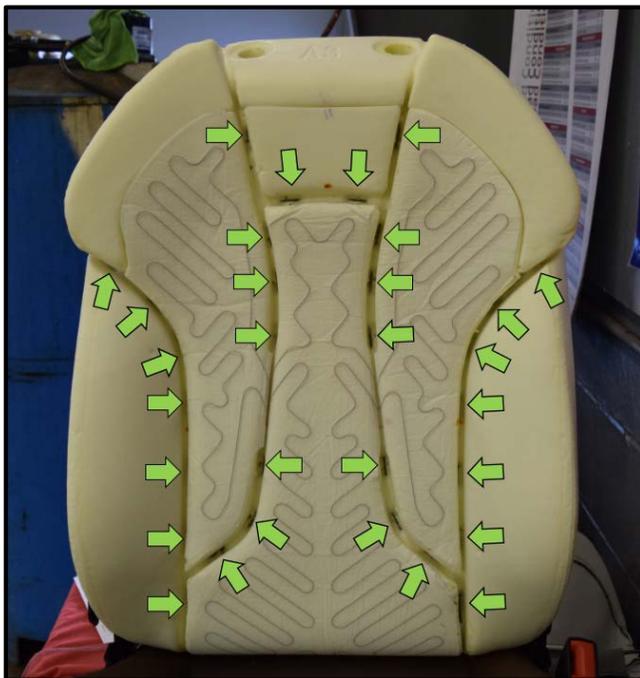
- When looking at the seat cushion, the upholstery clips are located approximately where shown <arrows>.
- During disassembly, start cutting the clips along the bottom edge, then work upward until all the clips have been removed.

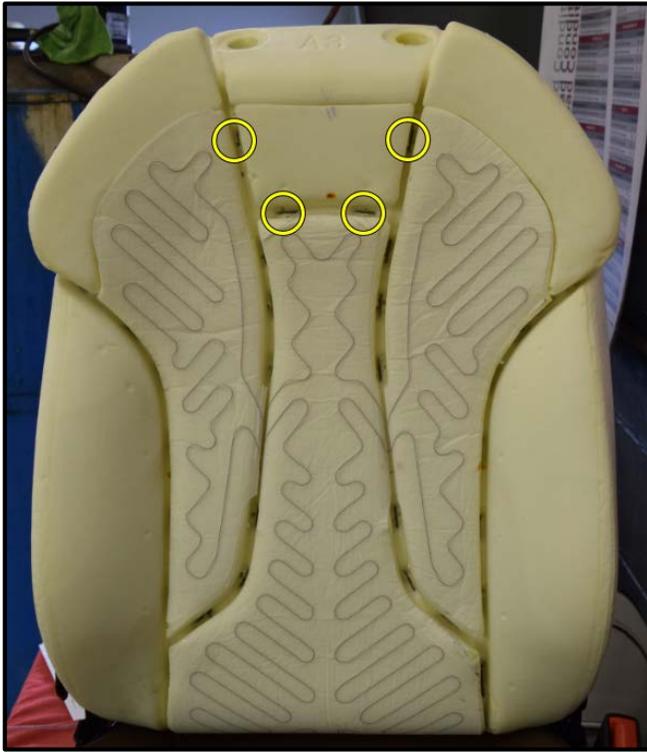
- Position the replacement seat cover onto the seat cushion. See the chart at the beginning of Section B for the part number of the appropriate seat cover.
- Starting at the top of the seat cushion, install and fasten the first four upholstery clips where shown <circles> using upholstery clip pliers VAG1634 (or equivalent).

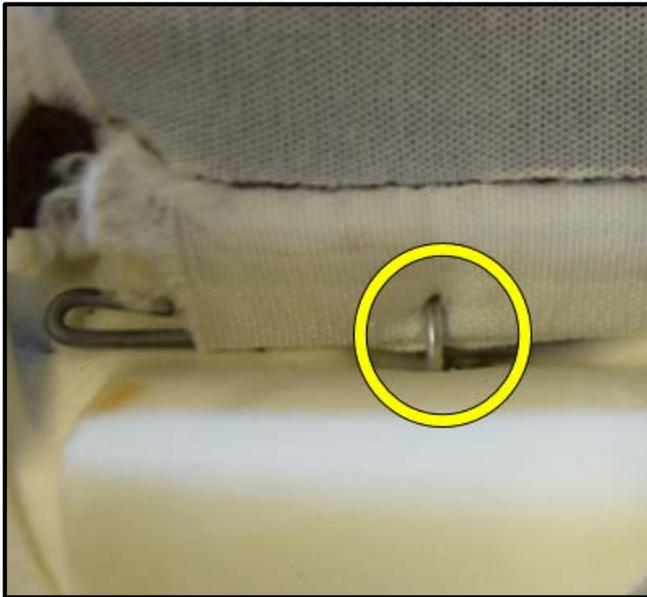
- Prior to fully clamping the upholstery clips closed, be sure each upholstery clip engages BOTH the webbing on the bottom side of the seat cover AND the fastening wire molded into the seat cushion as shown <circle>.

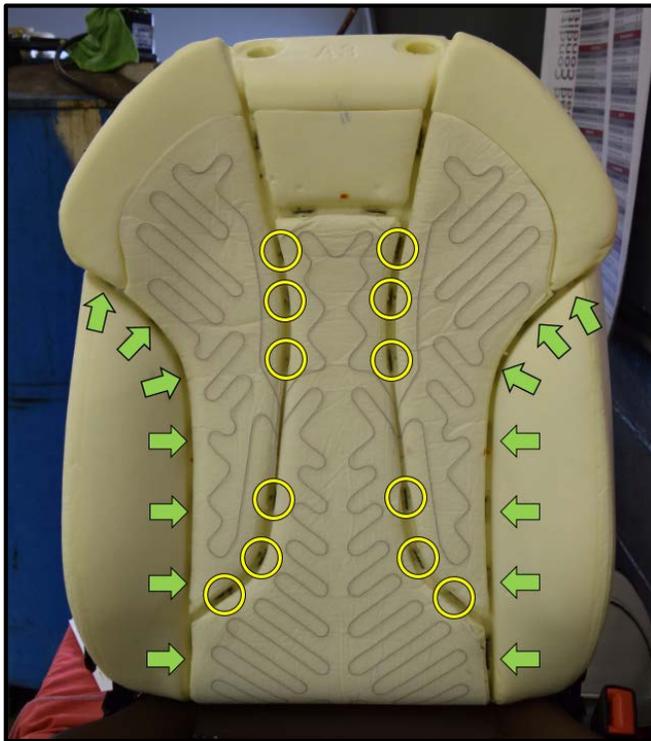
- Complete the seat cover installation.
- Install the upholstery clips from the top down, installing the inside clips <circles> first, then the outside clips last <arrows>.

Prior to installing the upholstery clips shown here, it may be helpful to wrap the replacement seat cover all the way around the seat cushion and into its fully installed position. The seat cover CANNOT be draped over the top of the seat cushion after the clips shown here are installed.

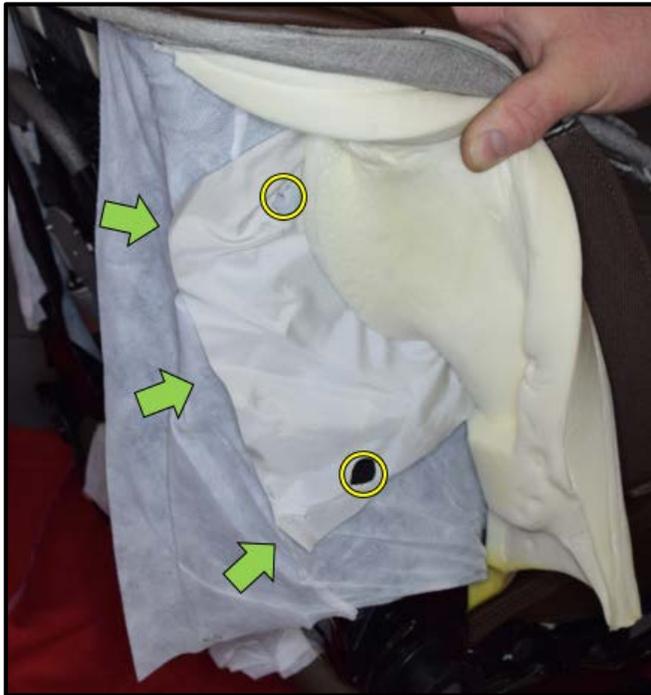
- Carefully push the seat cover and cushion on the outboard side of the seat back as far forward as possible <as shown>.
- Position the insulating sleeve over top of the side airbag mounting location as shown <arrows>.
- When installing the side airbag, the hook and mounting bolt should both pass through the cut-outs in the sleeve <circles>.

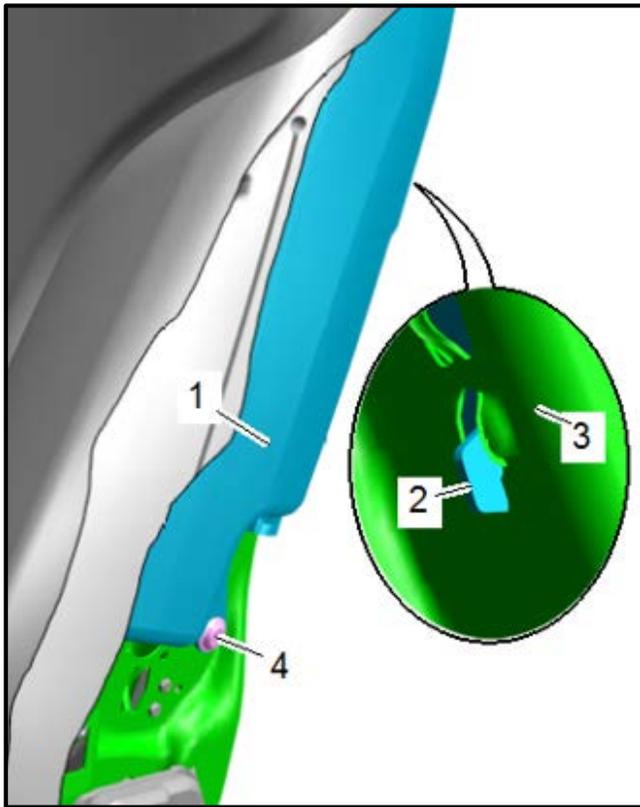
- Reinstall the side airbag into the seat.
- During installation, be sure to lock the hook <2> into the seat back frame <3> as shown.
- Clean the threaded hole for the airbag mounting bolt <4> with an appropriate thread tap.
- Apply an appropriate medium-strength thread locking compound onto the airbag mounting bolt threads.
- Install the replacement bolt, P/N N90737101, <4> and torque to **8Nm**.

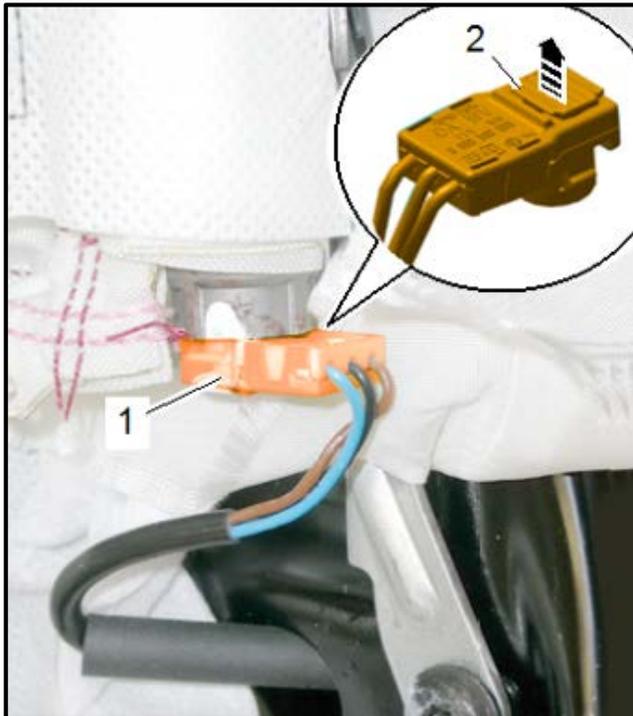
- Reconnect the connector <1> to the side airbag igniter and refasten the connector lock <2>.

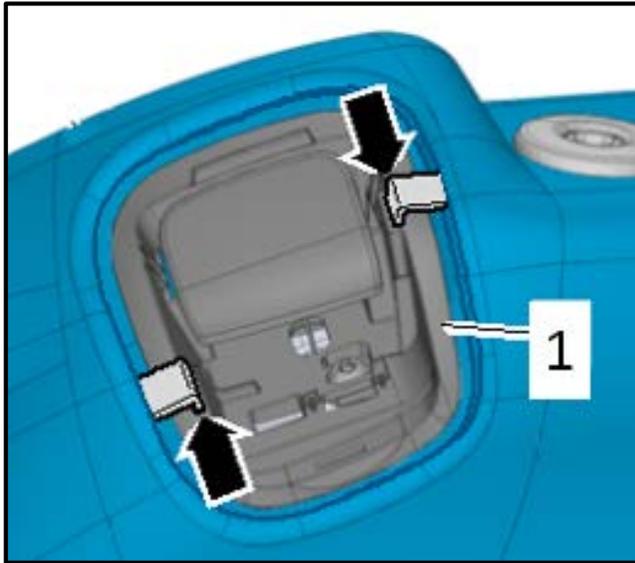
- Reinstall the seat cover fastening hooks <arrows> into the backrest release <1>.

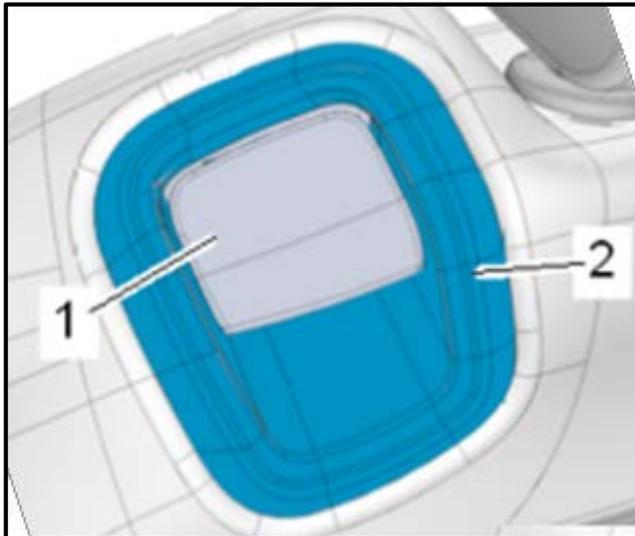
- Hold the backrest release lever <1> in the open position.
- Reinstall the trim <2> onto the seat.

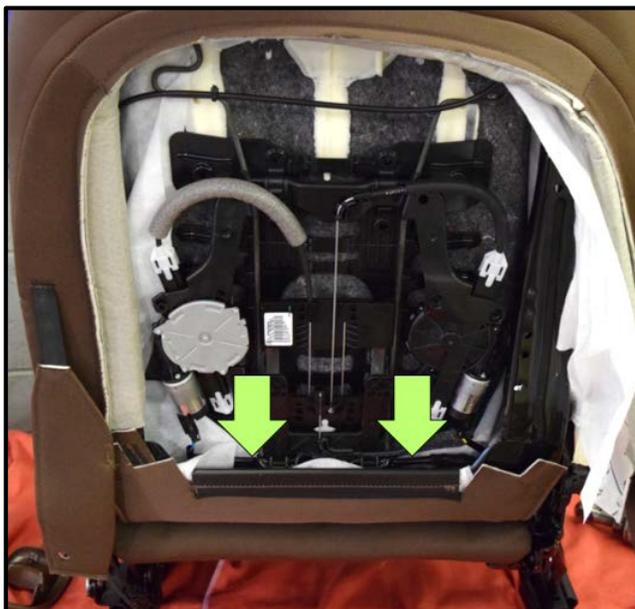
- Feed the bottom edge of the seat cover between the seat back and seat bottom, then fasten the cover clamping strip to the seat back frame as shown <arrows>.

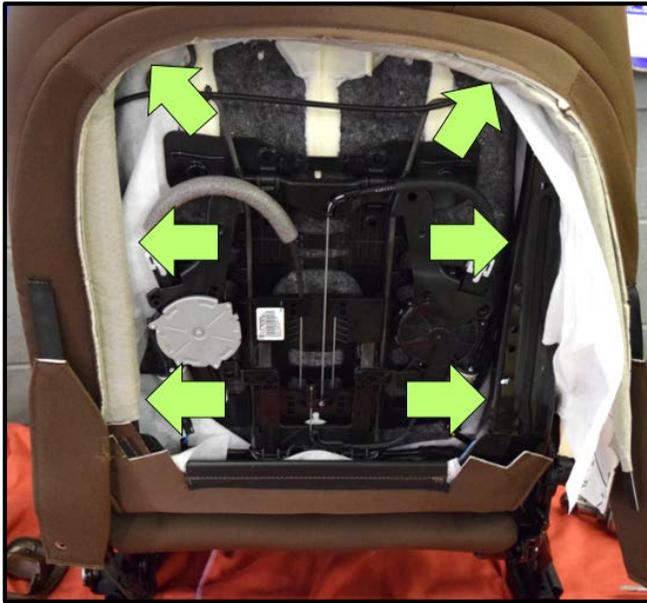
- Starting from one side, refasten the cover clamping strip to the seat back frame as shown <arrows>.

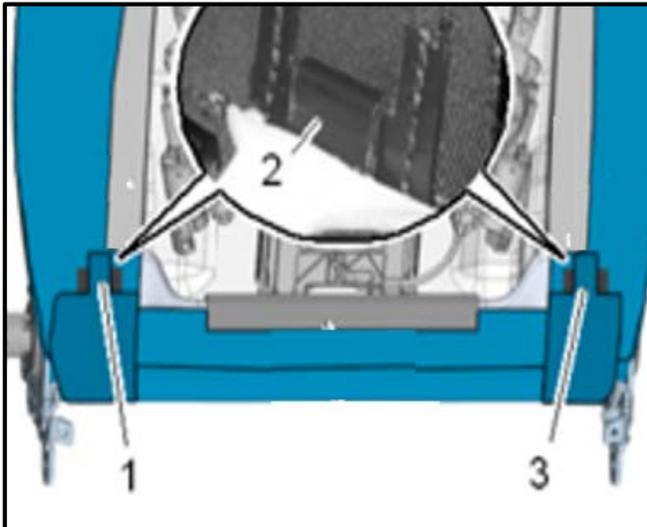
- Refasten the cover tabs <1 and 3> onto the seat back cover retainer <2>.

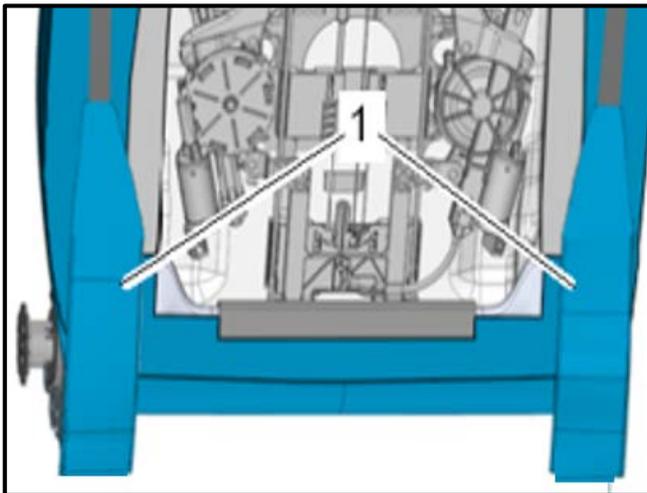
- Refasten the lower cover <1> onto the backrest hinge trim.

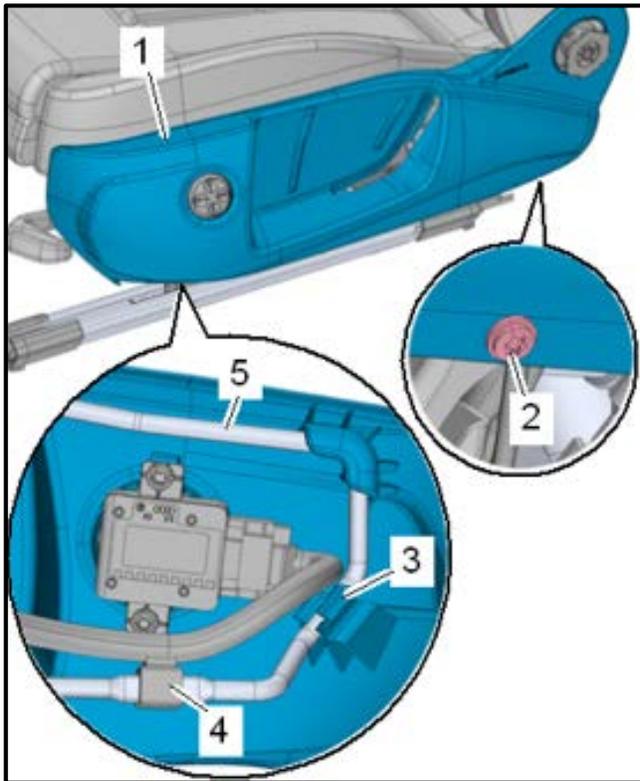
- If equipped with lumbar support, reconnect the connector onto the lumbar support adjustment switch and refasten the cable holder <4>.
- Reinstall the trim panel onto the bracket <5>.
- Refasten the rear of the trim panel <1> onto the backrest hinge and seat pan.
- Refasten the clip <3>.
- Reinstall the expanding rivet onto the outboard seat trim panel.

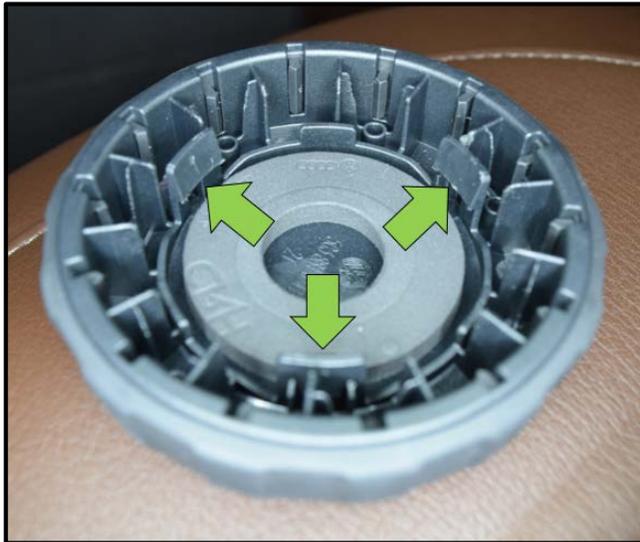
- Reinstall the recliner adjustment knob onto the seat until the tabs <arrows> engage the recliner adjustment mechanism.

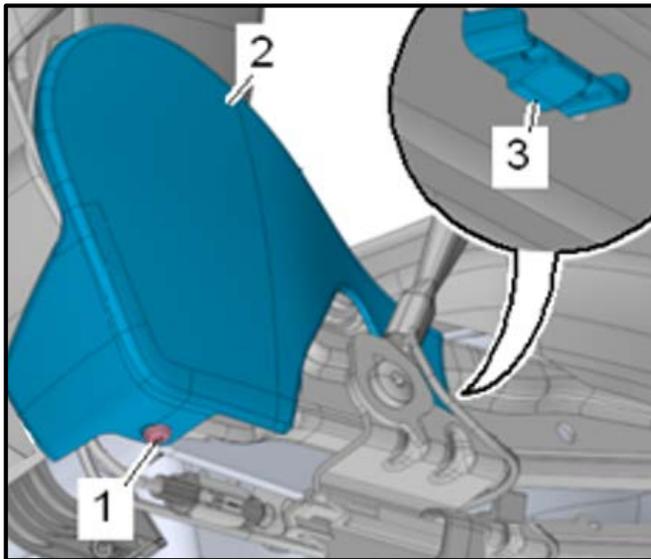
- Reinstall the trim <2> onto the backrest hinge <arrow> and onto the seat.
- Refasten the retaining tab <3>.
- Reinstall the expanding rivet <1> into the inboard side seat trim <2>.

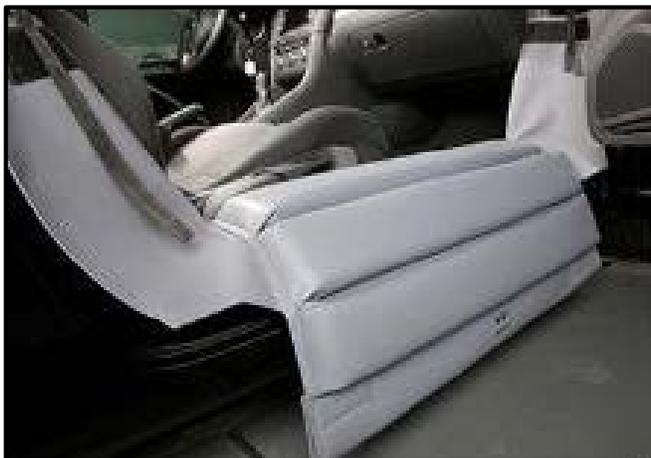
- Reinstall the seatback trim.
- Reinstall the headrest.
- If the seat is equipped with a head heater vent, reinstall the vent.
- To protect the sill panel before reinstalling the front seat, install the Universal Vehicle Protector VAS871 001 <as shown>.
- Carefully place the front seat back inside the vehicle.

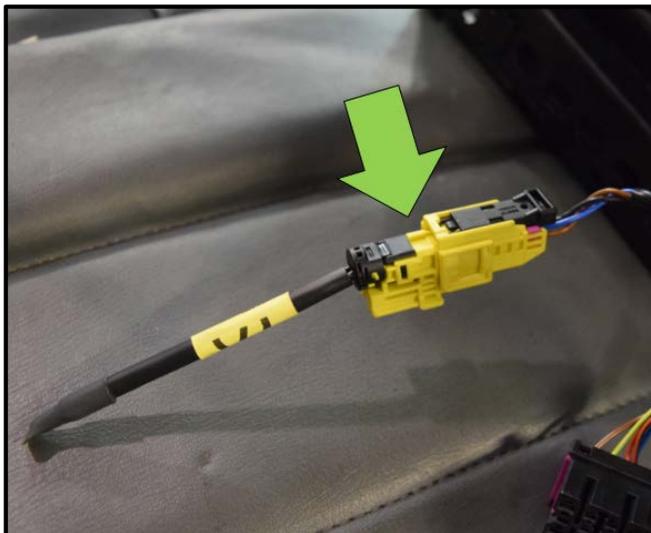
- Remove the Airbag Lockout Adapter VAS6282 from the side airbag wiring harness connector <arrow>.

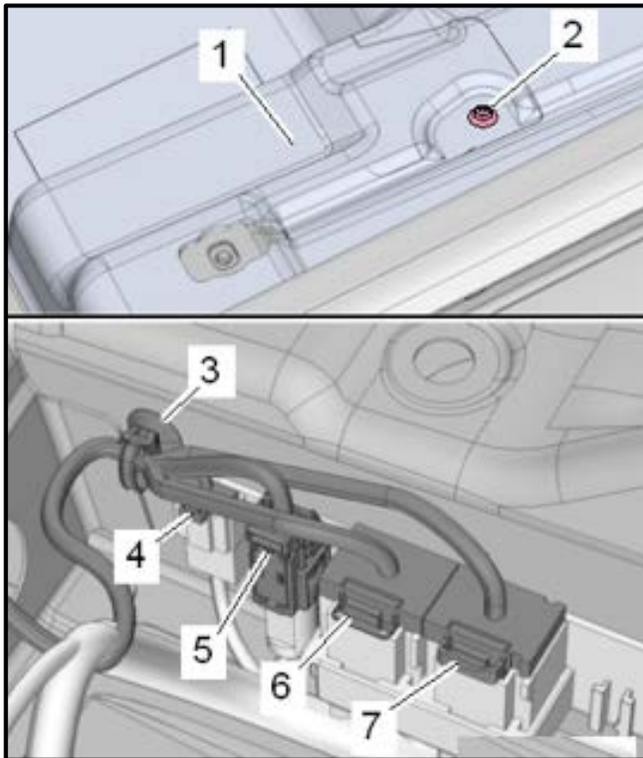
- Reconnect the seat wiring harness connectors <4 through 7>.
- Refasten the cable holder <3>.
- Close the access panel in the carpet <1> and refasten the expanding clip <2>.
- Reconnect and tighten the negative battery cable.
- Close the battery cover.
- Close the hood.

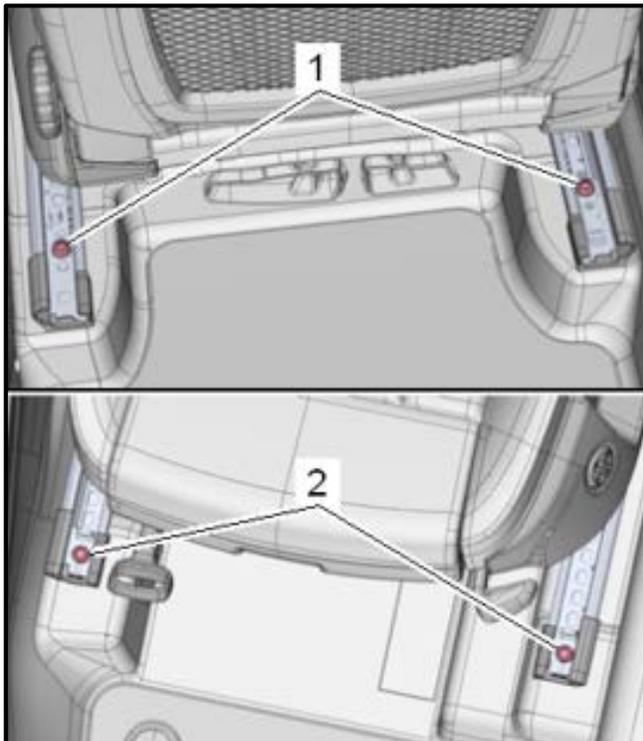
- Position the seat back to its original mounted position.
- Reinstall the mounting bolts <2> into the seat rails.
- Move the seat to the full-forward, fully raised position.
- Reinstall the front seat mounting bolts <1> into the seat rail.
- Torque all the seat mounting bolts to **40Nm**.
- Close the convertible top.

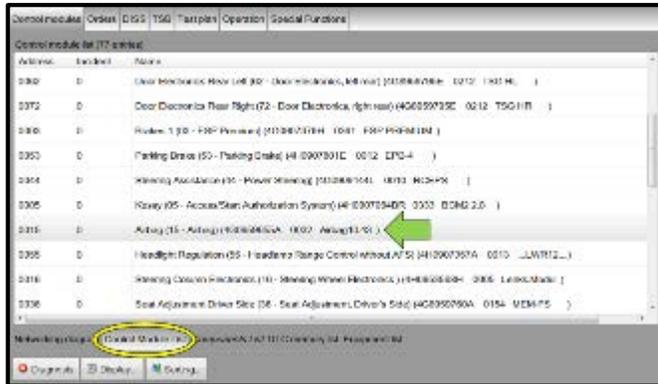
- Switch the ignition ON.
- Connect the VAS tester to the vehicle.
- Using ODIS, perform a complete GFF scan of the vehicle.
- From the “Control Module List” screen <circle>, right click on the Airbag Control Module <arrow>.
- When the drop down list is displayed, select “Guided Functions”.

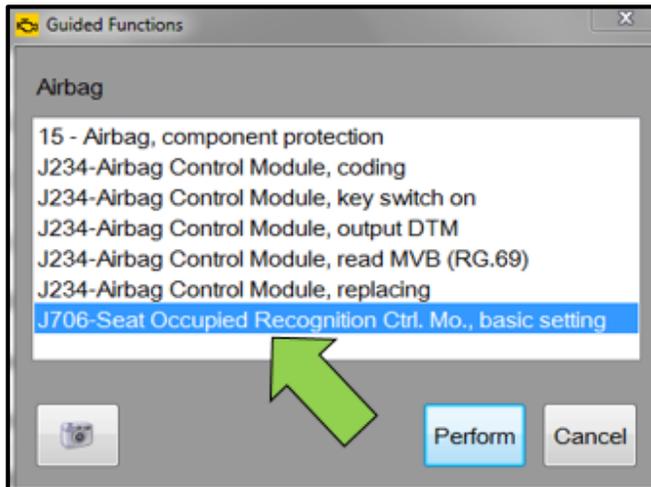
- From the “Guided Functions” list, select “J706 – Seat Occupied Recognition Ctrl. Mo., basic setting” <arrow>.
- Follow the on-screen directions to complete the PODS system basic settings.

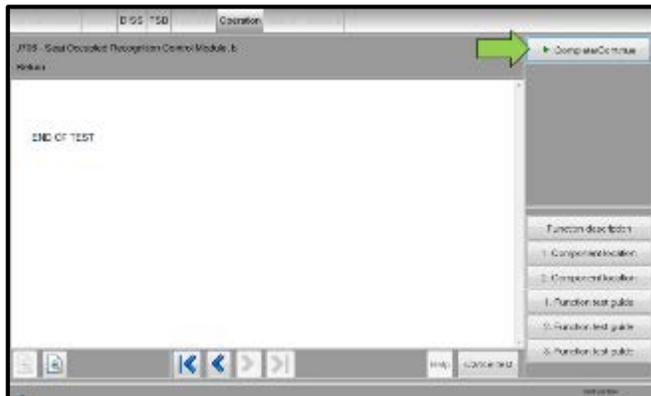
- When the message “END OF TEST” is displayed, select “Complete/Continue” <arrow>.
- Clear all DTCs.
- Reset customer convenience basic settings (i.e. clock, one-touch windows, seat position).
- Disconnect the VAS scan tool.
