# Recall Bulletin

## PRODUCT SAFETY RECALL

**SUBJECT:** Front Passenger Air Bag Inflator

**MODELS:** 2003-2007 Pontiac Vibe

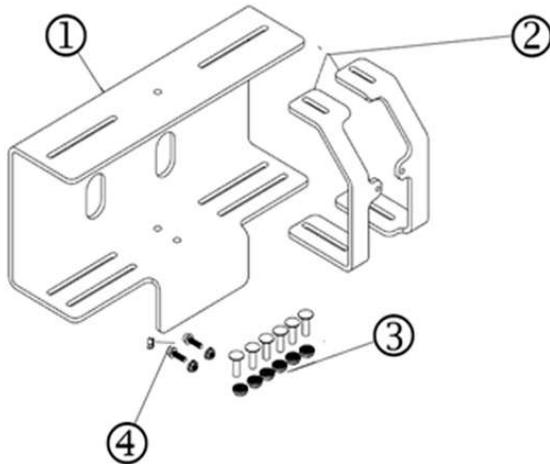
4006668

**Note:** Dealers are required to use the air bag mounting bracket, shown below, to replace the front passenger air bag inflator module. These brackets were previously provided to dealers by Bosch Automotive Service Solutions. The Bosch tool number is EL-51377. If your dealership does not have the air bag mounting bracket, do not attempt to perform this service procedure and immediately contact your District Manager - Aftersales for assistance. Attempting to replace the front passenger air bag inflator module without using the bracket poses a safety risk for the technician and anyone else in the area.

(1) Mounting Bracket (2) Support Bars (3) Support Bar Hardware (4) Air bag Mounting Hardware.

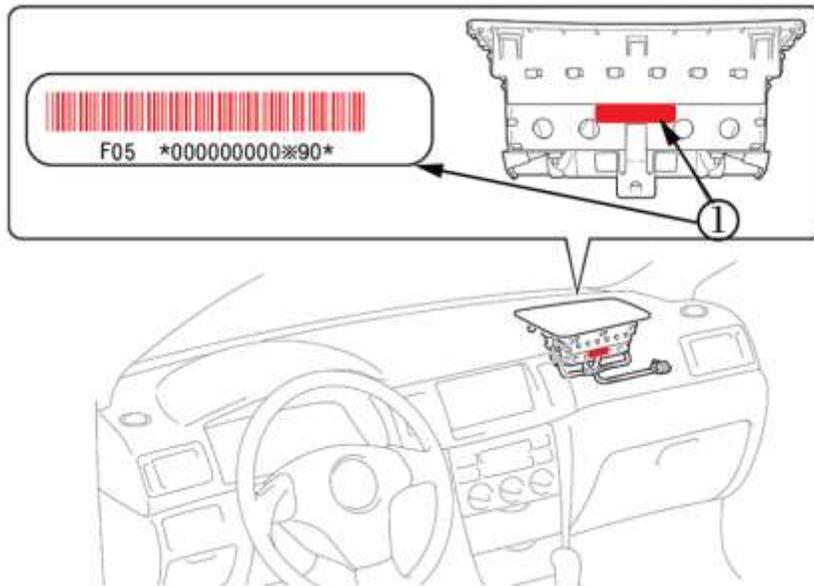
3470289

6. Locate passenger air bag bar code label (1). Refer to illustration.
7. Determine if an 'X' is present on the bar code label. The 'X', if present, will be located in the lower right-hand corner of the bar code label.
  - If an 'X' is NOT present, proceed to *Front Passenger Air bag Inflator Module Replacement* in this bulletin.
  - If an 'X' is present, the air bag module has already been repaired. Re-install the air bag module. Refer to *Air bag Instrument Panel Module Replacement* in SI. Proceed to step 25 in the *Front Passenger Air bag Inflator Module Replacement* section of this bulletin.

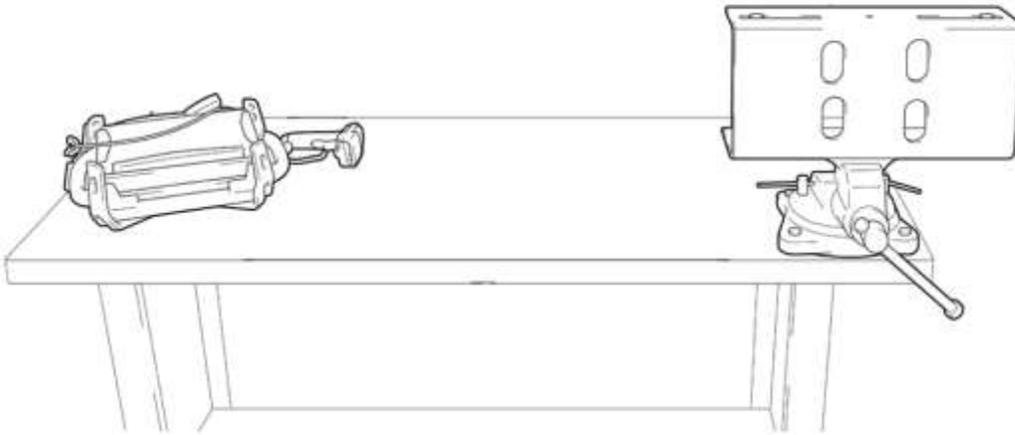
3607819

**Danger:** To avoid personal injury or death, it is critical to use an air bag module bracket when replacing an inflator module. Carefully read and follow the instructions below:

- Confirm the bracket assembly is installed securely in the vice.
  - Confirm there are no loose objects or people exposed to the back side of the bracket for safety in the unlikely event of air bag deployment due to improper work procedures. The air bag is NOT being replaced due to an inadvertent deployment concern.
  - Confirm that no objects, tools or people are within 3 feet (1 meter) of the back side of the bracket.
  - Confirm that no objects, tools or people are within 2 feet (0.6 meters) of the sides of the bracket.
  - BEFORE starting work and periodically while working on the air bag module, touch a metallic part of the work bench to discharge static electricity in the body.
1. Mount the air bag module bracket securely in a vice.

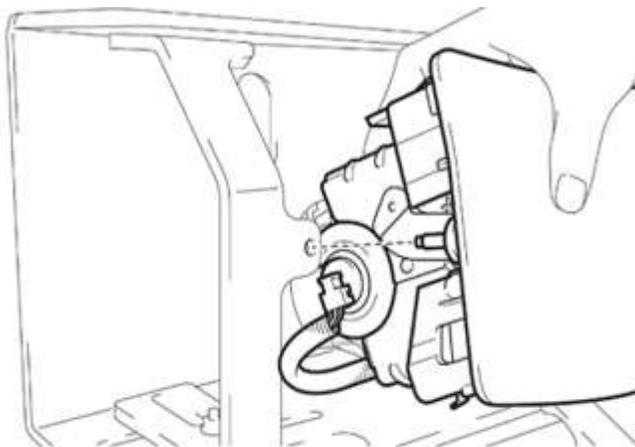
3607829

2. Position the two mounting studs on the air bag assembly into the holes on the bracket support bars.

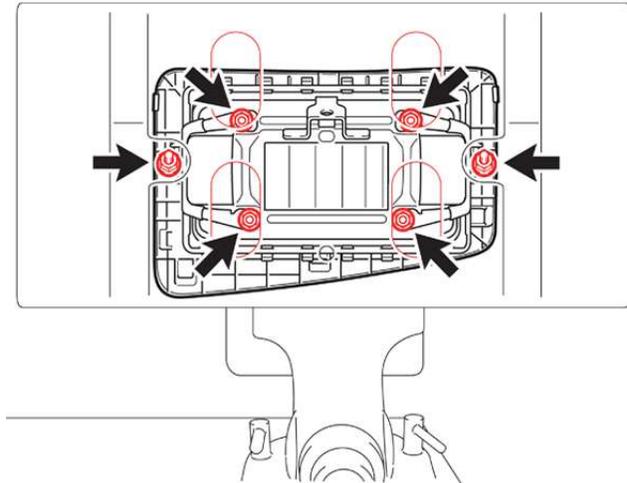
3607904

3. Loosely install the air bag to the support bars with the nuts supplied in the bracket kt.
4. Position the air bag so that all four stopper plate nuts can be removed through the access holes.
5. Tighten the two nuts holding the air bag to the support bars.
6. Confirm the following steps have been completed BEFORE proceeding to the next step:
  - The mounting bracket is secure in the vise.
  - The air bag module is secured to the support bars of the bracket.
  - The support bars are secured on the mounting bracket using one (1) bolt/nut at the top of each support bar and two (2) nuts/bolts at the bottom of each support bar.

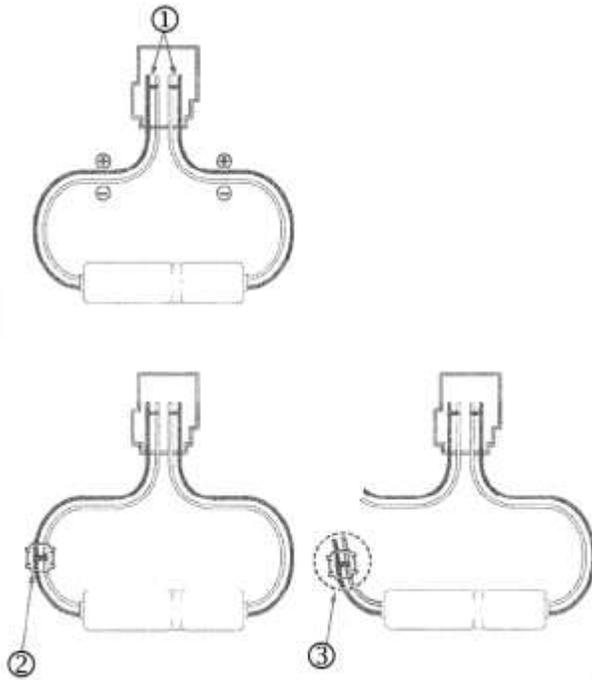
3470510

**Note:** The connector of an air bag inflator has a short-circuiting mechanism that eliminates voltage difference when disconnected (1). To allow for the replacement of the inflator module, a new short circuit using an electro tap (2) **MUST** be created **BEFORE** cutting the wires (3) and removing the inflator.

7. Create a short circuit before disconnecting the inflator wire harness.

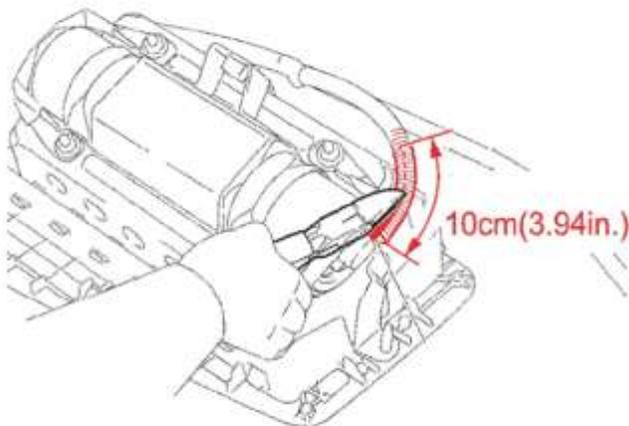
3470432

**Caution:** **DO NOT** damage the internal wires when cutting open the corrugate tube. **DO NOT** use a knife or razor blade to cut the tube to avoid damaging the wires. This step may be performed on either end if the inflator.

7.1 Cut open the corrugated tube on the yellow harness approximately 10 cm (4 in) using snippers.

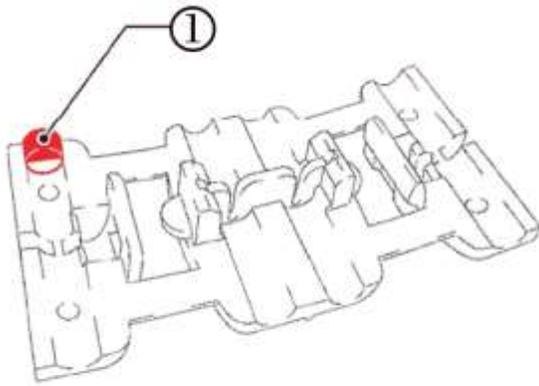
3470344

**Danger:** The tab on the electro tap must be removed to ensure a good short.

7.2 Cut off the tab of the electro tap (1) (included in the kit) shown in the illustration.

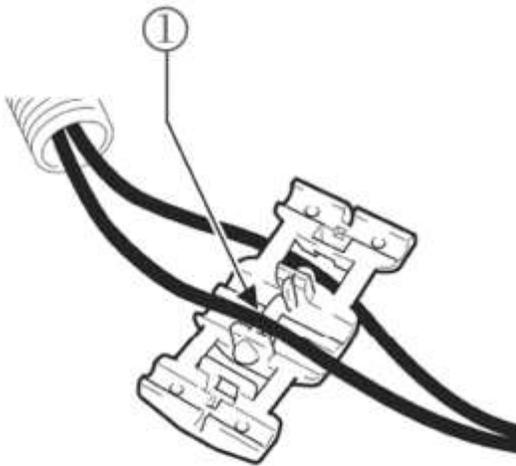
3470361

7.3 Short-circuit the two wires using the electro tap. Place one wire (1) in the electro tap as shown in the illustration.

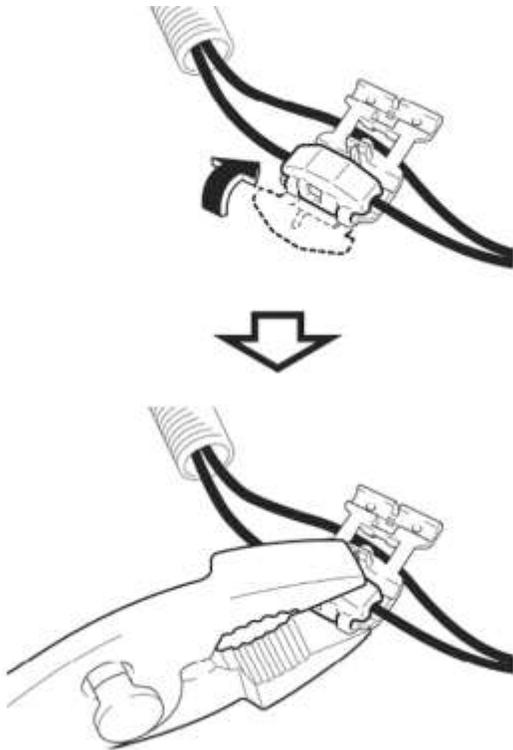
3470357

**Note:** Simultaneously working on the two wires tends to cause a mistake. Be sure to set the wire in the electro tap one wire at a time. Lock the electro tap firmly using pliers. If locked by hand, the electro tap may unfasten.

7.4 Fold and pinch the half of the electro tap where the first wire was just placed using pliers to lock firmly.

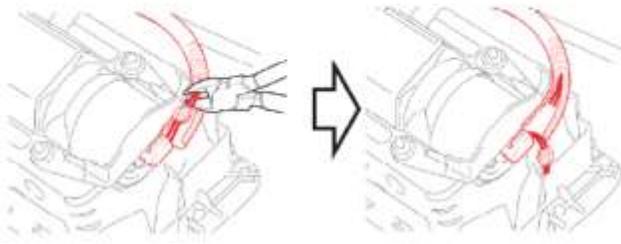
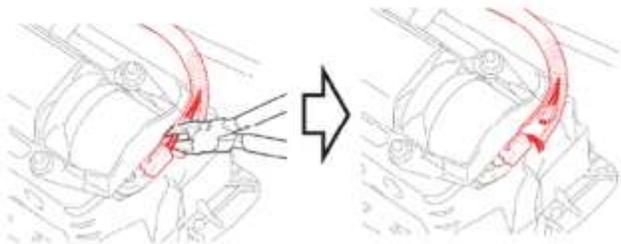
3470348

OK: Cut wires at opposite side to inflator. NG: Do NOT cut at inflator side.

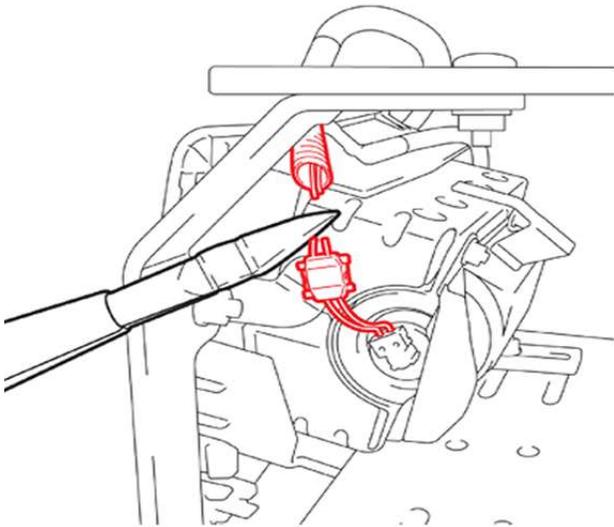
3607837

**Danger:** Do NOT measure resistance of the inflator wires. This may cause accidental activation of the inflator.

**Caution:** Ensure to cut the two wires at the correct location. Refer to the illustration.

8. Cut the two wires at the side of the electro tap opposite to the inflator (the side of the electro tap that is farthest away from the inflator).

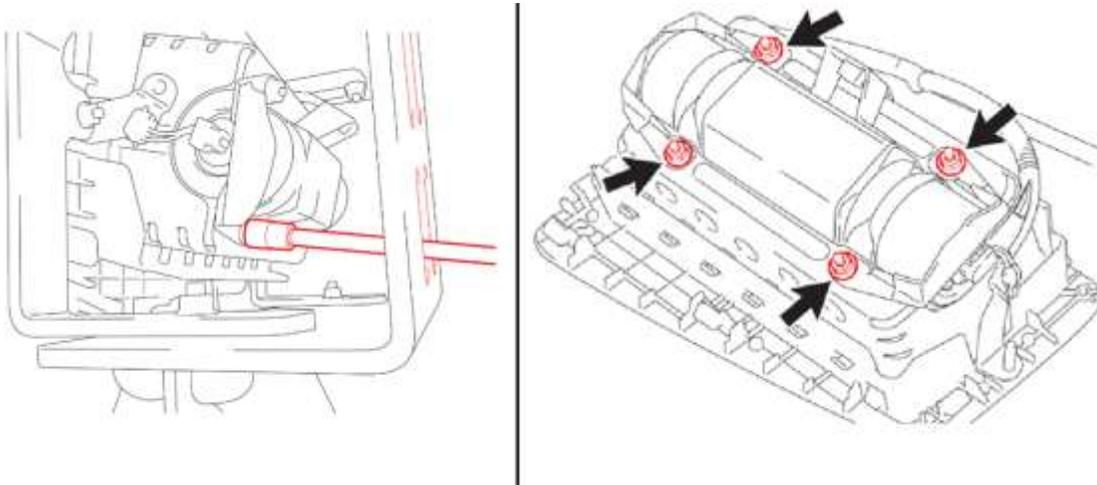
3607844

**Caution:** DO NOT use power tools. The bracket support bars may need to be repositioned to remove the nuts through the access holes.

9. Use the access holes in the bracket to loosen and remove the four self-locking nuts.

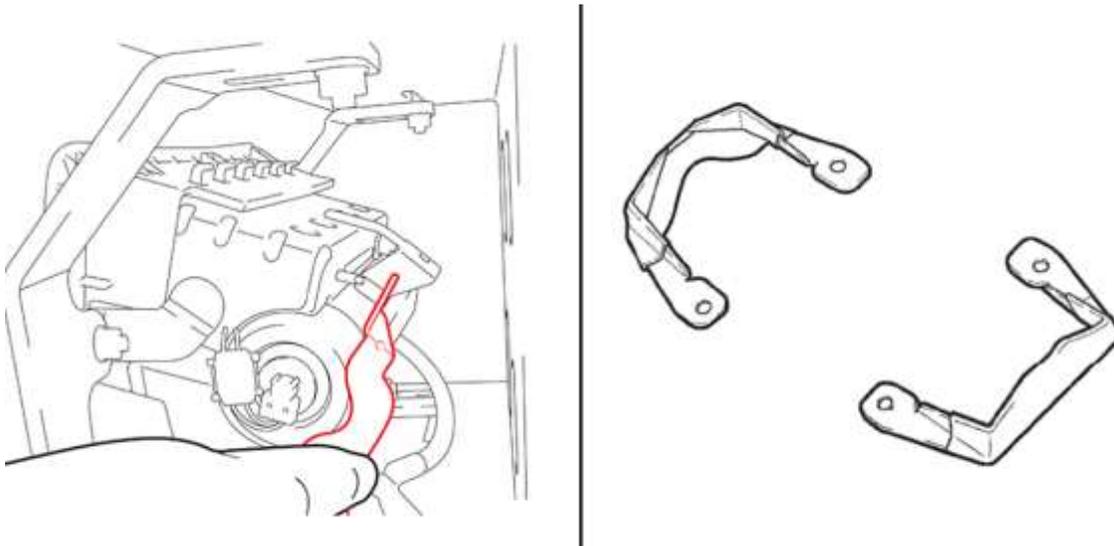
3607850

10. Remove the stopper plates.

11. Discard the 4 nuts and 2 stopper plates as they are not to be reused.

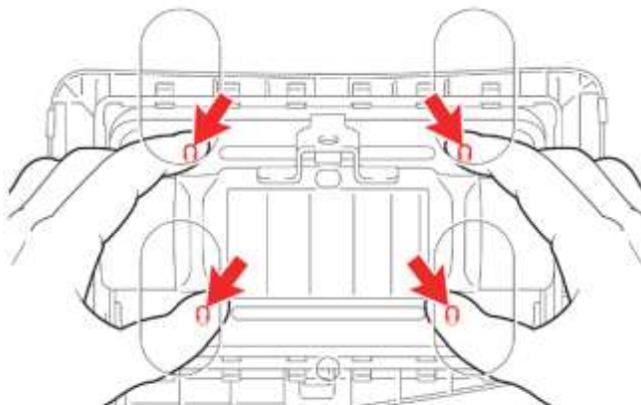
3607857

12.1 Gently push in the 4 studs to loosen the inflator for removal.

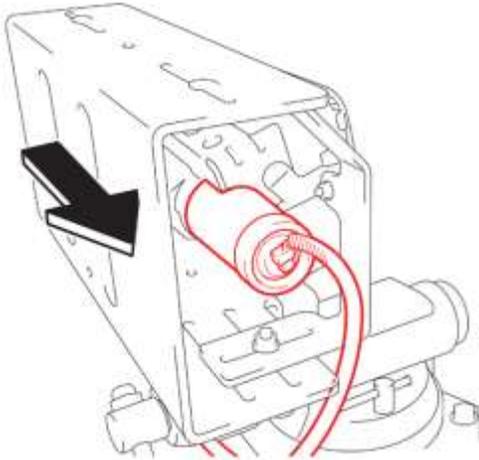
3607866

12.2 Remove the inflator from the air bag assembly and place it on a safe work surface.

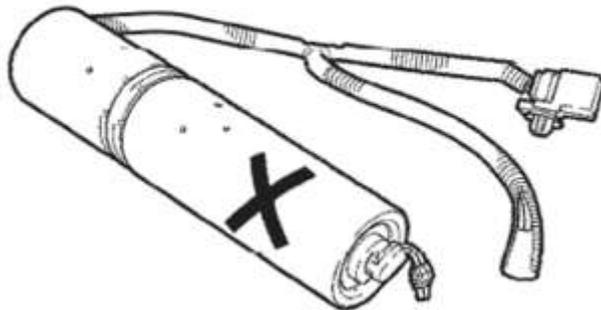
3470416

12.3 Put a mark on the removed inflator and store it in the provided replacement part box. Refer to the packaging instructions that were included with the new inflator module kit.

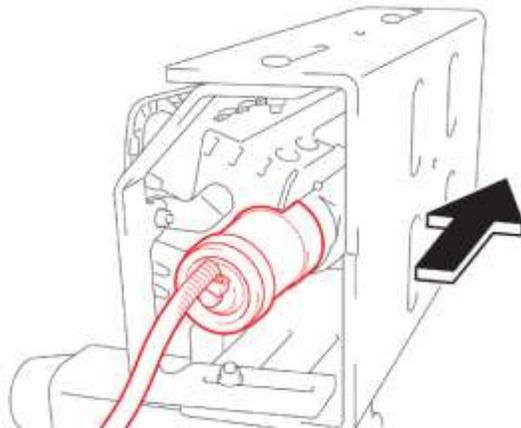
3607873

13. Carefully slide the new inflator into the air bag assembly.

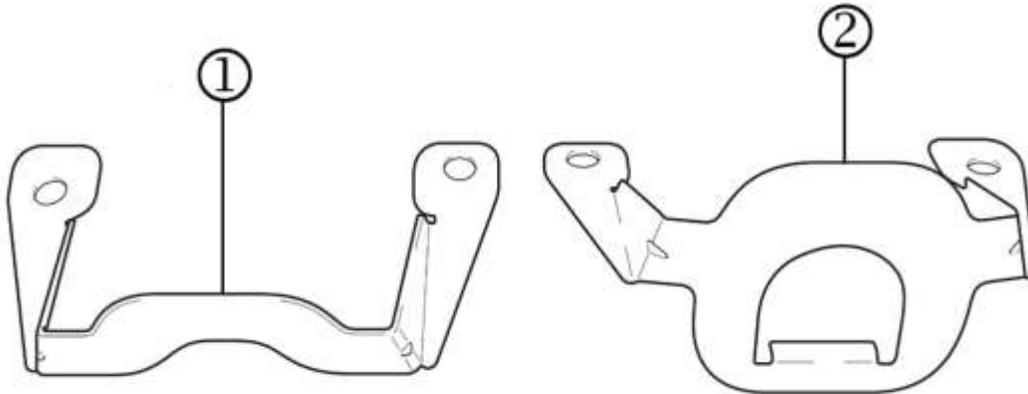
3607880

14. Confirm the identification of the stopper and the position determining plate. **THEY ARE DIFFERENT.** Refer to the illustration: (1) Stopper Plate (2) Position Determining Plate.

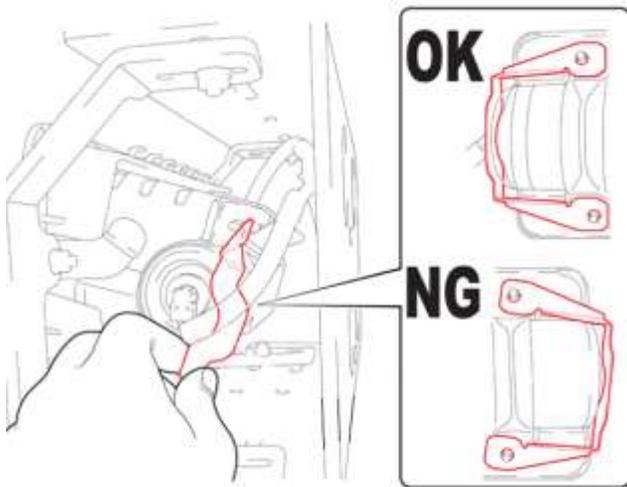
3607886

**Warning:** Confirm the stopper plate to inflator fitment is correct. **DO NOT** pinch the harness between the inflator and the stopper plate.

15. Loosely install a *new* stopper plate.

- 15.1 Place the **NEW** stopper plate on the air bag assembly on the side where the harness is already connected.
- 15.2 Confirm the end of the inflator sits flat against the stopper plate. If they do not align the inflator is installed backward.
- 15.3 Install **NEW** stopper plate nuts by hand. They will be torqued on a later step.

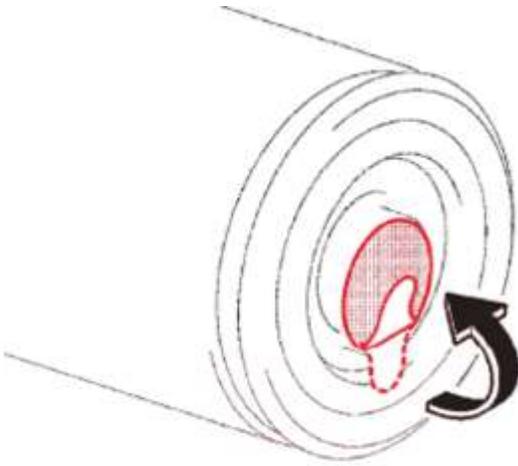
3470378

**Note:** *DO NOT* fully remove the seal until just before connecting the harness.

16. Fold the seal in order to prevent it from being caught under the position determining plate in the next step.

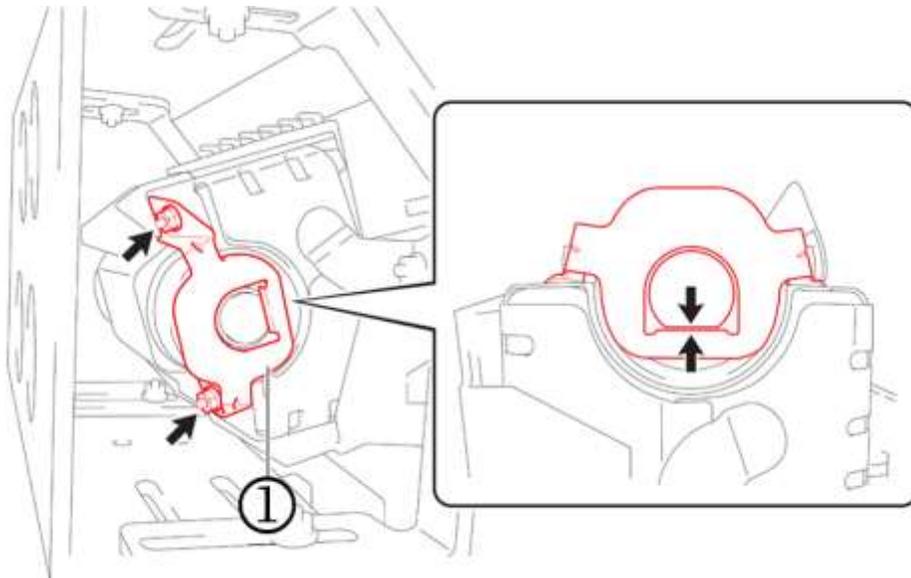
3610413

**Warning:** Confirm the flats on the position determining plate and inflator are aligned. *DO NOT* pinch the harness between the inflator and the plate.

17. Install the *new* position determining plate.

17.1 Place the **NEW** position determining plate on the air bag assembly on the side with the connector seal.

17.2 Install **NEW** nuts by hand.

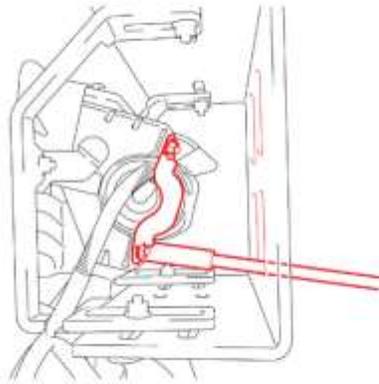
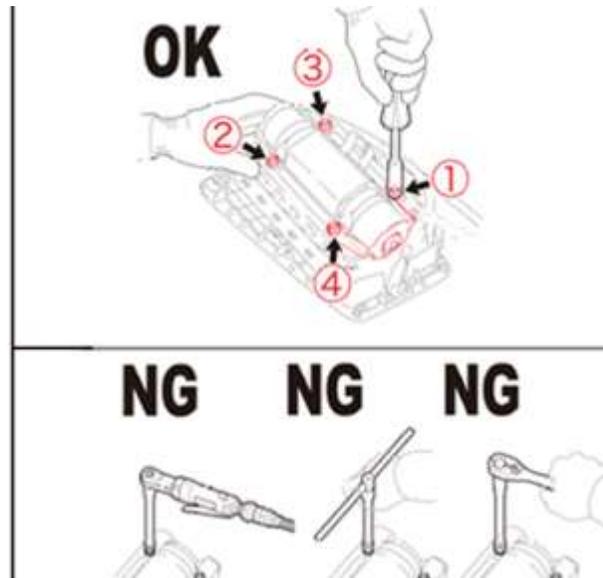
3610416

**Caution:** There will be some resistance when tightening the nuts because they are self-locking. Confirm the nuts are tightened correctly. **DO NOT** use a power tool, T-handle, or ratchet when tightening the nuts to avoid over-torquing.

18. Tighten four (4) **NEW** plate nuts evenly in several increments in the order shown in the illustration using a 10 mm socket driver while pushing the inflator. (You will encounter some resistance during tightening because these nuts are self-locking nuts.)

**Torque Specification: 3.9 Nm (35 in-lb)**

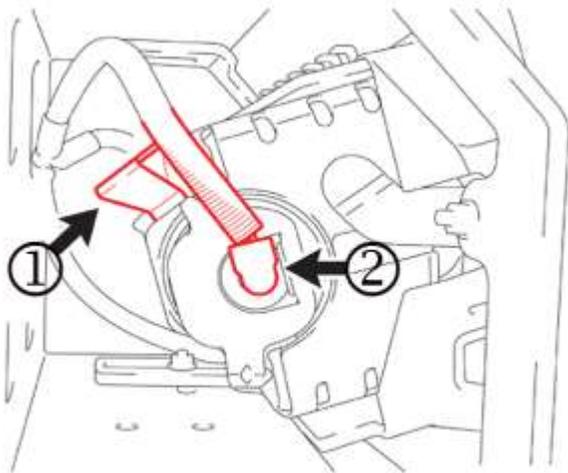
3610412

**Warning:** The connector should be connected **IMMEDIATELY** after removing the seal. Once the connector is installed it **CANNOT** be removed. If the connector is installed in the incorrect orientation the terminals may be bent or the connector may not fully engage.

19. Connect the inflator connector (2).

19.1 Remove the connector seal from the inflator.

19.2 Confirm the alignment of the harness connector as shown in the illustration, and then connect the harness. The connector wires should lead toward the center mounting bracket (1) on the air bag assembly.

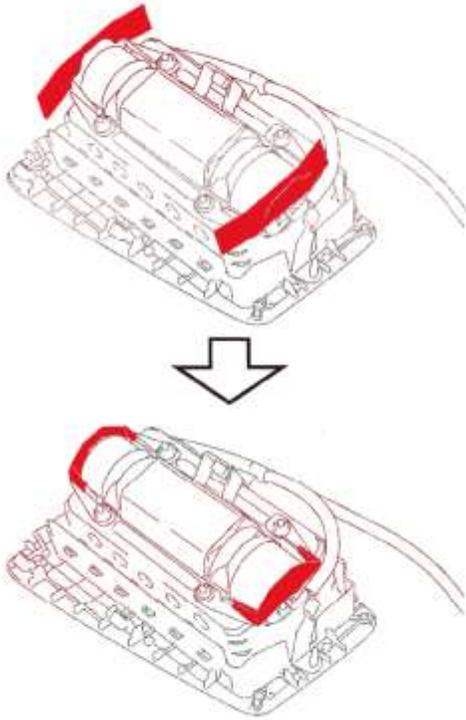
3470478

21. Attach the felt tape to the edges of the stopper and position determining plate.

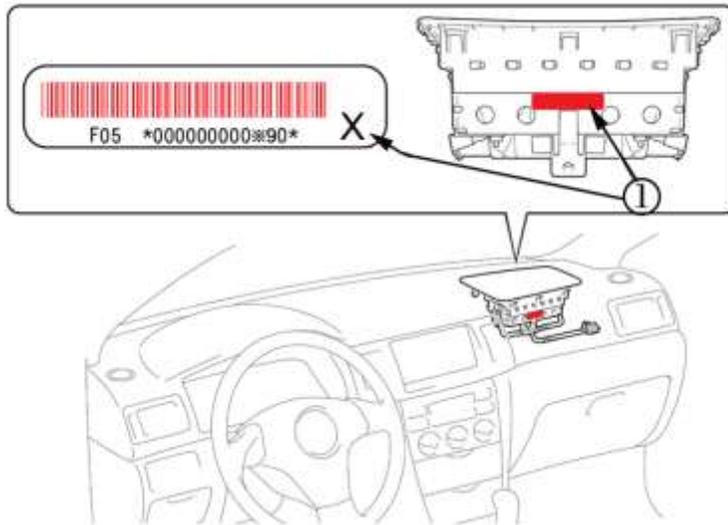
3610495

22.5 Using a pen or marker, put an 'X' in the lower right-hand corner of the air bag bar code label (1).
