GROUP Safety Recall Campaign	MODEL 2011 MY Forte (TD)
	NUMBER SC 129	DATE March 2016
VOLUNTARY SAFETY RECALL CAMPAIGN		
SUBJECT: A/T FLUID COOLER HOSE REPLACEMENT (SC 129)

SUBJECT: A/T FLUID COOLER HOSE REPLACEMENT (SC 129)

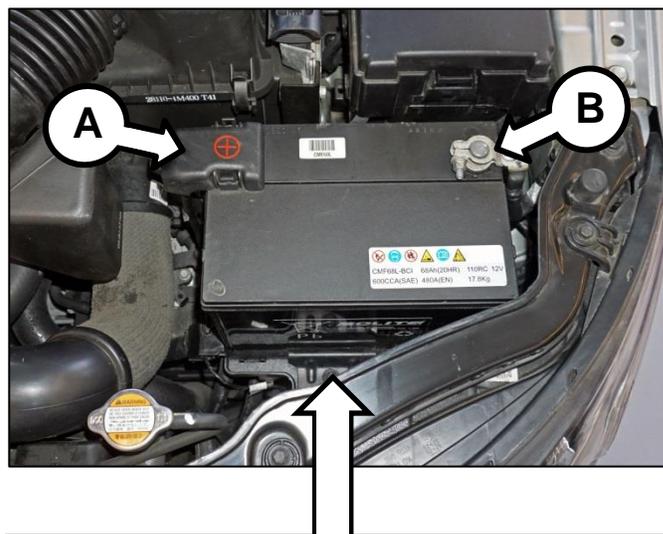
1. Turn ignition switch to the OFF position.
2. Record the customer's radio presets.
3. Disconnect the Positive (+) terminal (A) and Negative (-) terminal (B) from the battery.

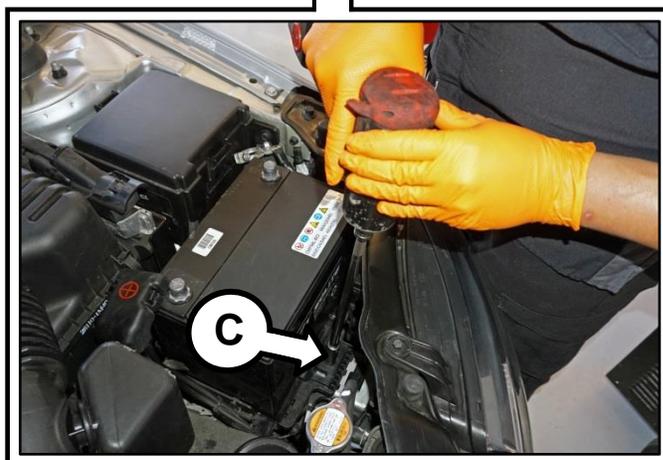
4. Remove one (1) bolt securing the battery mounting bracket (C) to the chassis.

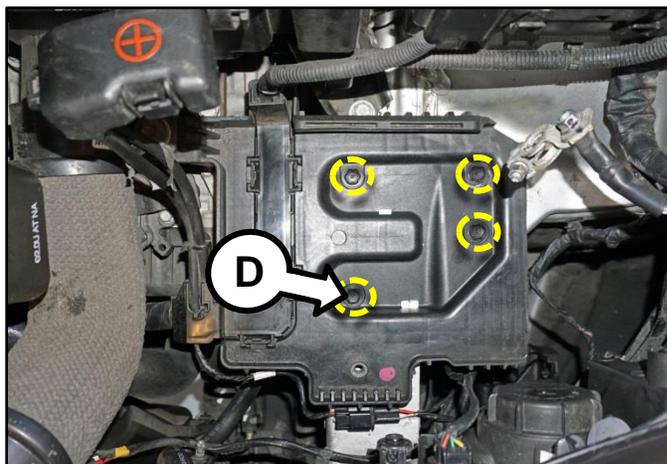
5. Remove four (4) bolts (D) securing the battery tray to the chassis.

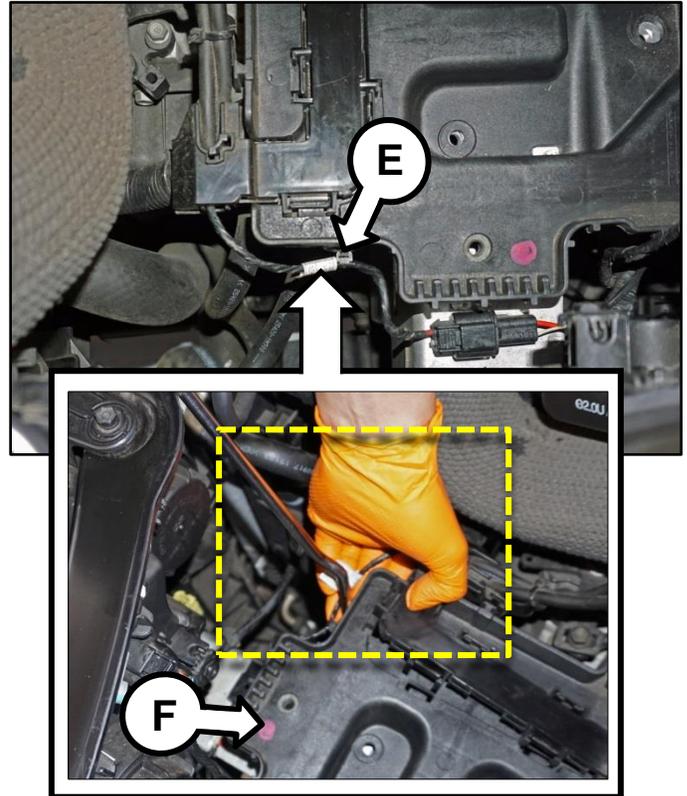
6. Undo the battery connector attachment point (E) on the battery tray (F), as shown.

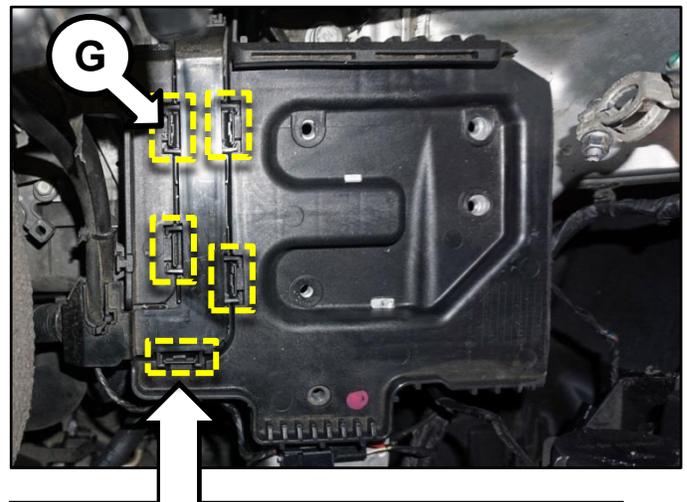
7. Locate the five (5) mounting locations (G) for the harness channel.

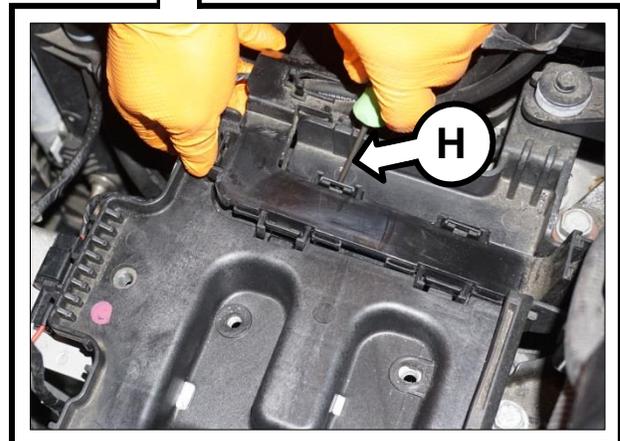
8. Use a pick tool tool (H) to undo each mounting location, as shown.

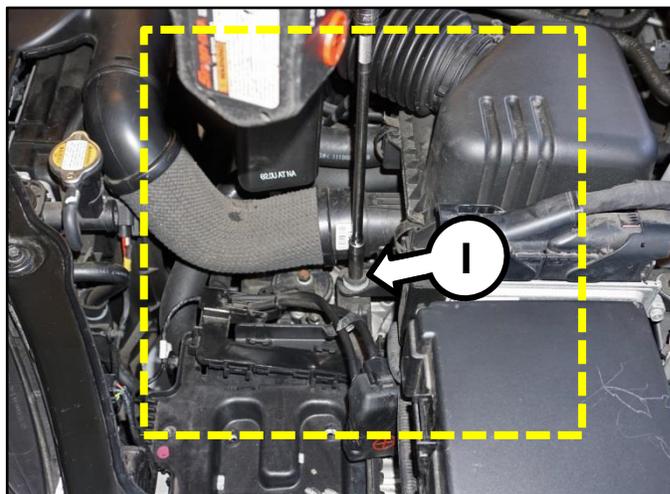
9. Remove the final battery tray mounting location (I), as shown.

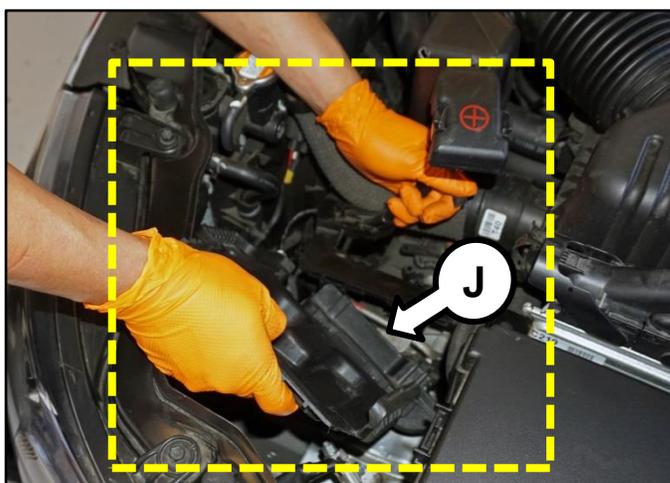
10. Remove the battery tray (J), as shown.

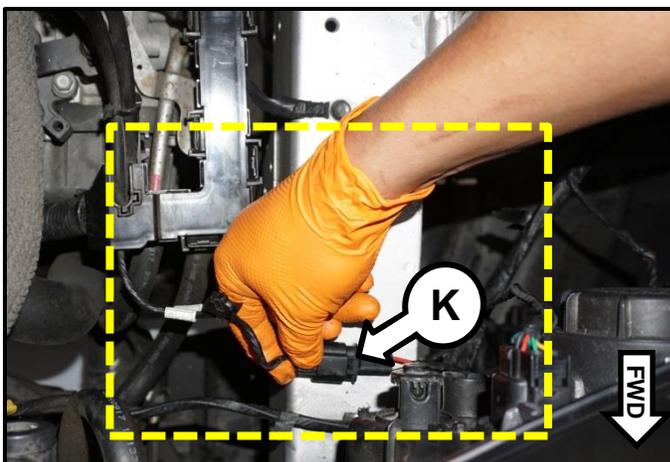
11. Disconnect the battery sensor connector (K), as shown.

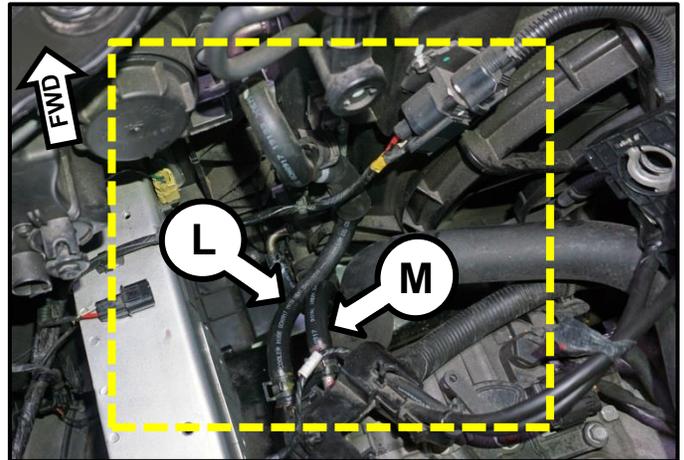
12. Locate the upper (L) and lower (M) A/T cooler hoses.

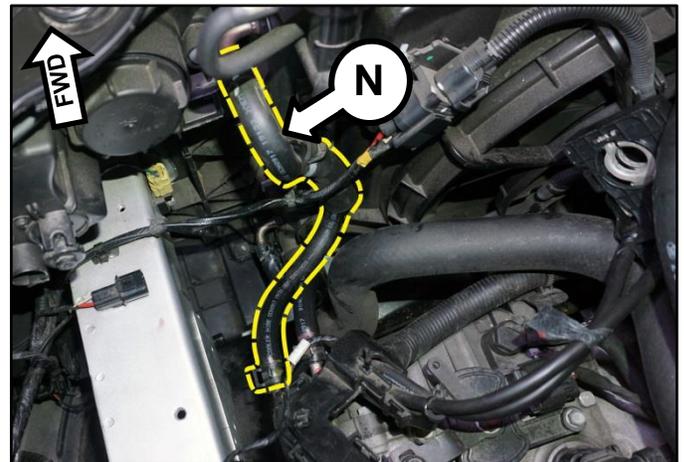
13. Remove the upper A/T cooler hose (N).

15. Install the replacement lower A/T cooler hose and secure with clamps.
16. Install the replacement upper A/T cooler hose and secure with clamps.

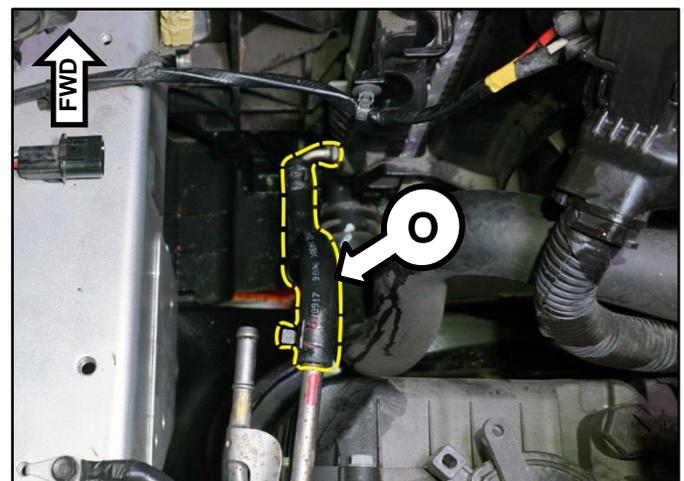
14. Remove the lower A/T cooler hose (O).
