Front Lower Control Arm Washer Installation

Classification	Campaign Bulletin	Section/Group	31 - Suspension	Country/Region	North America, Europe
Year	2012-2013	Model	Model S	Version	All

This Service Bulletin supersedes SB-13-31-003 R1, dated 16-Mar-15. Each content change is marked by a vertical line in the left margin. Discard the previous version and replace it with this one.

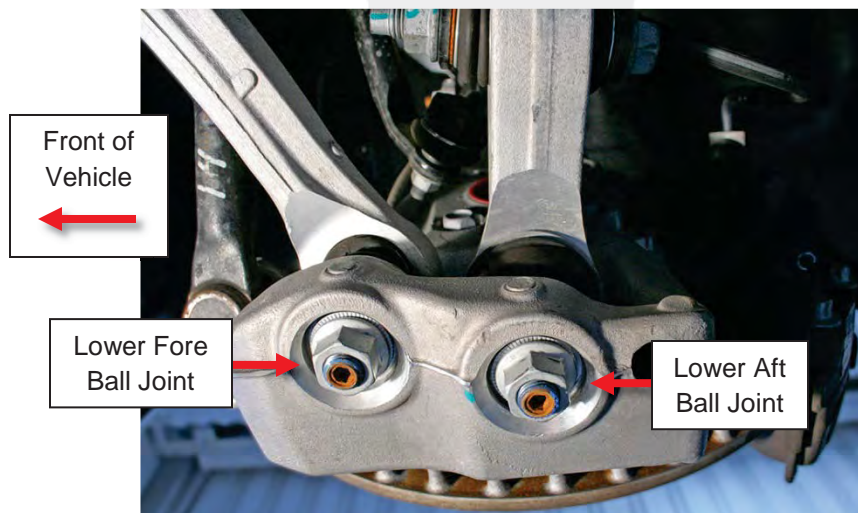
Figure 1 (RH side shown)

1. Remove the front wheels (refer to Service Manual procedure 34012401).
2. Check the front fore and aft lower control arms for visible play at the connections to the knuckle (Figure 1).
 - If there is no visible free play, skip directly to the “Wedge-Lock Washer Installation” section of this document.
 - If visible free play is found, continue to the next step in this procedure.
