**SB-10056440-7546****FORD:**

2011-2014 F-150

**ISSUE**

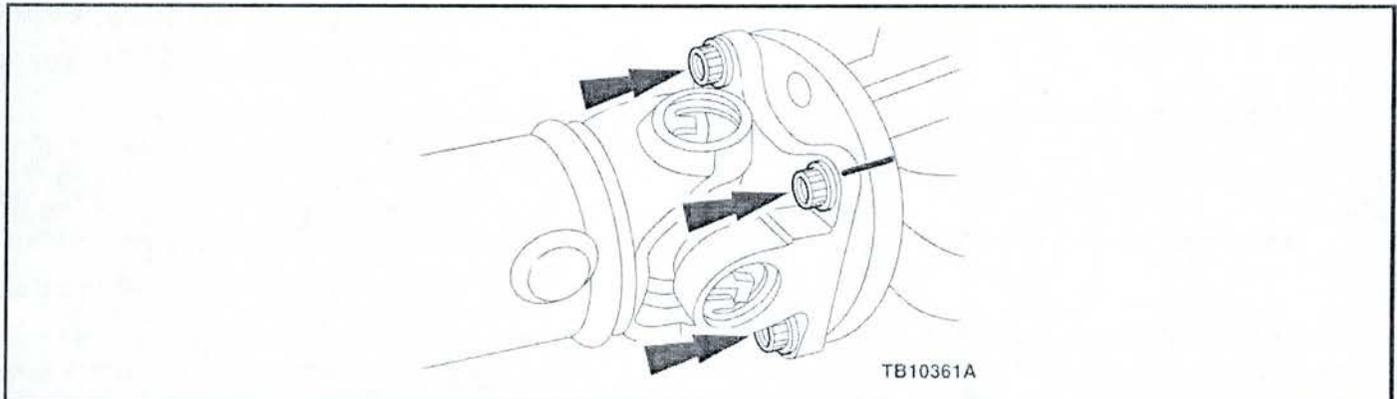
Figure 1 - Article 14-0090

- b. No - proceed to Step 3.
3. With the vehicle in neutral, position it on a hoist. Refer to WSM, Section 100-02.
4. Index-mark the driveshaft flange and pinion flange for correct alignment during installation. (Figure 1)

15. Install the rear disc brake calipers. Refer to WSM, Section 206-04.
16. Position the driveshaft to the pinion flange and align the index marks. (Figure 1)

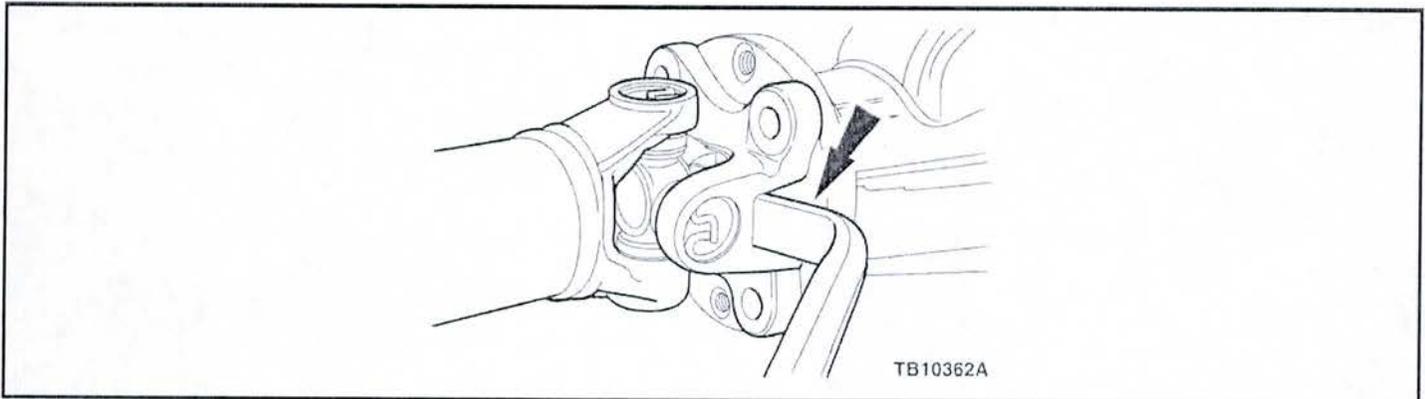
Figure 2 - Article 14-0090

5. Remove and discard the four (4) driveshaft flange bolts.
6. Disconnect the driveshaft centering socket yoke from the pinion flange. (Figure 2)

- a. The driveshaft centering socket yoke fits tightly on the pinion flange pilot. Never hammer on the driveshaft or any of its components to disconnect the driveshaft centering socket yoke from the pinion flange. Pry only in the area shown with a suitable tool to disconnect the driveshaft centering socket yoke from the pinion flange.
