SB-10056603-8580

CUSTOMER SATISFACTION PROGRAM

SUBJECT: Brake Vacuum Pump Fuse Value

MODELS: 2015 Chevrolet Colorado
2015 GMC Canyon

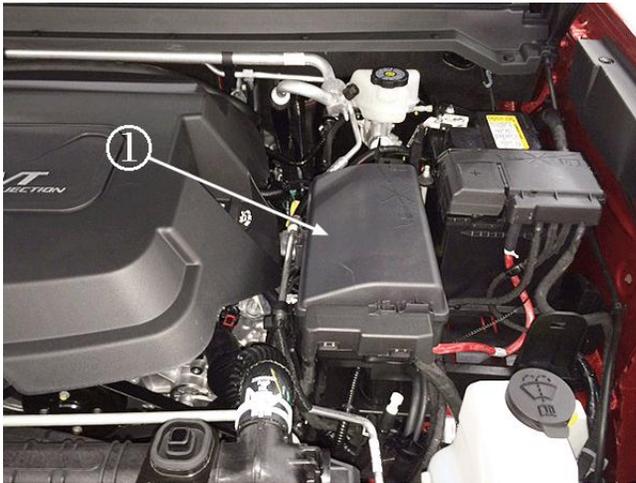
3992588

1. Open the hood and locate the underhood electrical center/junction block cover (1).

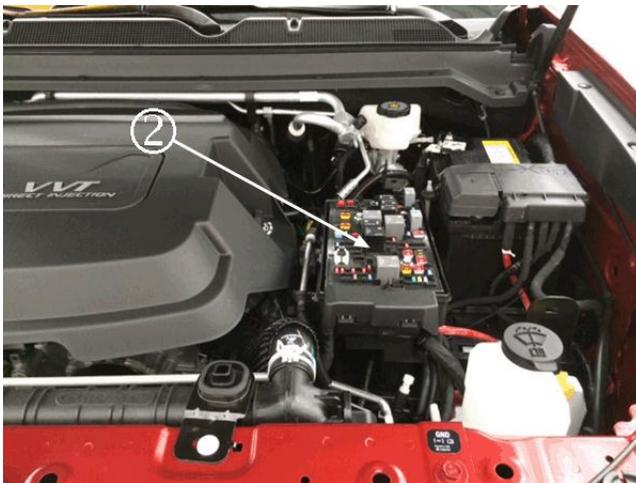
3999897

2. Remove the underhood electrical center/junction block cover (2).

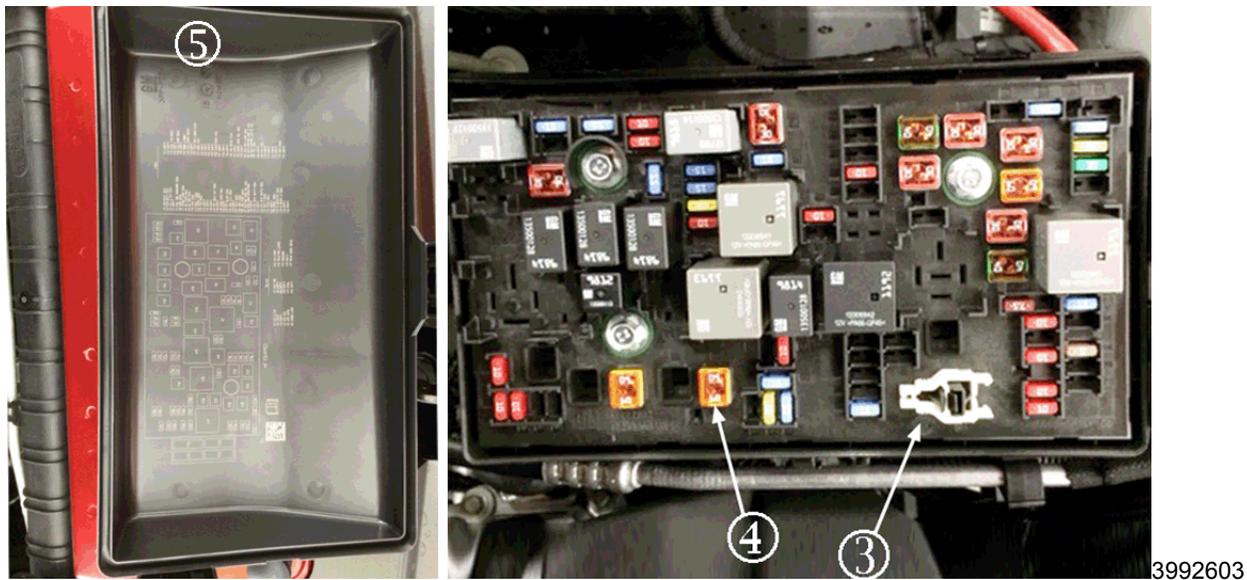
3. Locate fuse puller (3).
4. Remove and discard the F45 (60A) fuse (4) from the underhood electrical center/junction block using the fuse puller. Refer to the inside of the cover (5) for fuse location. There is an engraving in the plastic that indicates the fuse number.
5. Install a new 30 amp fuse in the F45 location.
6. Discard the old underhood electrical center/junction block cover.
7. Install the new underhood electrical center/junction block cover. The new cover lists the F45 location as a 30 amp fuse.
