GROUP Body	MODEL 2013MY Rio (UB)
NUMBER 087	DATE November 2012

## TECHNICAL SERVICE BULLETIN

**SERVICE ACTION: LUGGAGE TRAY ASSEMBLY KIT INSTALLATION (SA130)**

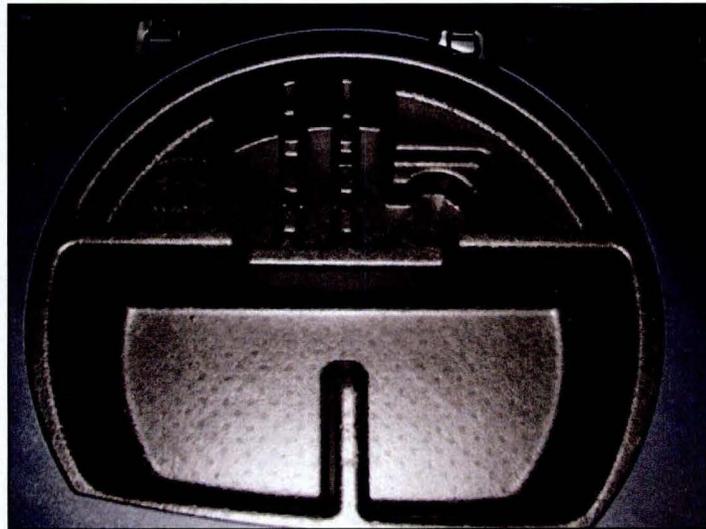
This bulletin provides information relating to the missing luggage tray assembly in some 2013MY Rio vehicles produced from June 11, 2012 to September 6, 2012. To correct this issue, installation of the Luggage Tray Assembly Kit will be required for all affected units. Kia is requesting the completion of this Service Action on all affected Rio vehicles in dealer stock prior to delivery. Before conducting the procedure, verify that the vehicle is included in the list of affected VINs.

*New Luggage Tray Assembly*
