GROUP Body	MODEL 2014MY Cadenza (VG)
	NUMBER PS282	DATE January 2014

SUBJECT: Rattling, Squeaking or Creaking Noises From Roof Area

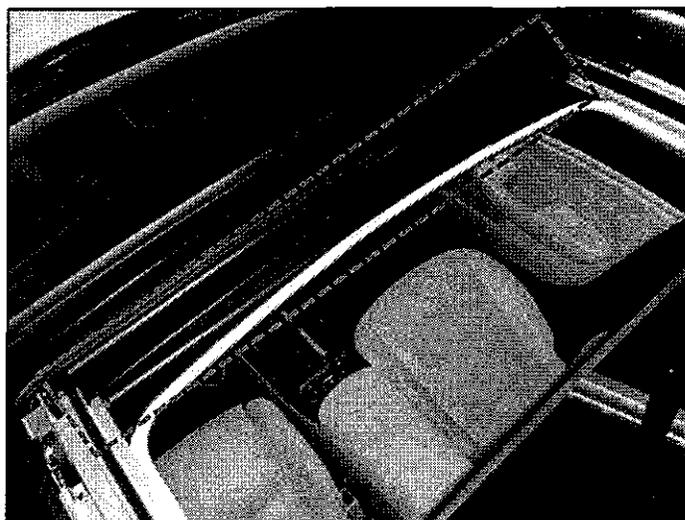
1. Open the panoramic sunroof and remove the front cover assembly. Make sure to re-install any missing retaining clips back in place on the front cover assembly.

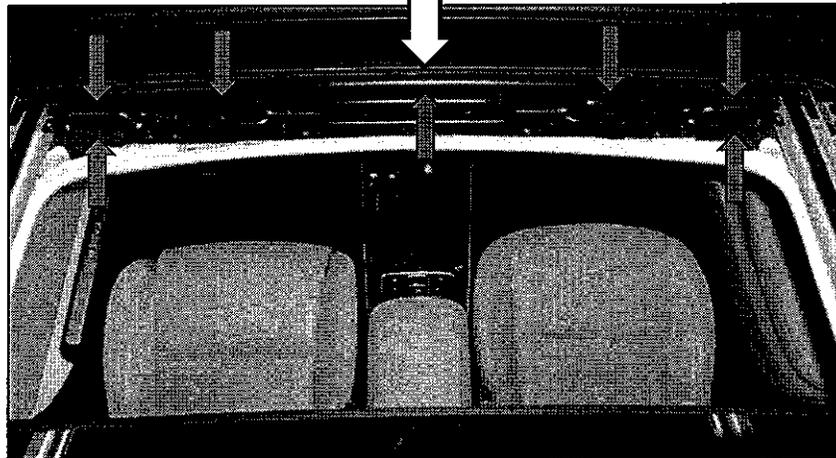
2. Add seven (7) pieces of felt tape along the front of the panoramic sunroof opening in order to isolate the front cover assembly from the body and prevent possible squeaks or rattles.

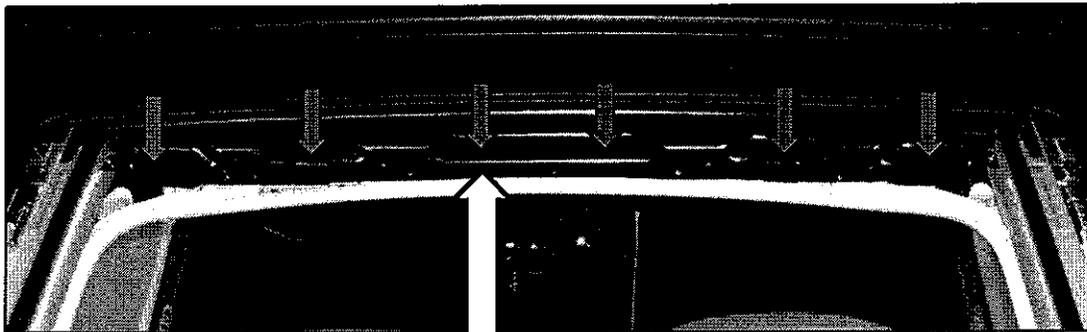
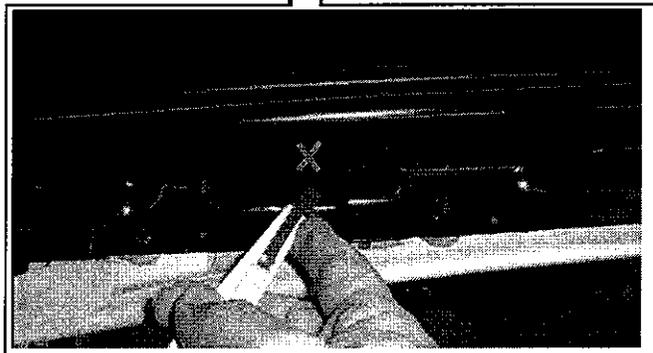
3. Apply six (6) pieces of felt tape over the mounting holes for the front cover assembly. Cut the felt in an "X" pattern at each mounting hole to allow for easy insertion of fasteners.

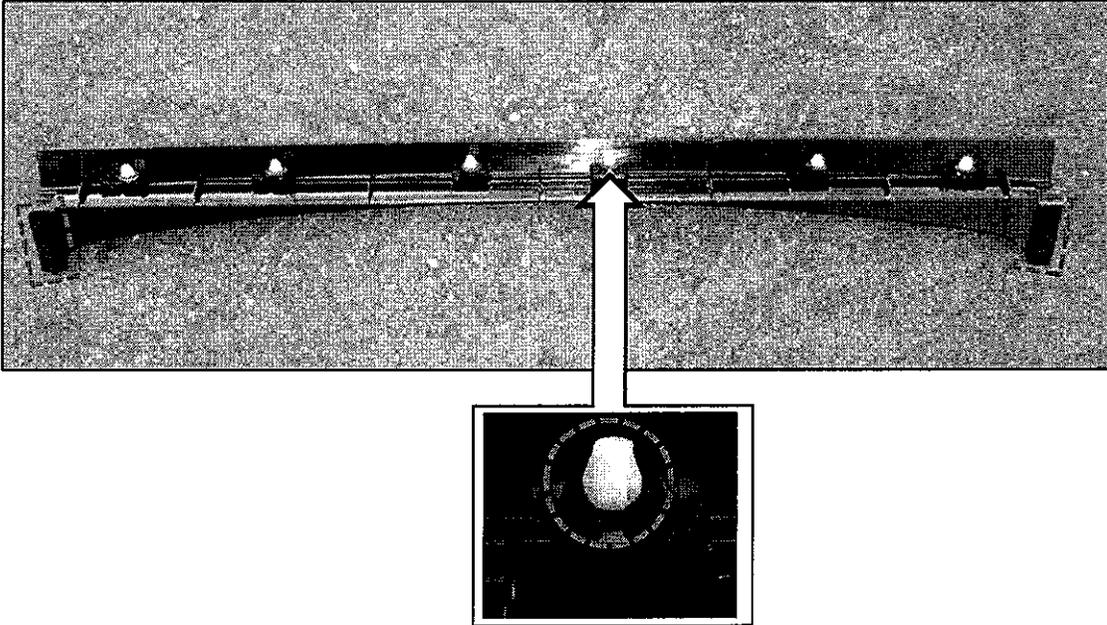
4. Apply two (2) pieces of felt tape to the ends of the front cover panel, as shown. Also, make sure to remove the felt discs from the front cover assembly retaining clips.

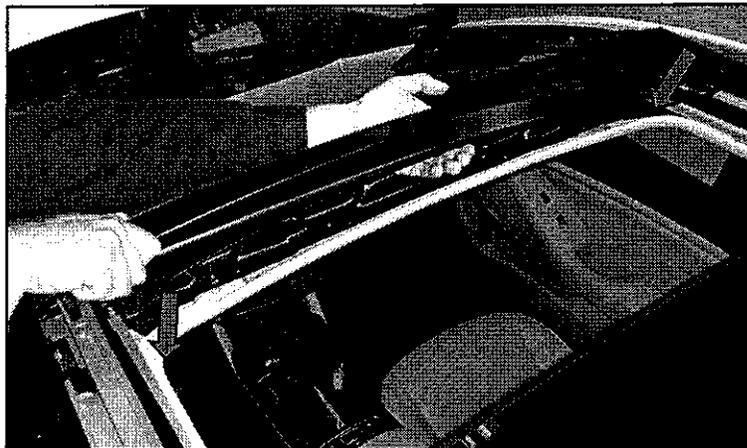
5. Check to make sure all retaining clips are properly installed on the back of the front cover assembly.
6. Re-install the front cover assembly by engaging one end under the sunroof rail and slightly bending it until the other end can be inserted into the opposite side.
