GROUP <b>Electrical</b>	MODEL <b>Cadenza (VG)</b>
	NUMBER <b>PS273</b>	DATE <b>August 2013</b>

<b>SUBJECT: AVN HEAD-UNIT AND/OR MONITOR REPLACEMENT</b>

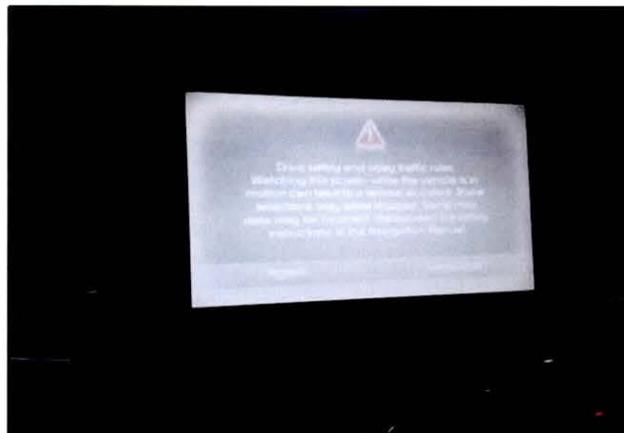
When performing a replacement of the AVN head unit or monitor on Cadenza vehicles, make sure to disconnect the negative (-) terminal from the battery before conducting any repairs. All power should be discontinued to the AVN monitor when unplugged from the AVN head unit. If power is supplied to AVN monitor while disconnected from the AVN head unit, the screen may be damaged. Screen damage may not be apparent at the time of repair, however, a white screen may occur at initial start-up, after the vehicle has been at rest, and may deteriorate over time (see image below).
