GROUP
Body Electrical

MODEL
**2014MY Optima
(QF/TF) w/Base
Audio**

NUMBER
PS348

SUBJECT: DIM HEAD UNIT DISPLAY IN COLD WEATHER CONDITIONS

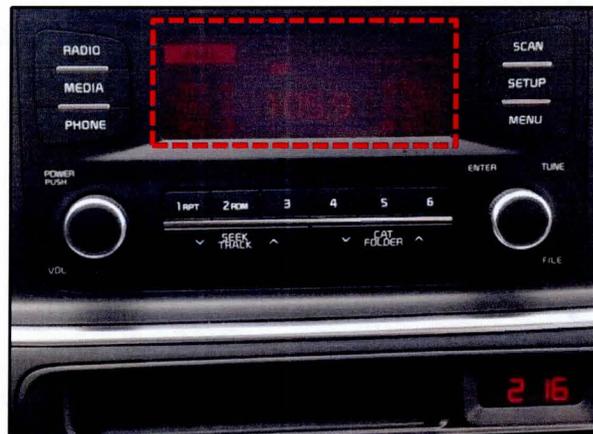
When addressing a customer complaint related to a Base Audio head unit display which appears to have no display or a dim display (see image below) at or below freezing conditions, pull the vehicle into a shop (warmer area) and check to see if full brightness is regained after a period of time. If full brightness is regained, the head unit should be replaced to resolve the concern. A countermeasure for this issue was applied to vehicles in production, on February 28, 2014 and to remanufactured units at the PDCs, beginning on May 1, 2014. If after replacement of the head unit the vehicle returns with the same concern, call Techline and open a case.
