Campaign Service

BULLETIN NUMBER:
CB16-X-002

NONCOMPLIANCE RECALL

VIN LABEL PRINTER ERROR - 16V-105

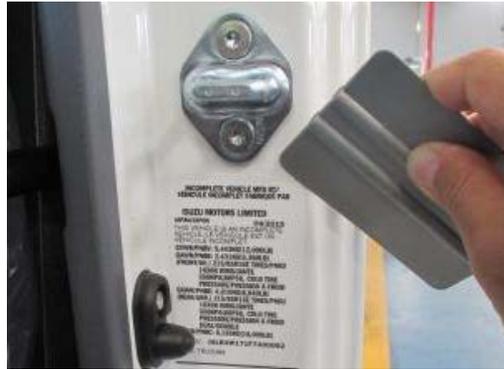
Figure 1

- 1) Carefully remove old label from B-pillar door jamb (driver's side door) using the 3M™ Scotchcal™ application squeegee to avoid paint damage (See Figure 1).

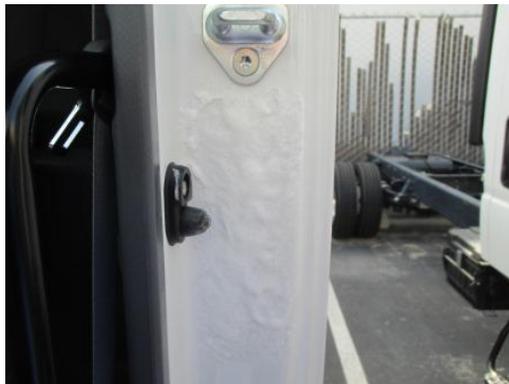
Figure 2a

- 2) Remove old label glue residue by applying a light coat of CRC™ gasket remover (See Figure 2a) and letting it soak for no more than two (2) minutes before wiping it off with a clean cloth (See Figure 2b).

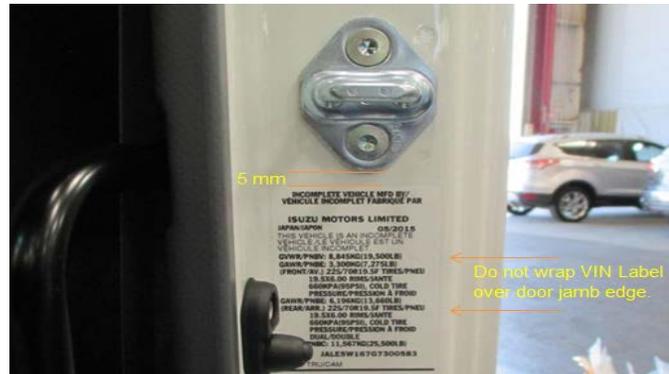
Figure 3

- 2) Apply the new corrected certification label in area shown (See Figure 3), located **5mm below the striker** in the driver's door jamb. Be careful **not to wrap label over door jamb edge**.

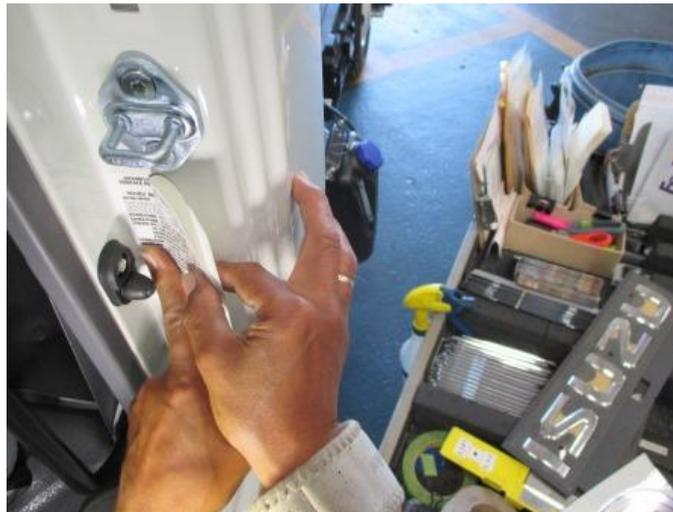
Figure 4

- 3) Apply the label starting from the inboard edge using the back of the label to keep it straight avoiding air pockets and wrinkles (See Figure 4).

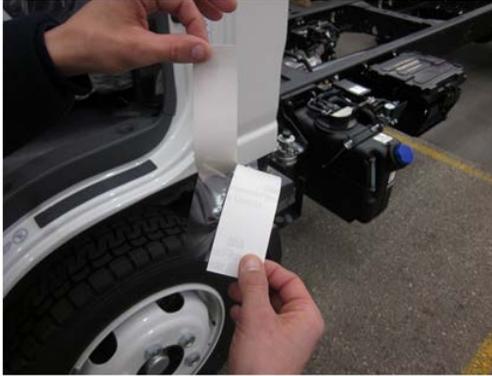
Figure 5

- 4) To apply protective film over the VIN and Weight Rating label, peel half of the backing away from protective film (See Figure 5).

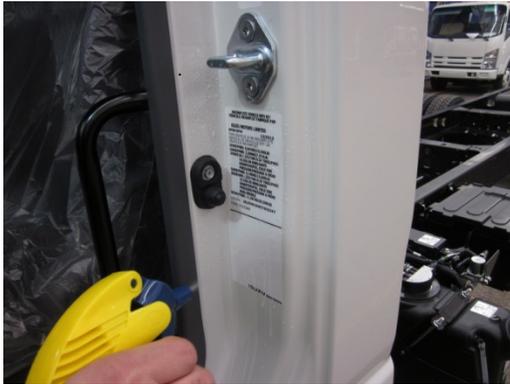
Figure 6a

- 5) Apply water/soap solution (5 drops of Dawn® dishwashing liquid per 32 fl. oz. of distilled water) to the new installed label (See Figure 6a) and to the application side of protective film (See Figure 6b) to ease film installation.

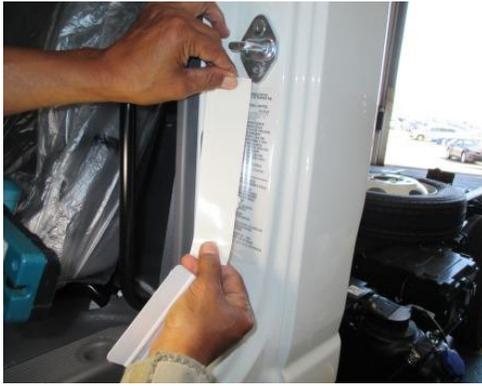
Figure 7a

- 6) Apply the protective film to the label starting with the outboard edge (Figure 7a). Use the squeegee to hold the protective film in place (See Figure 7b).

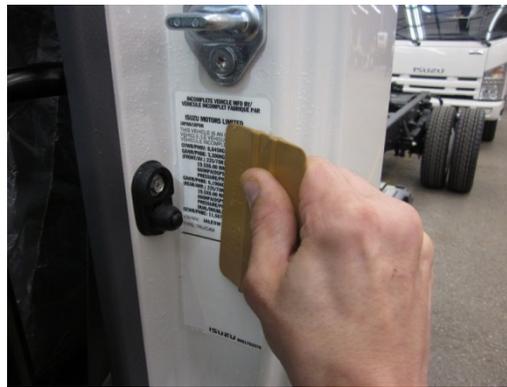
Figure 8

- 7) Peel the second half of the film backing, apply water/soap solution to protective film as needed and remove excess water/soap solution using the 3M™ Scotchcal™ application squeegee (See Figure 8).

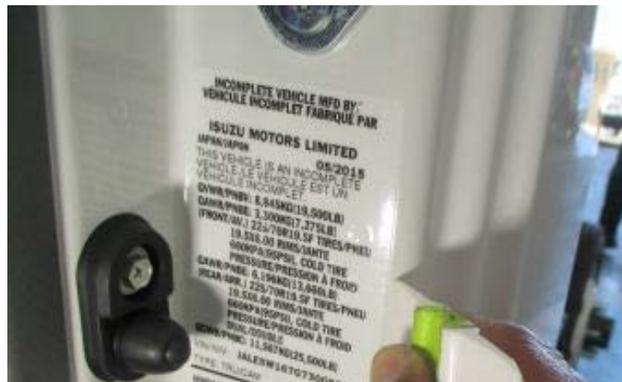
Figure 9

- 8) Carefully finish the edges around the label by removing any excess water/soap residue (See Figure 9).
