GROUP Safety Recall Campaign	MODEL 2016MY Optima (JFa)
	NUMBER SC 131	DATE April 2016
VOLUNTARY SAFETY RECALL CAMPAIGN		
SUBJECT: DRIVER'S FRONTAL AIRBAG MODULE REPLACEMENT (SC 131)

SUBJECT: DRIVER'S FRONTAL AIRBAG MODULE REPLACEMENT (SC 131)

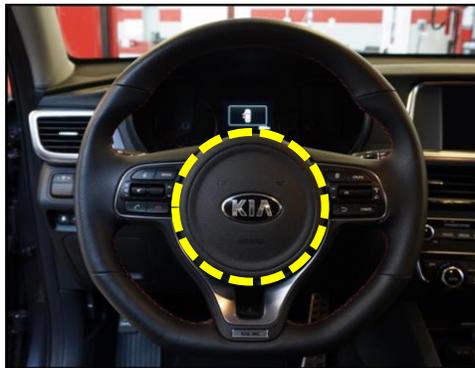
This bulletin provides the procedure to replace the driver's frontal airbag module of seventeen (17) 2016 MY Optima vehicles, produced from November 10, 2015 through February 12, 2016. A secondary chemical enhancer required for the proper deployment of second-stage frontal airbag was not loaded during the airbag inflator build at the supplier. As a result, the second stage of the driver's frontal airbag will not deploy if the vehicle is involved in a crash that triggers the second-stage deployment of the driver's frontal airbag. To correct this condition, Kia is requesting the completion of this voluntary safety recall on all affected vehicles. Before conducting the procedure, verify the vehicle is included in the list of 17 affected VINs (listed on Page 7).

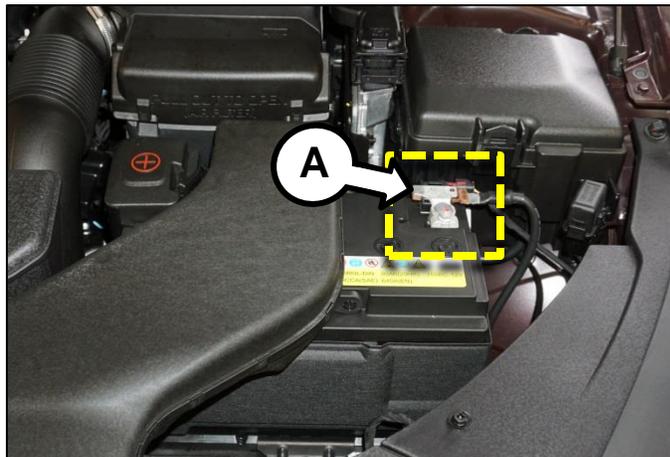
1. Record the customer's radio presets.
2. Disconnect the Negative (-) battery terminal (A), and wait for at least 3 minutes before starting the procedure.

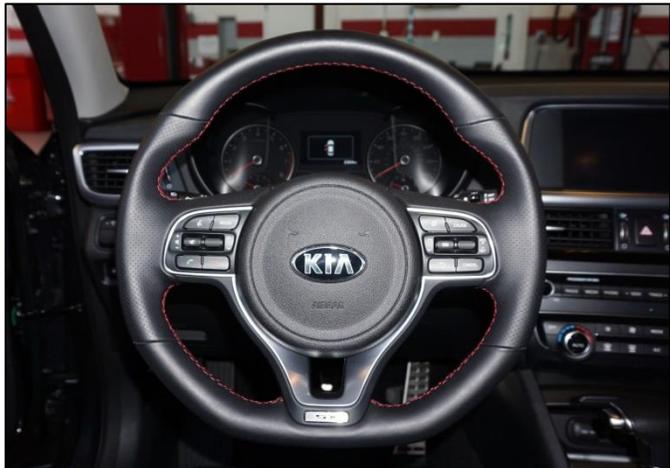
3. Set the steering wheel to the straight ahead position, as shown.

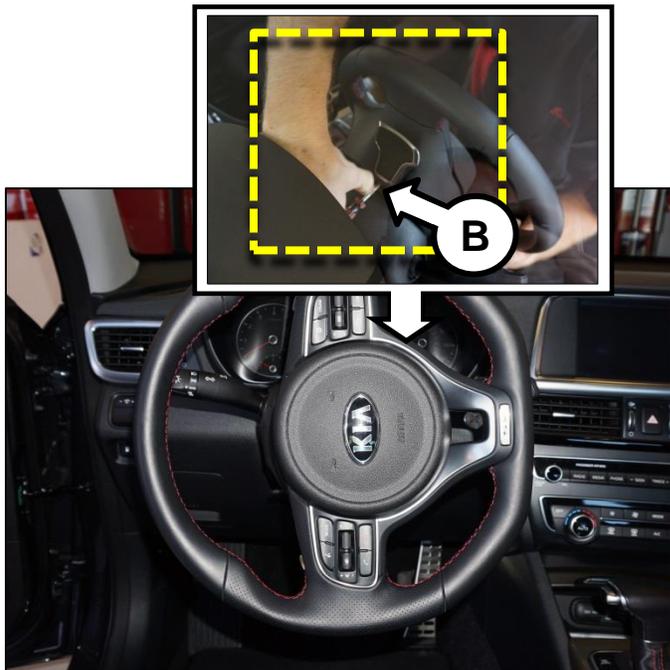
4. Turn the steering wheel 90° to the left and insert a small screwdriver from behind the steering wheel, as shown, to undo the tab (B) securing the airbag module.

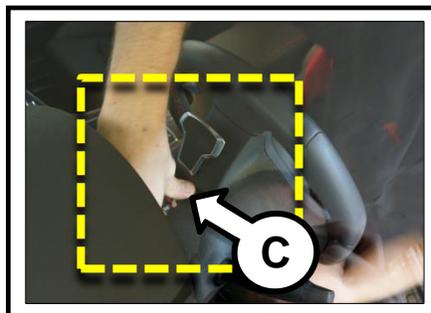
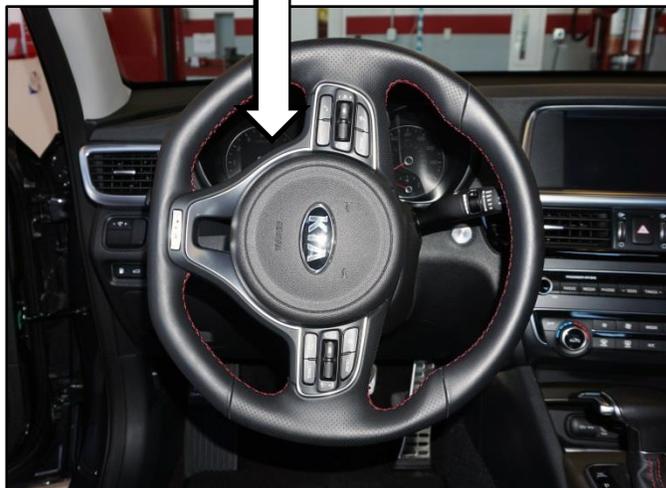
5. Turn the steering wheel 180° to the right and insert a small screwdriver from behind the steering wheel, as shown, to undo the tab (C) securing the airbag module.

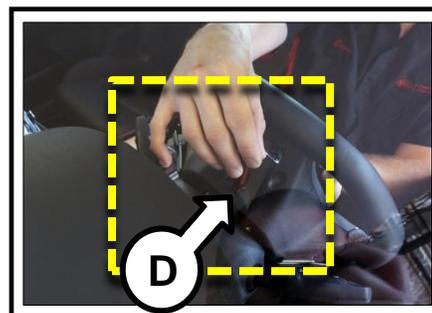
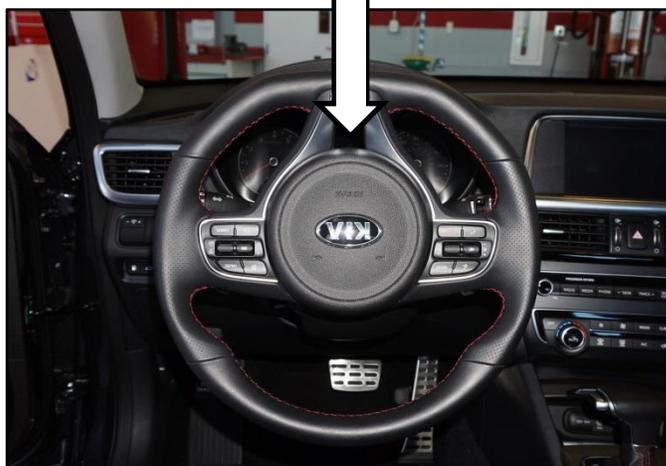
6. Turn the steering wheel a further 90° to the right, until up-side down, and insert a small screwdriver from behind the steering wheel, as shown, to undo the tab (D) securing the airbag module.

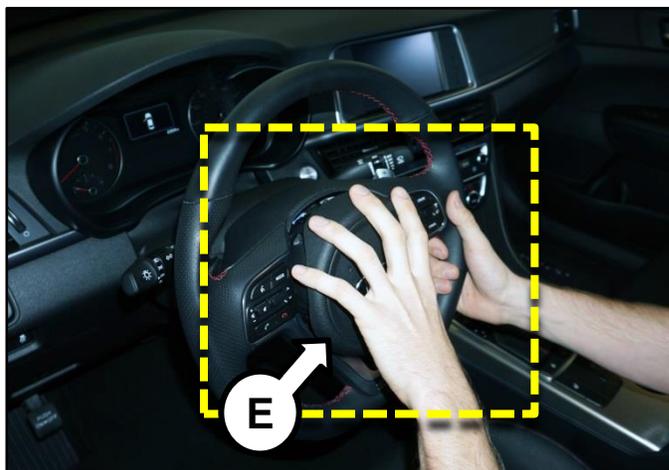
- 7. While supporting the airbag module (E), return the steering wheel to the straight ahead position, as shown.

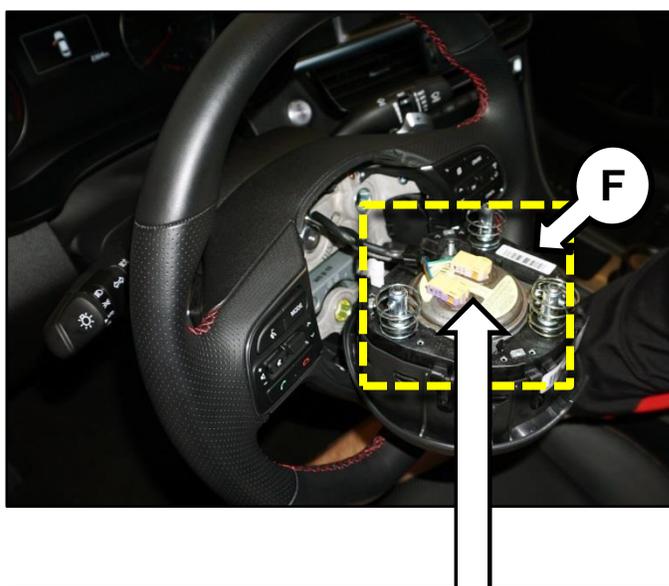
- 8. Carefully allow the airbag module (F) to rest horizontally, as shown.

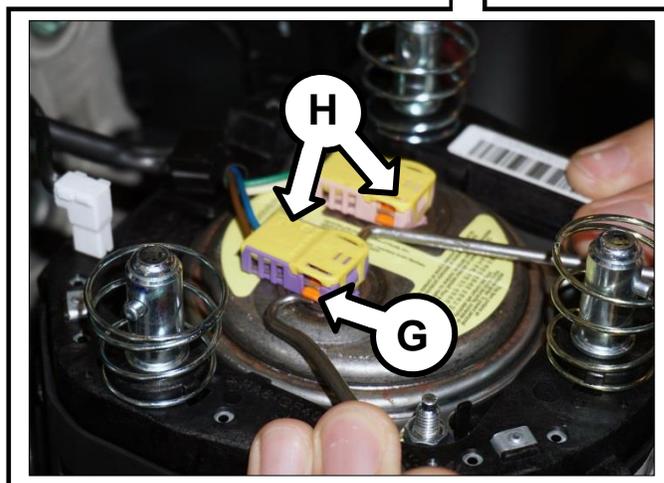
- 9. Use a prying tool to carefully undo the tabs (G) securing each of the two (2) airbag module connectors (H), as shown.

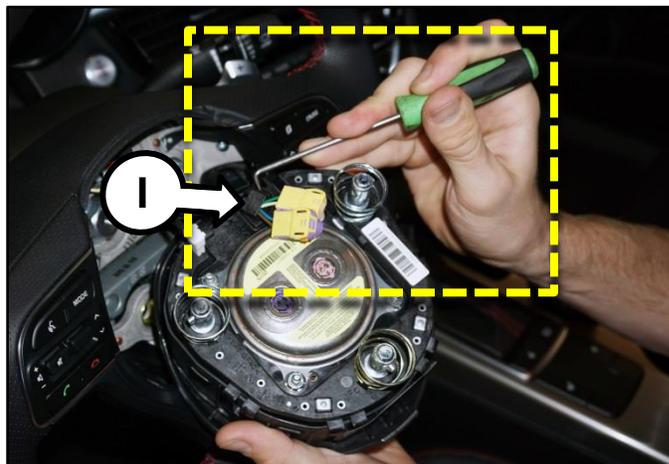
10. Use a prying tool to carefully undo the latch (I) on the guide for the airbag module harness.

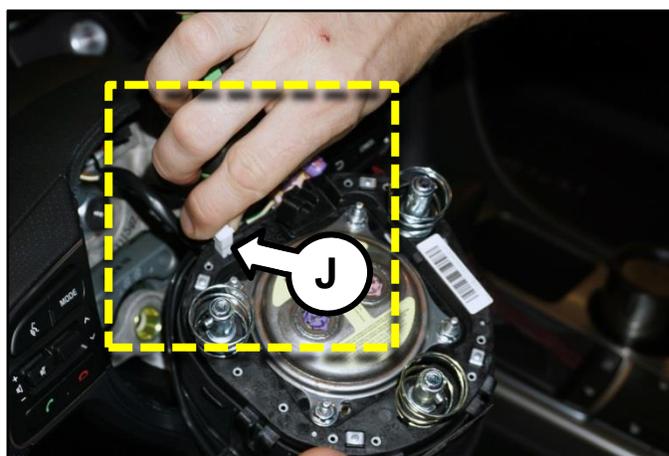
11. Remove the horn connector (J) from the airbag module and then remove the airbag module from the steering wheel.
