MODEL
2007~2009MY
Spectra (LD)

NUMBER
130

TECHNICAL SERVICE BULLETIN

SUBJECT: FRONT PASSENGER OCS SENSOR MAT DIAGNOSIS
AND REPLACEMENT

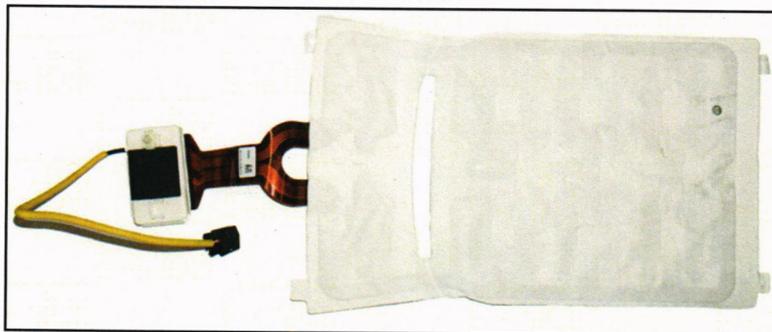
This bulletin provides information related to the replacement of the front passenger Occupant Classification System (OCS) sensor mat in 2007~2009MY Spectra (LD) vehicles, produced from September 26, 2006 through April 6, 2009. The sensor mat is intended to detect child seats and small stature occupants who could be harmed by deployment of the passenger frontal air bag. If the sensor mat is not working properly, the airbag warning light on the cluster will illuminate and DTC(s) B1447, B1448, B1449 and/or B1450 may be stored. If the airbag warning light is illuminated and one or more the above DTCs are stored, follow the repair procedure outlined in this bulletin to replace the OCS mat.

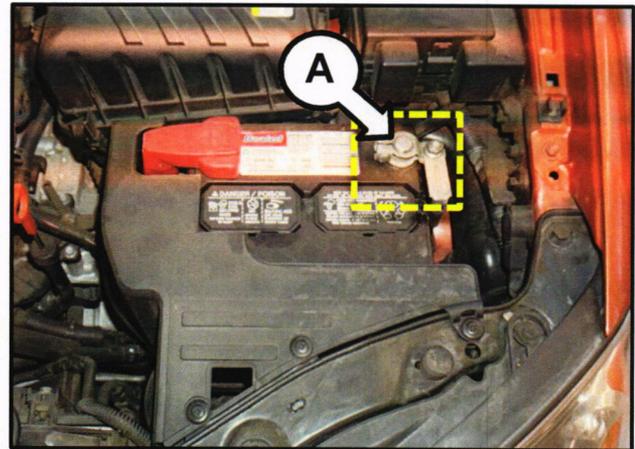
1. Place the ignition key in the 'OFF' position and record customer's radio presets.
2. Disconnect Negative (-) terminal (A) from the battery. **NOTE: make sure voltage is bled off before proceeding.**

Not removing the Negative (-) terminal from the battery may result in accidental airbag deployment and possible physical injury.

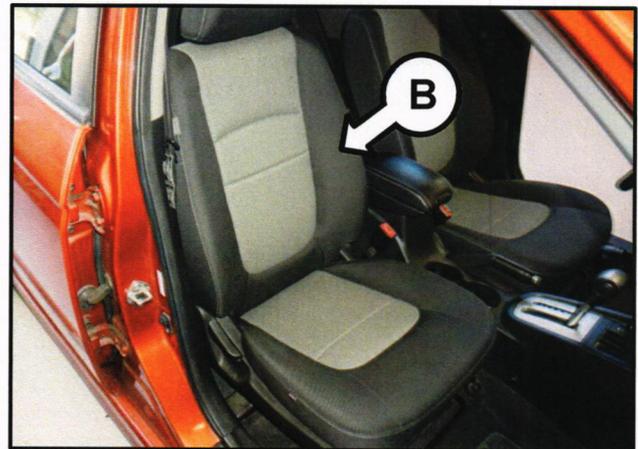
3. Remove the passenger seat assembly (B) by referring to the applicable Service Manual on KGIS.

Tightening Torque (Seat Mounting Bolts):
29 ~ 39 lb-ft (39 ~ 53 Nm)

Use caution when removing the seat from the vehicle to avoid scratching any interior trim panels.

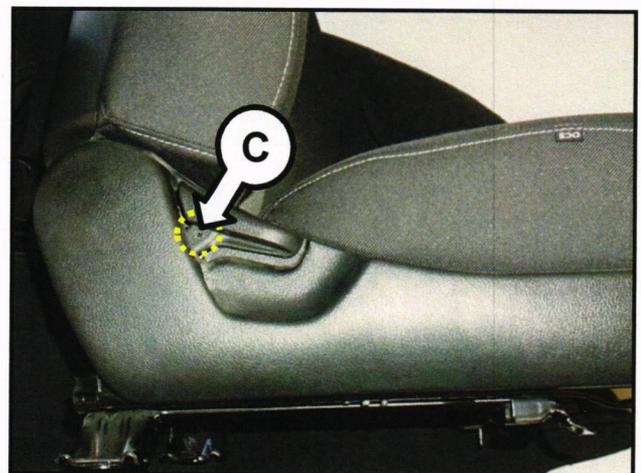
4. Remove one (1) screw (C) securing the seat back release lever cover and remove the cover from the lever.

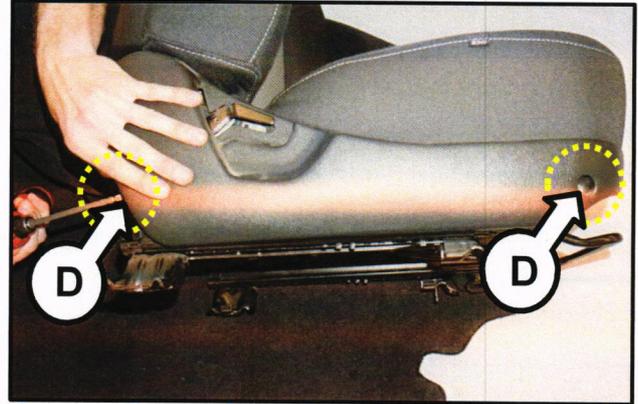
5. Remove two (2) screws (D) securing the seat side cover to the seat frame and remove the side cover.

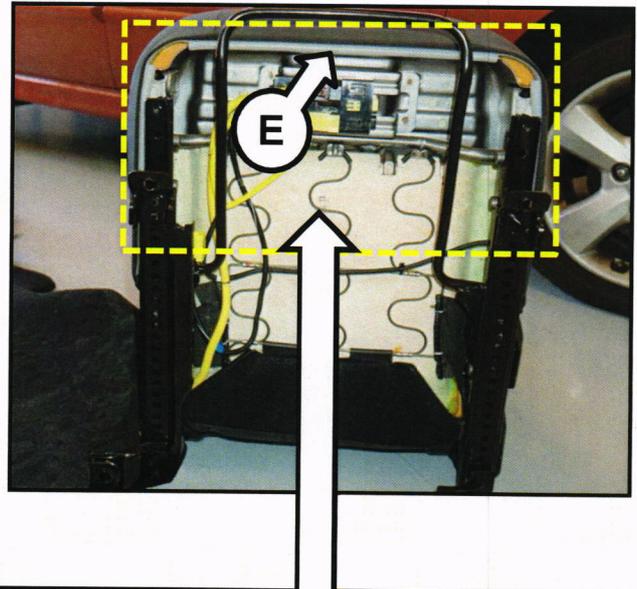
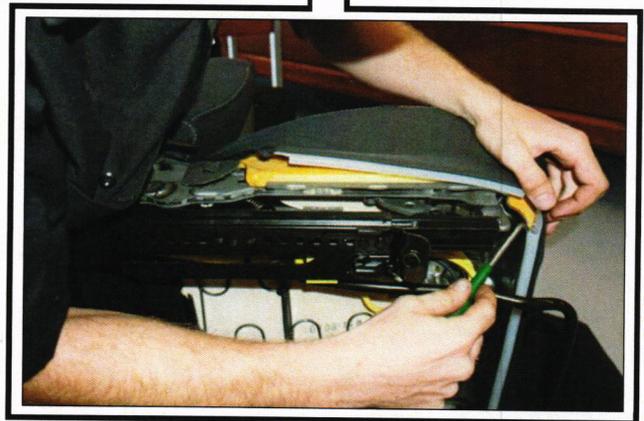
6. Carefully undo the seat cover plastic hooks (E) running across the front of the seat.

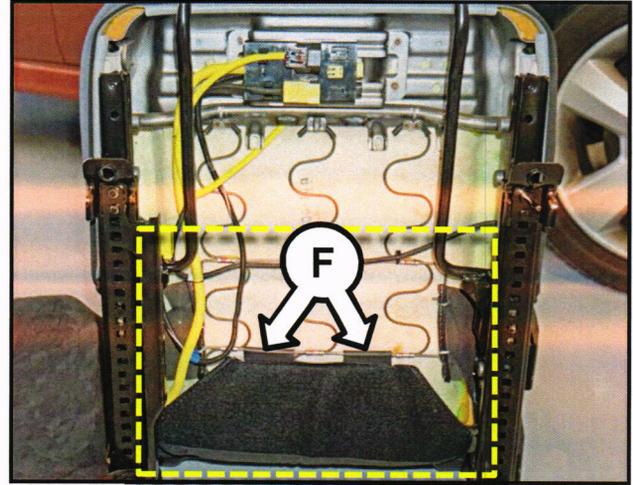
7. Undo two (2) plastic hooks (F) securing the rear seat cover attachment panel.

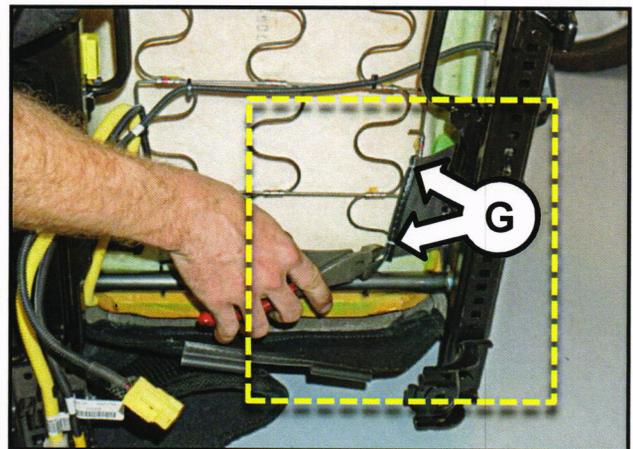
8. Use a pair of side cutters to remove two (2) hog rings (G) from the right side seat cover attachment panel, as shown.

Replace with new hog rings (P/N: 88627 11201). To install the new hog rings, use the Hog Ring Pliers (P/N 09880 4F000A) or equivalent.

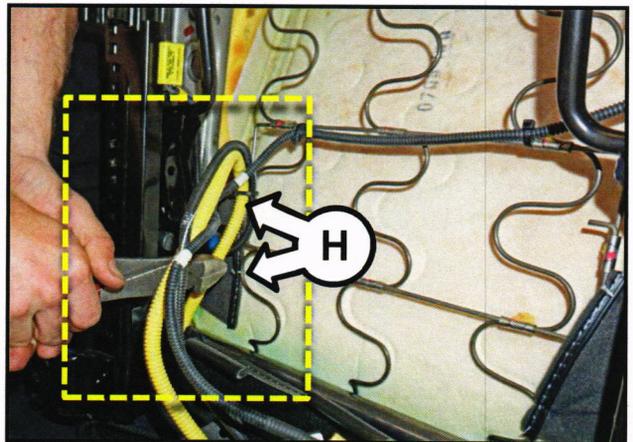
9. Use a pair of side cutters to remove two (2) hog rings (H) from the left side seat cover attachment panel, as shown.

Replace with new hog rings (P/N: 88627 11201). To install the new hog rings, use the Hog Ring Pliers (P/N 09880 4F000A) or equivalent.

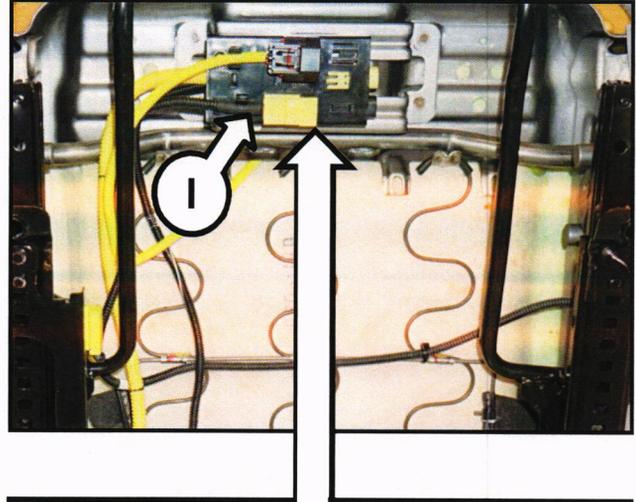
10. Carefully remove the connector mounting plate (I) from the seat frame.

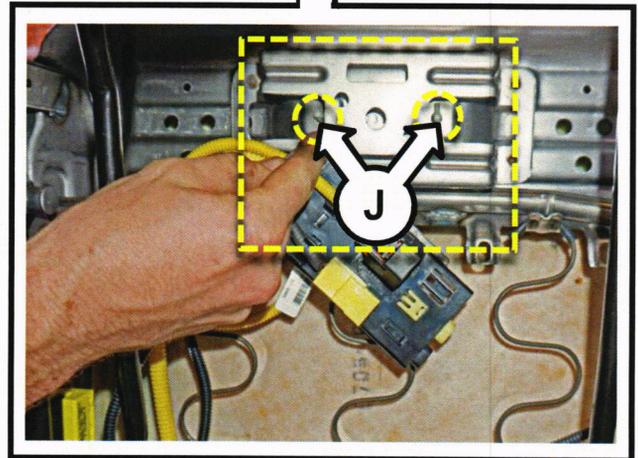
11. Use a pick tool to remove two (2) plastic clips (J) securing the OCS control module to the seat frame.

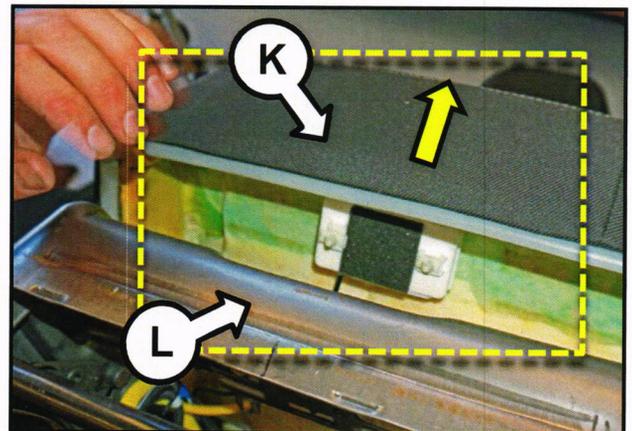
12. Carefully pull the seat cushion assembly (K) away from the seat frame (L).

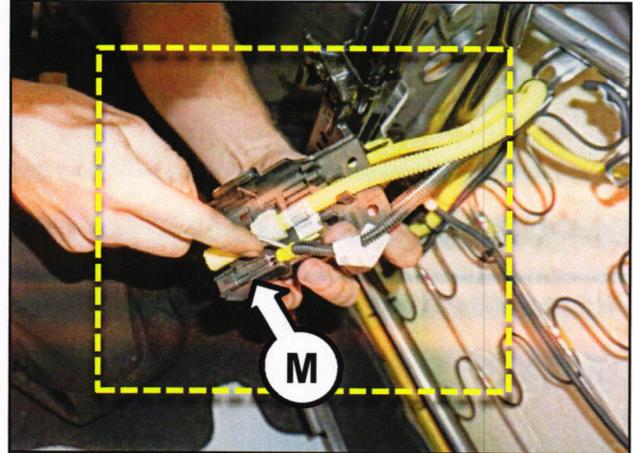
- 13. Use a pick tool to carefully remove the OCS connector (M) from the mounting plate, as shown.

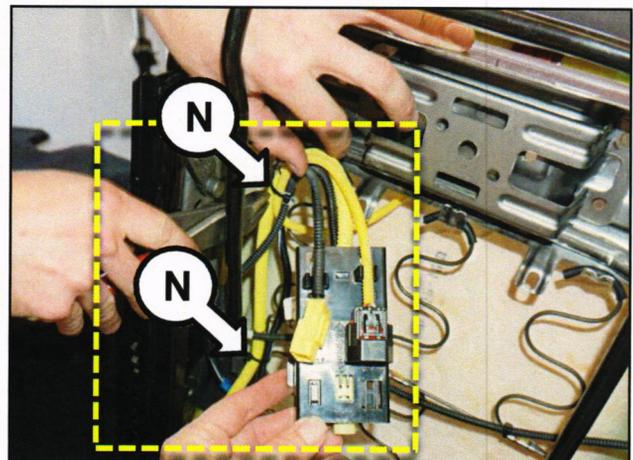
- 14. Use a pair of side cutters to carefully remove the cable ties securing all under-seat harnesses together.

To prevent damage to the under-seat harnesses, make sure to replace all cable ties removed in step 14.

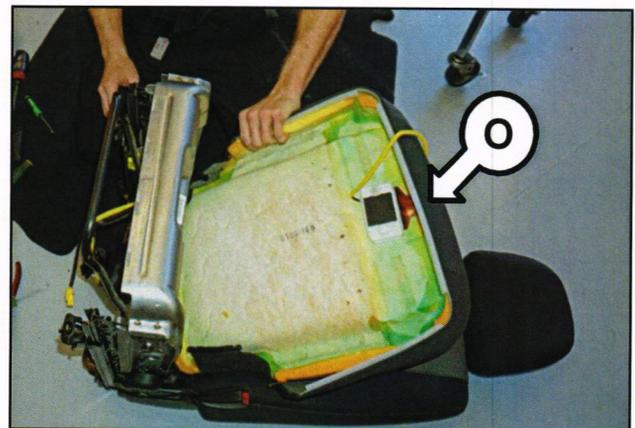
- 15. Carefully remove the seat cushion assembly (O) from the seat frame, as shown.

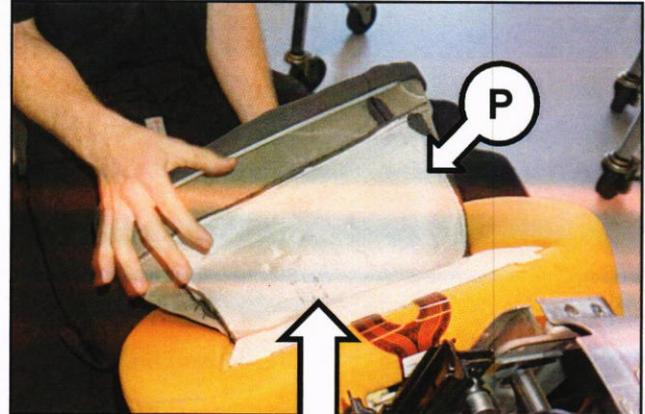
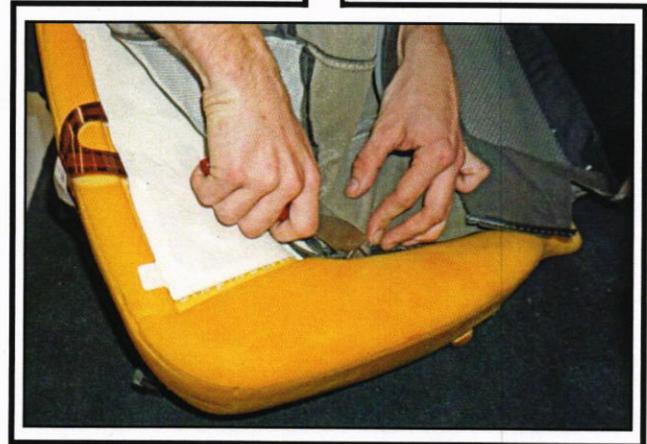
16. Carefully pull the seat cover material (P) back and remove nine (9) hog rings securing the seat cover to the seat cushion.

Replace with new hog rings (P/N: 88627 11201). To install the new hog rings, use the Hog Ring Pliers (P/N 09880 4F000A) or equivalent.

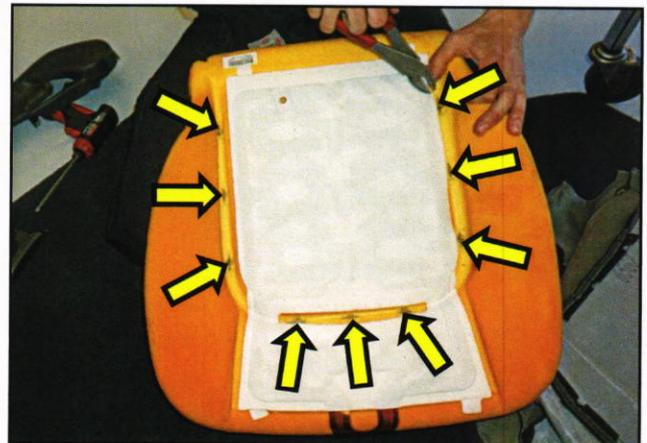
17. Remove the seat cover from the lower cushion and inspect each of the nine (9) seat cover attachment points for remaining hog ring debris.

To prevent damaging the seat cover material, make sure to remove all hog ring debris from the lower cushion.

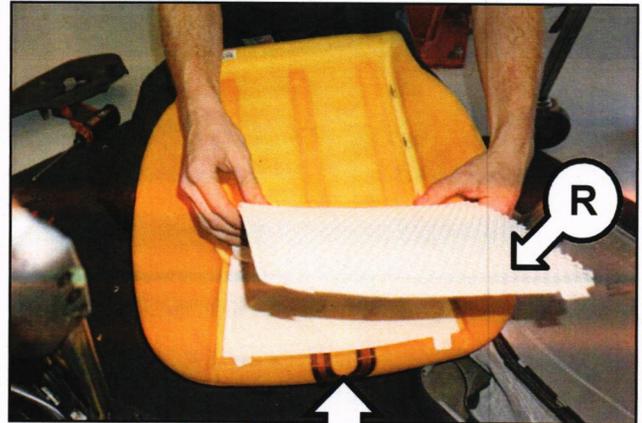
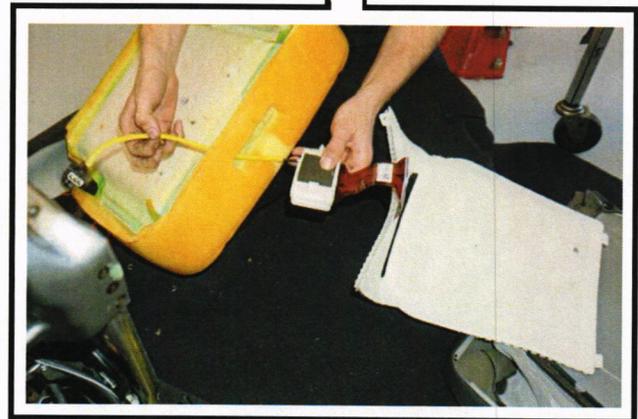
18. Remove the original OCS mat (R) and harness from the seat cushion, as shown.

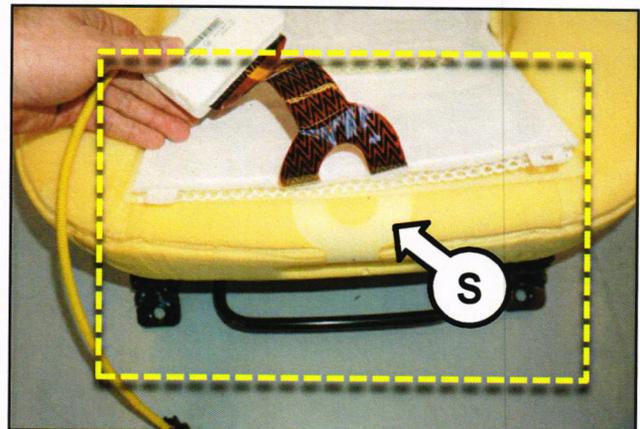
19. Place the replacement OCS mat on the lower cushion and note the indentation in the foam (S). This indentation should be used to align the replacement mat with the seat cushion.

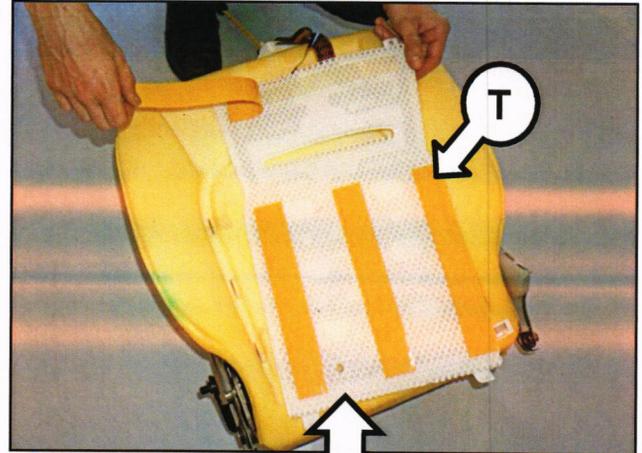
20. Turn the replacement OCS mat over and remove the protective lining (T) from the four (4) adhesive strips

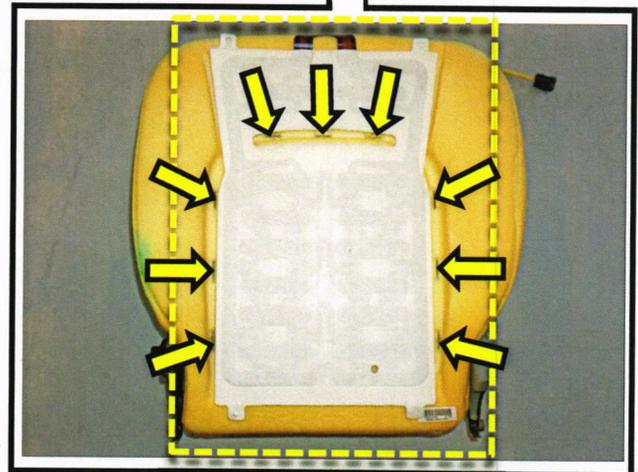
21. Place the OCS mat on top of the seat and examine the placement mat. **NOTE:** make sure the OCS mat does **NOT** obstruct access to any of the nine (9) seat cover attachment points, as shown.

The OCS mat **MUST** be in the correct position prior to applying pressure and adhering it to seat cushion.

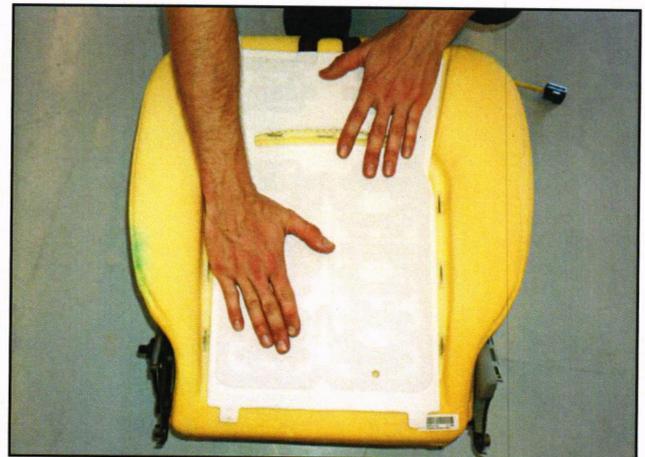
22. Press down, as shown, to ensure the OCS mat is firmly adhered in place.

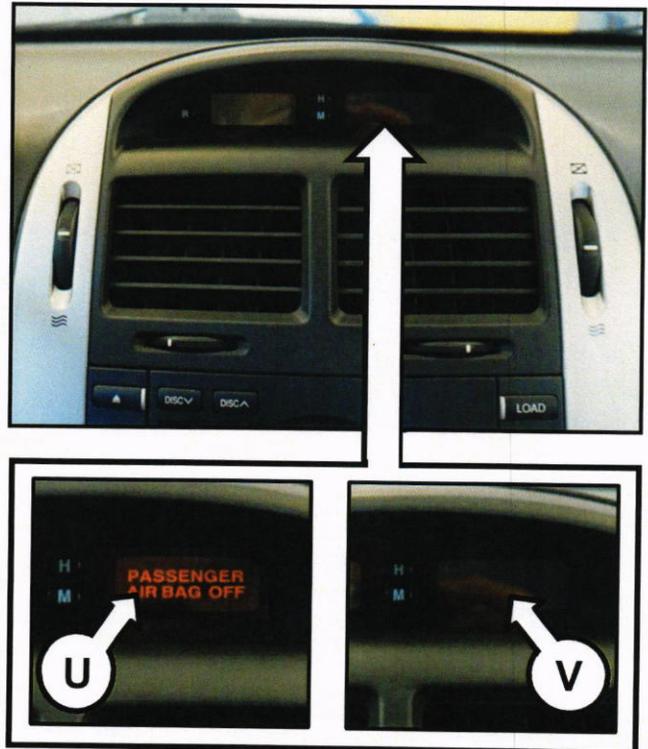
24. Reconnect the Negative (-) terminal to the battery.
25. Verify the operation of the PASSENGER AIR BAG "OFF" indicator lamp, as described below:

- 1) Indicator lamp ON (U):
 - Infant or child restraint system with a 12 month old.
 - Unoccupied
- 2) Indicator lamp OFF (V):
 - Properly positioned adult or child age 13 and up.
