SUBJECT: DEMONSTRATION / DELIVERY HOLD - Compliance Recall 16C11
Certain 2016 Model Year F-150 and Explorer Vehicles Equipped with Manual Seat
Backrest Recliner
Driver Seat Backrest Frame Inspection

CERTAIN 2016 MODEL YEAR F-150 AND EXPLORER VEHICLES EQUIPPED WITH MANUAL SEAT BACKREST RECLINER — DRIVER SEAT BACKREST FRAME INSPECTION

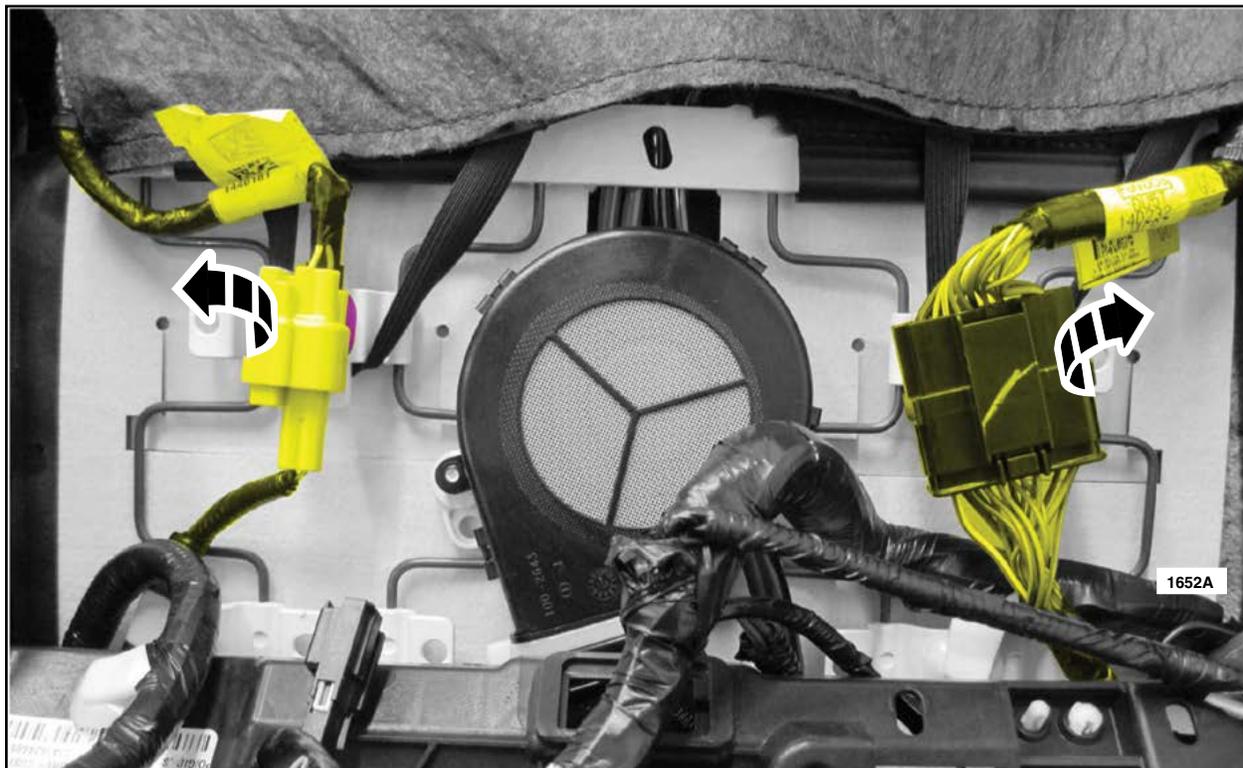
FIGURE 1

1. From behind the driver seat, release both electrical connector retainers from under the seat and position the wire harnesses aside. See Figure 1.

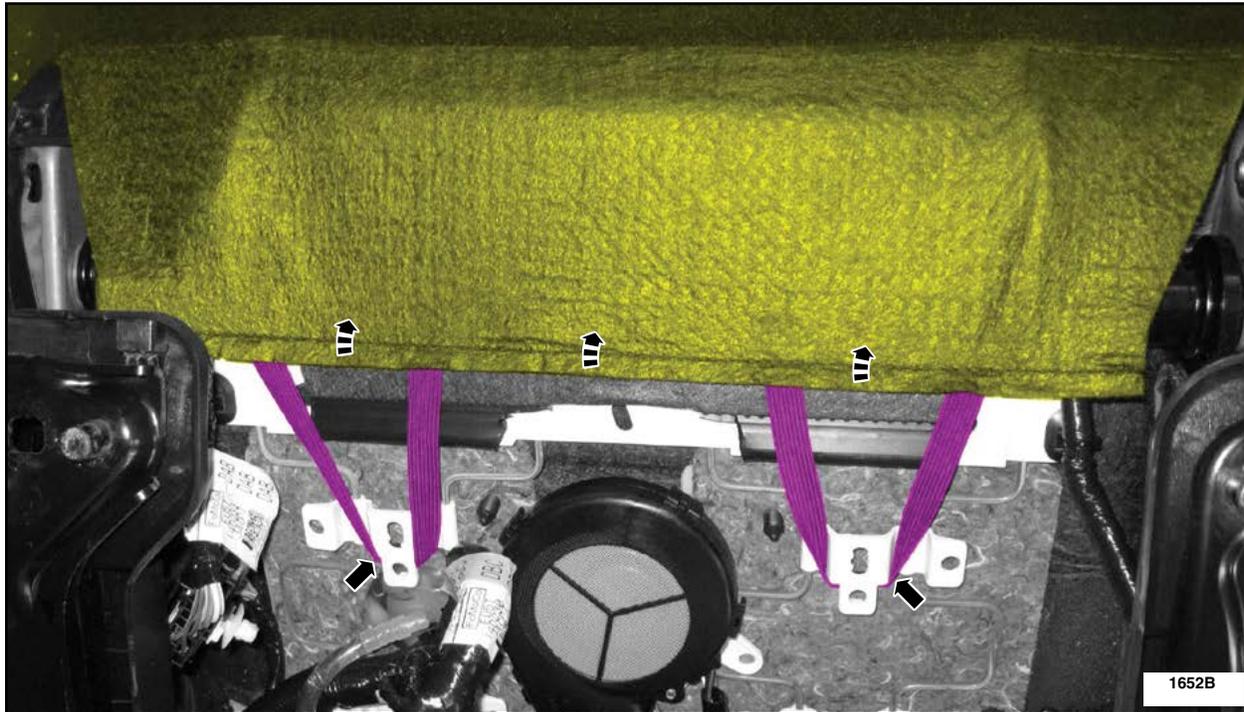
FIGURE 2

2. Detach the two backrest cover straps and position the backrest cover upward. See Figure 2.

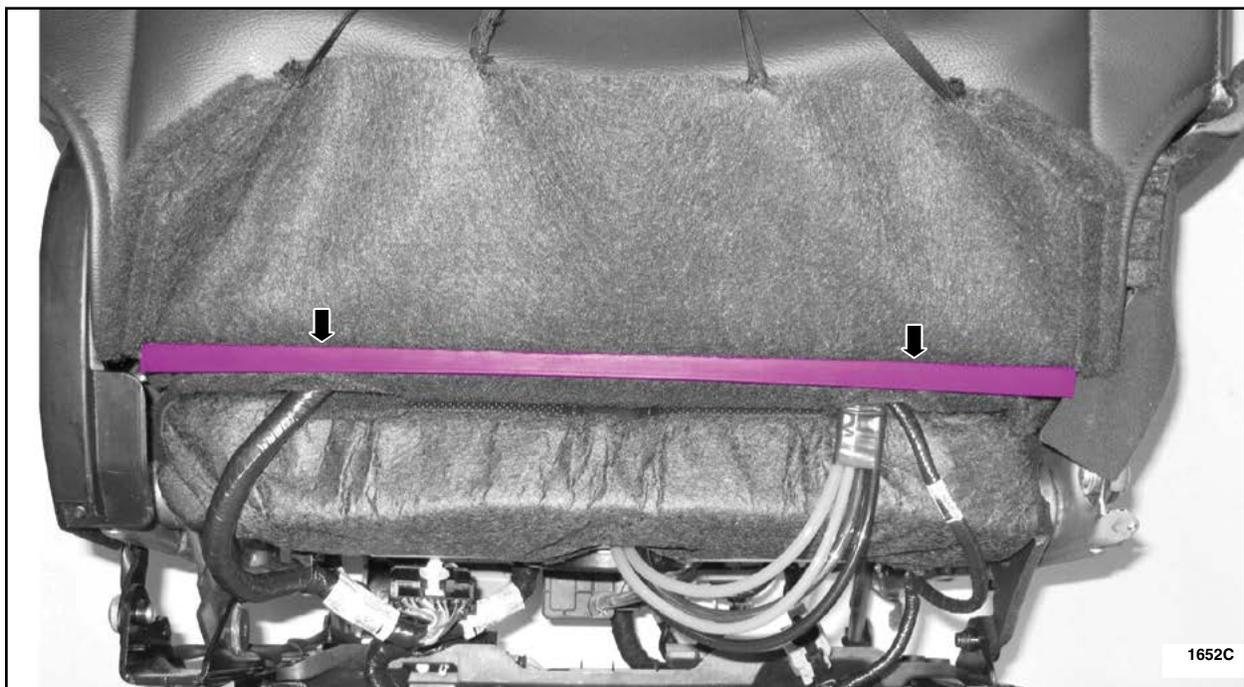
FIGURE 3

3. Detach the backrest cover lower J-clip. See Figure 3.

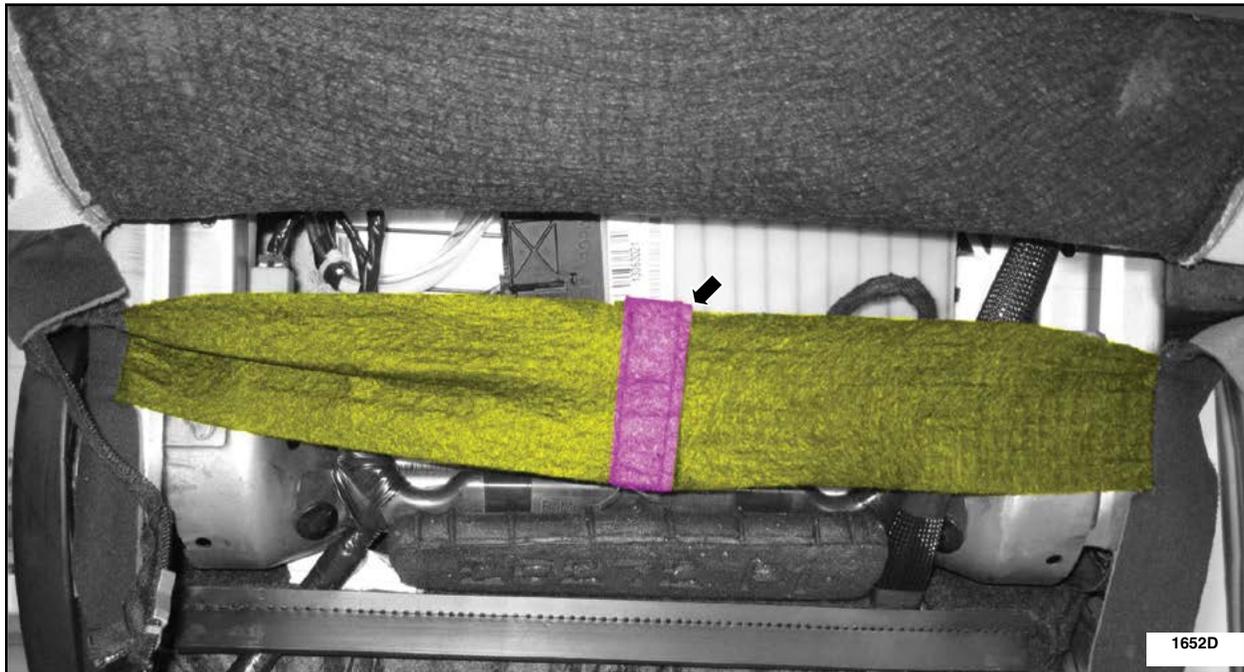
FIGURE 4

4. For F-150 vehicles, detach the hook-and-loop retainer and position the backrest cover strap aside. See Figure 4.

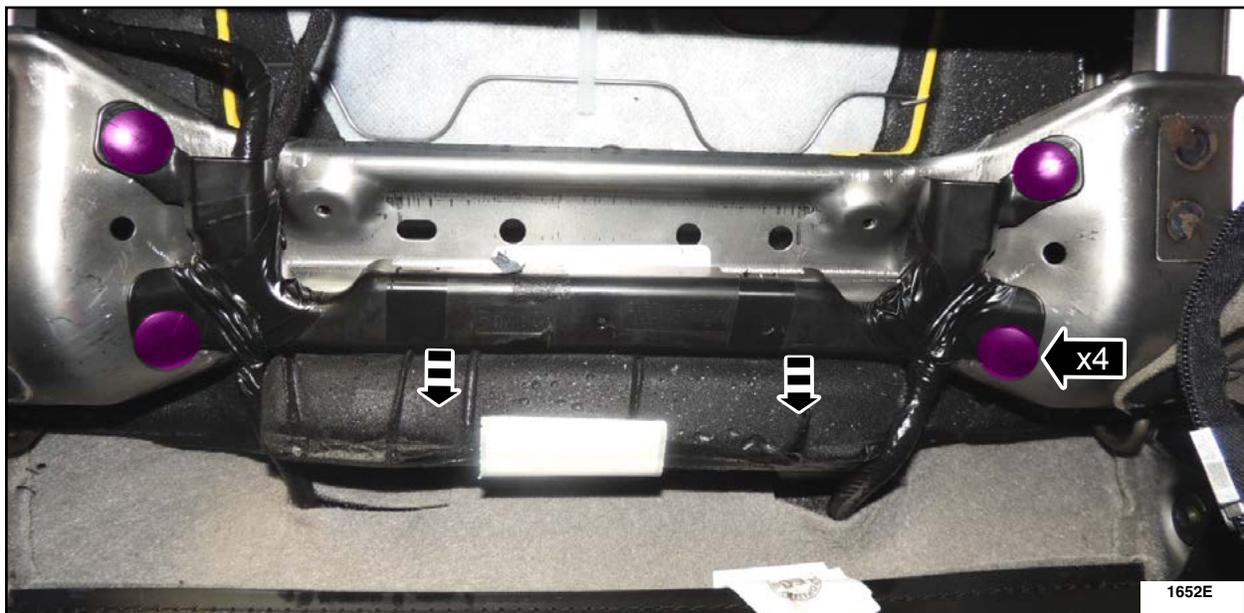
FIGURE 5

5. Remove the four push-pin retainers and position aside the wire harness to access the driver seat backrest frame label or engraved part information. See Figure 5.

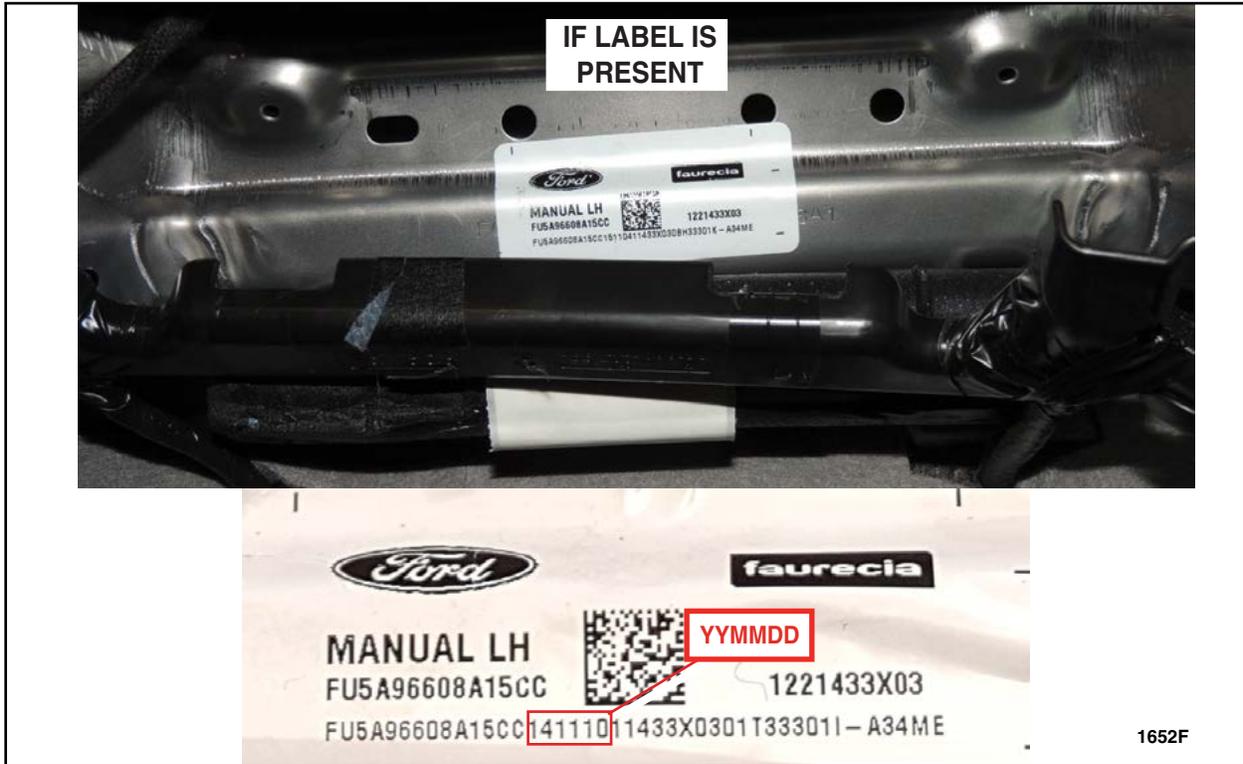
FIGURE 6

6. Determine the driver seat backrest frame build date, which will be listed on a label or engraved.
See Figures 6 and 7.

7. Was the driver seat backrest frame built on February 15, 2016 (161502) through February 19, 2016 (161902)?

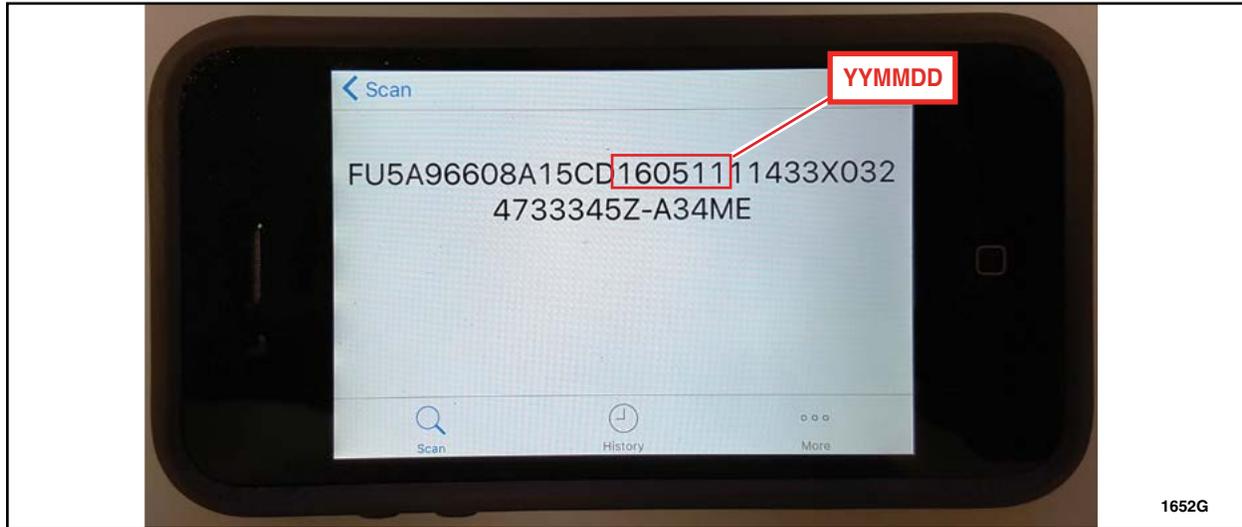
FIGURE 8

NOTE: Alternatively, a QR code scanner application can be used to retrieve the build date code using a smart phone or tablet.

- The build date code will be listed in YYMMDD format after the fourteen character engineering part number. See Figure 8.

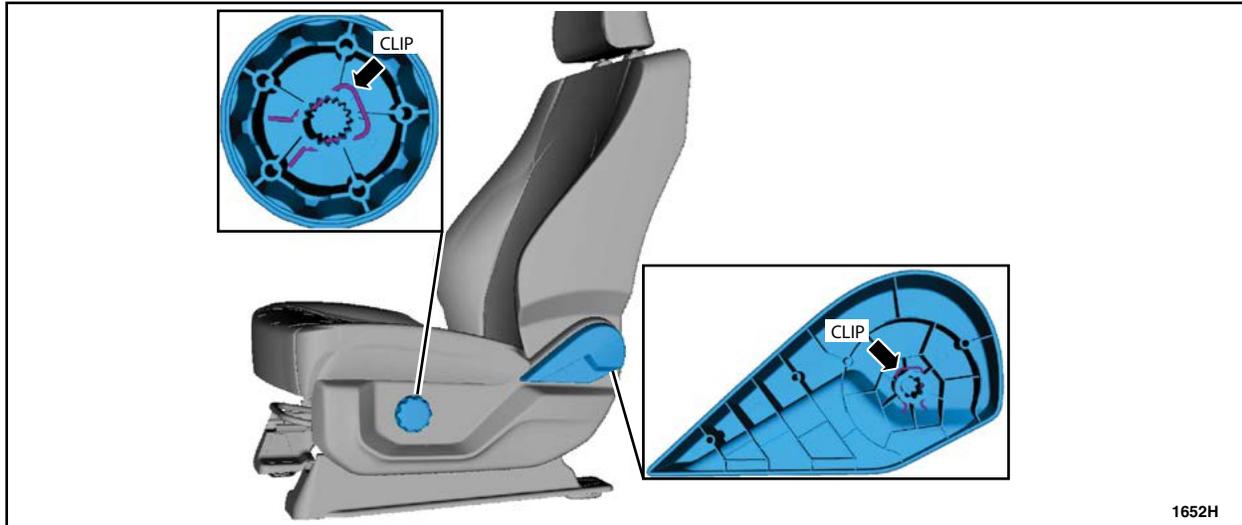
FIGURE 9

1. Remove the driver front seat. Please follow the Workshop Manual (WSM) procedures in Section 501-10A.
2. If equipped with manual lumbar, adjust the lumbar to the fully relaxed position.
3. Remove the recline handle and lumbar knob (if equipped). See Figure 9.

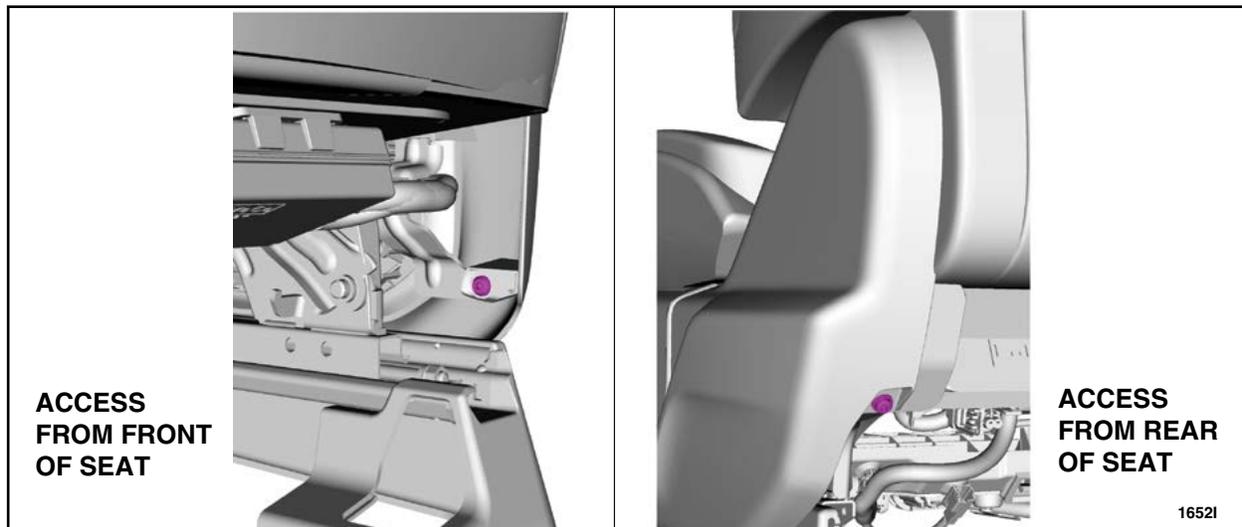
FIGURE 10

4. Remove the two head restraint guide sleeves. Please follow the WSM procedures in Section 501-10A.
5. Remove the two side shield screws. See Figure 10.

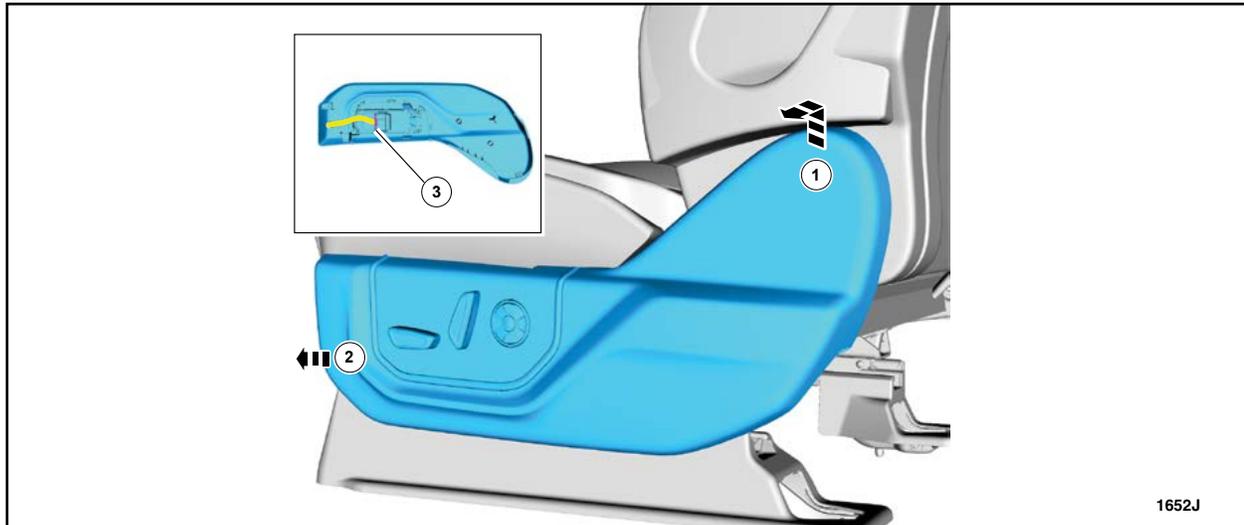
FIGURE 11

6. Remove the side shield. See Figure 11.

1. Lift up on the rear of the side shield and pull outward.
2. Push the side shield forward.
3. Disconnect the electrical connector.

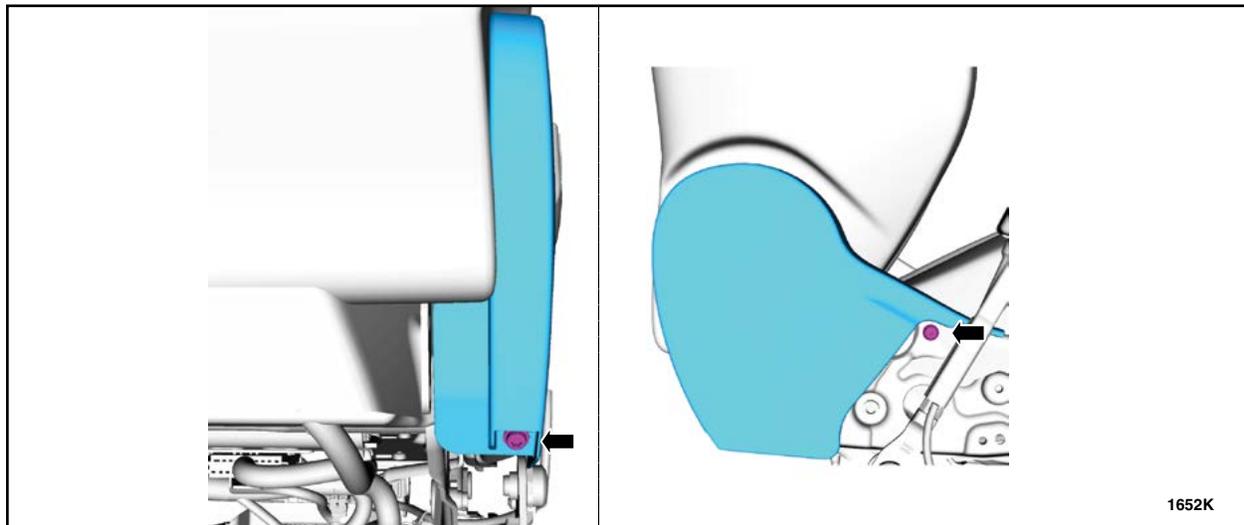
FIGURE 12

7. Remove the two screws and the recline cover. See Figure 12.

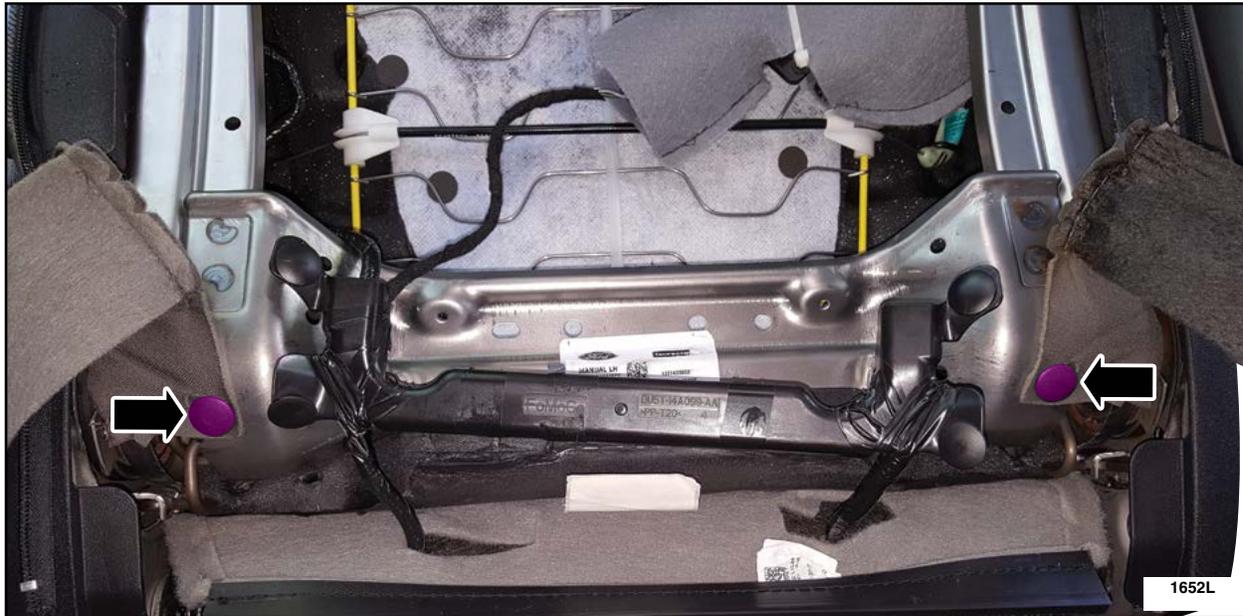
FIGURE 13

8. Remove the two seat cover side push-pins. See Figure 13.

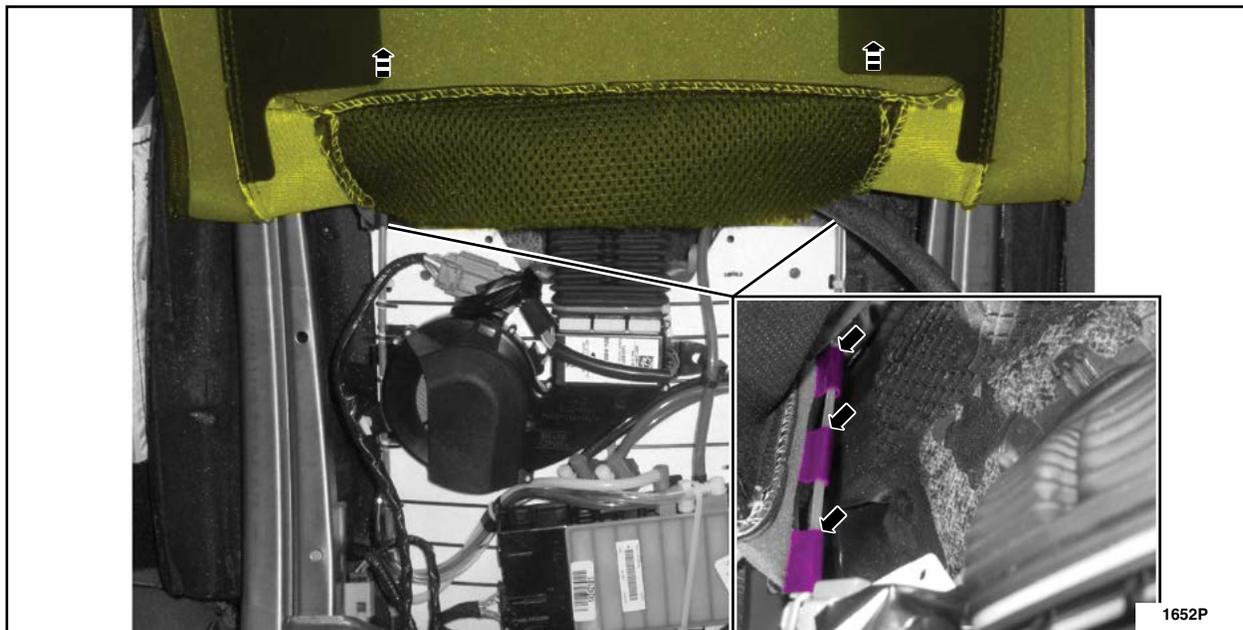
FIGURE 14

10. If equipped, detach the backrest cover J-clips from the lumbar support wire and position the backrest cover up. See Figure 14.

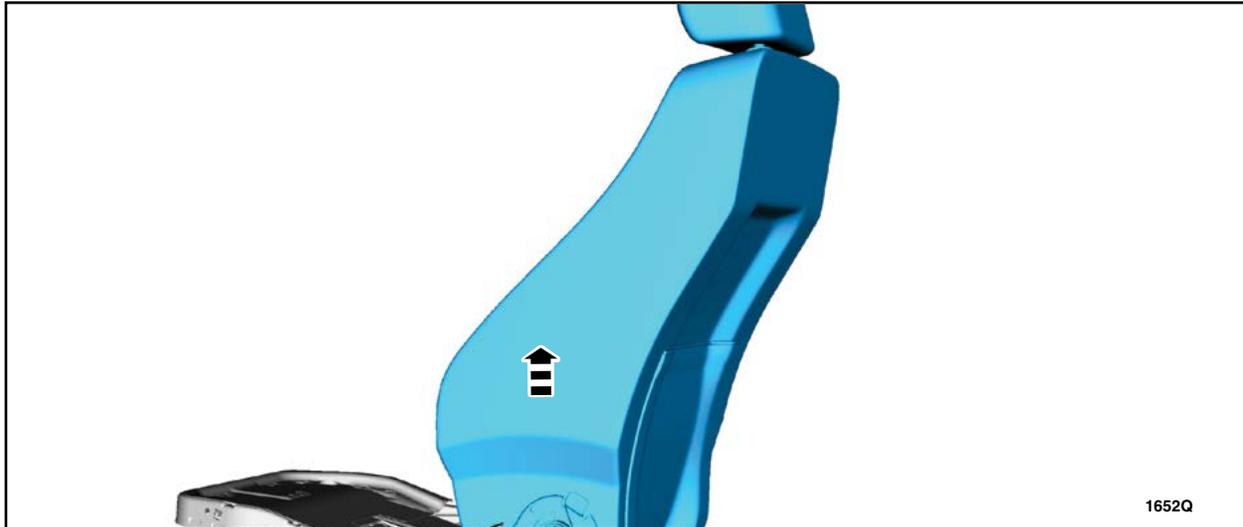
FIGURE 15

11. Remove the seat backrest cushion, cover, and the side airbag as an assembly. See Figure 15.

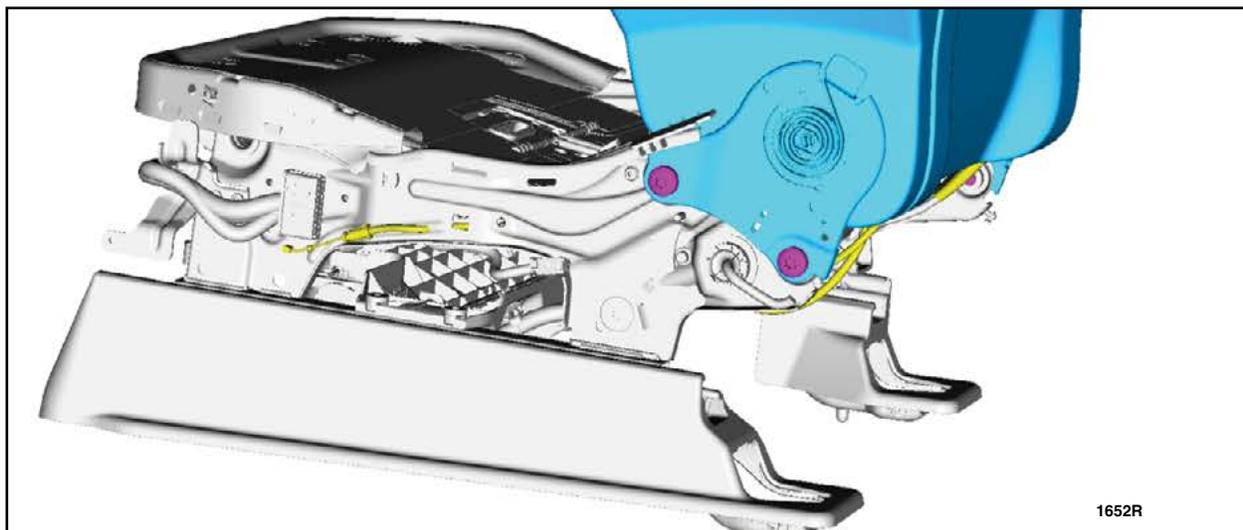
FIGURE 16

12. Remove and discard the four bolts and remove the front seat backrest. Disconnect the lumbar cable if equipped. See Figure 16.

- Torque: 33 lb.ft (45 Nm).

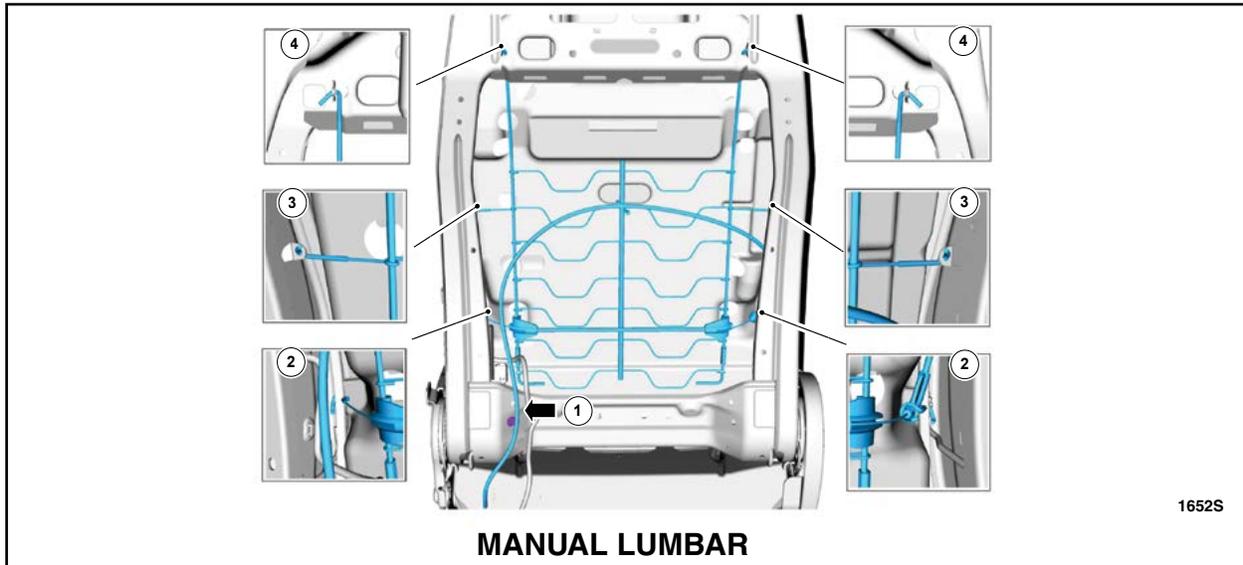
FIGURE 17

13. Remove the lumbar assembly. See Figures 17 and 18.

1. Release the lumbar assembly cable retainer (manual lumbar only).
2. Detach the lumbar assembly cable (manual lumbar only).
3. Detach the lumbar assembly J-hooks.
4. Detach the lumbar assembly upper J-hooks.
5. Disconnect the electrical connector (power lumbar only).

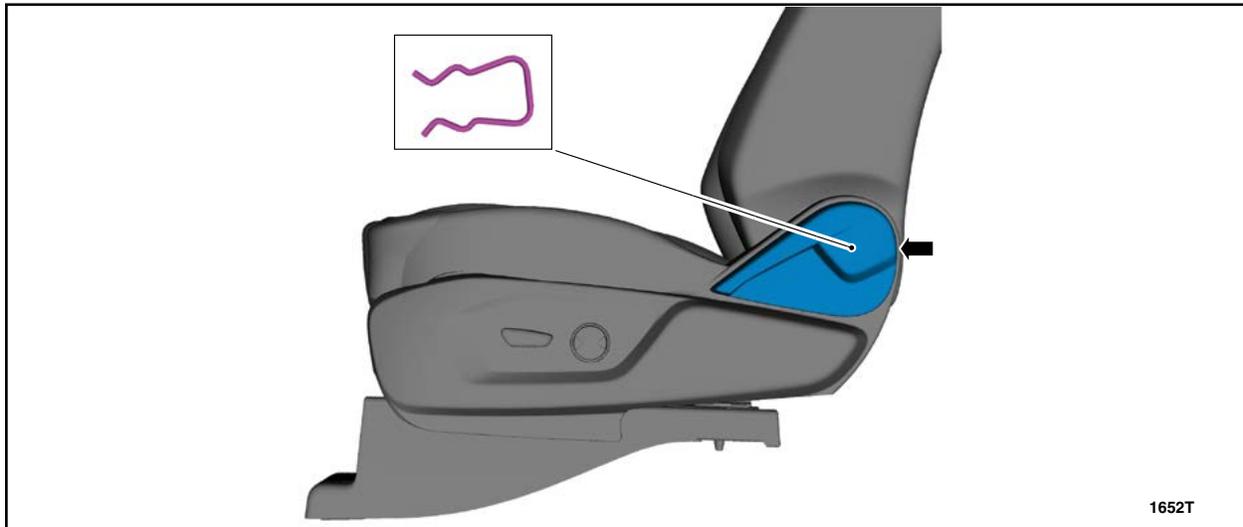
FIGURE 19

1. Remove the driver front seat. Please follow the Workshop Manual (WSM) procedures in Section 501-10A.
2. Remove the two front head restraint guide sleeves. Please follow the WSM procedures in Section 501-10A.
3. If equipped, remove the recline handle. See Figure 19.

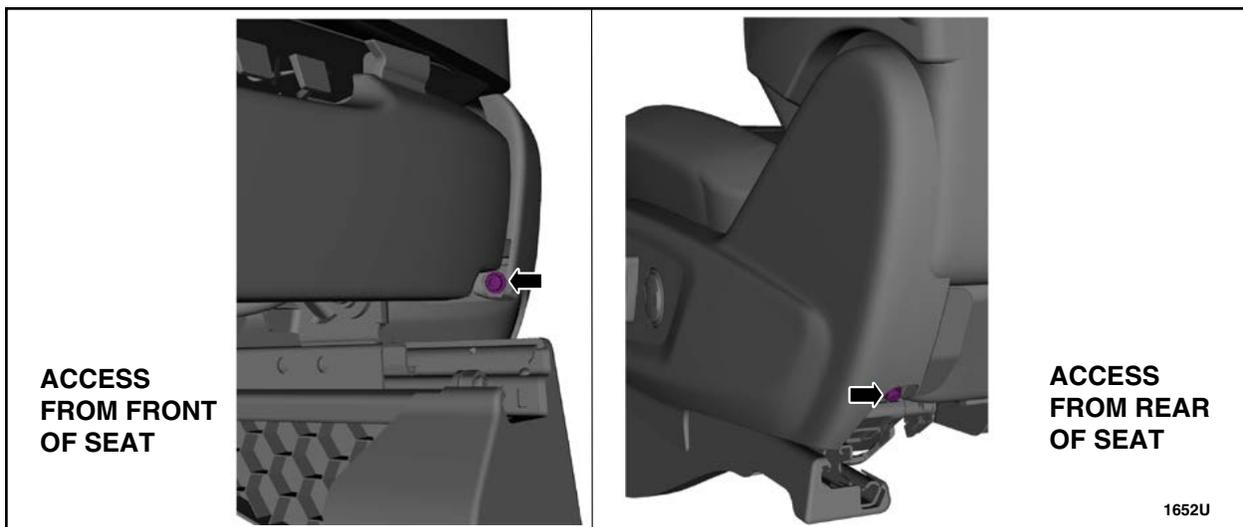
FIGURE 20

4. Remove the two side shield screws. See Figure 20.

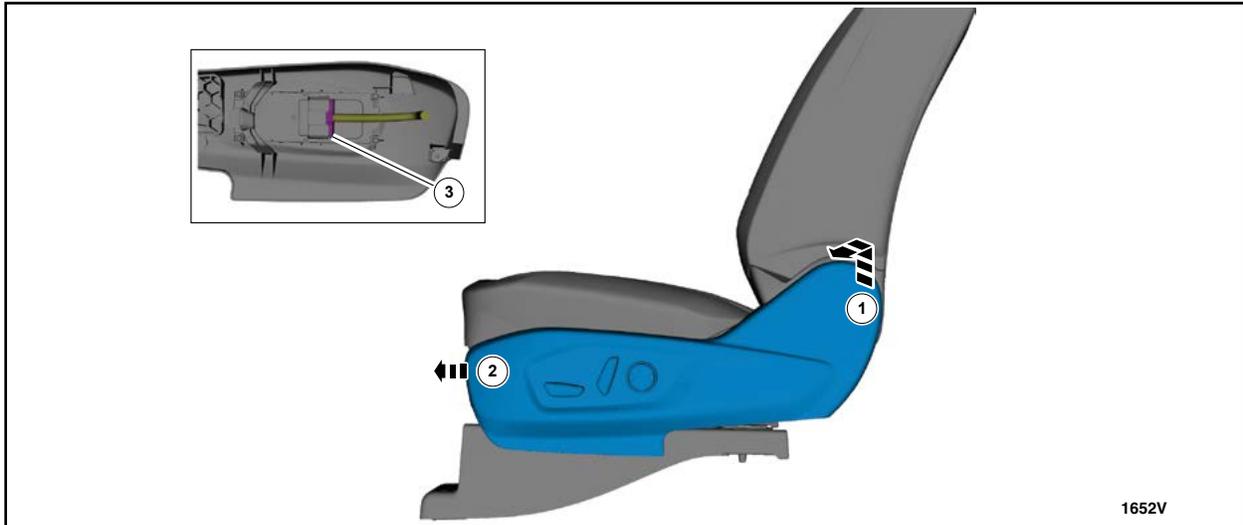
FIGURE 21

5. Remove the side shield. See Figure 21.

1. Lift up on the rear of the side shield and pull outward.
2. Push the side shield forward.
3. Disconnect the electrical connector.

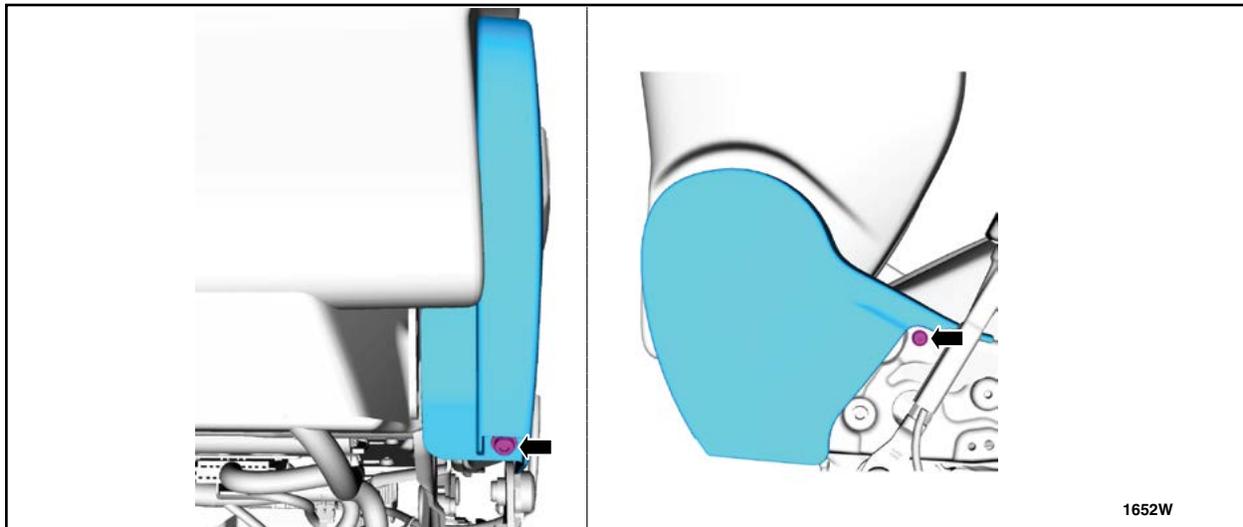
FIGURE 22

6. Remove the two screws and the recline cover. See Figure 22.

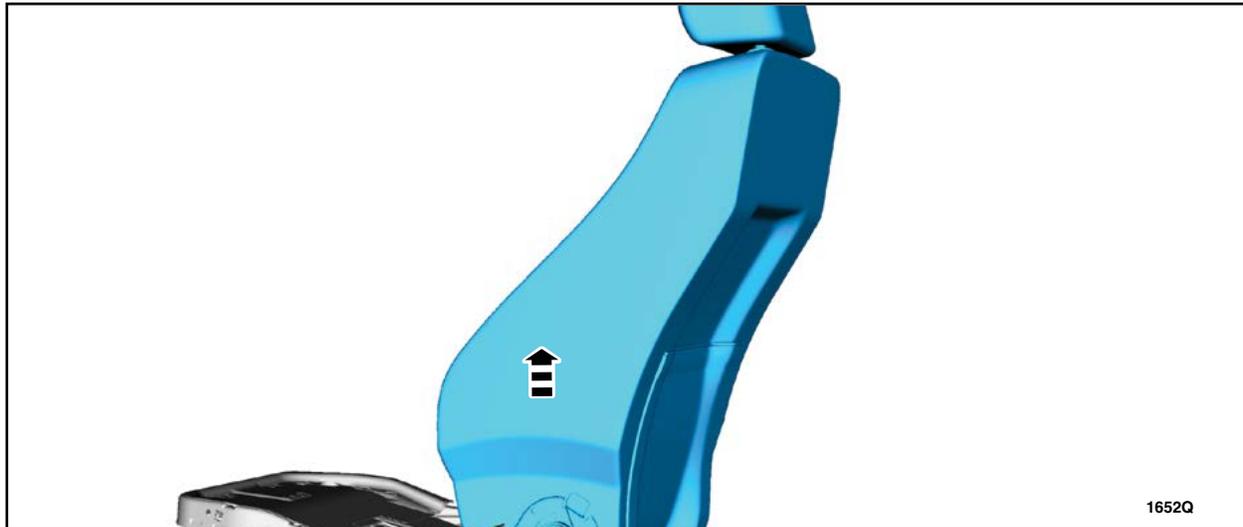
FIGURE 23

7. Remove the side airbag. Please follow the WSM procedures in Section 501-20B.
8. Remove the seat backrest cushion, cover, and the side airbag as an assembly. See Figure 23.

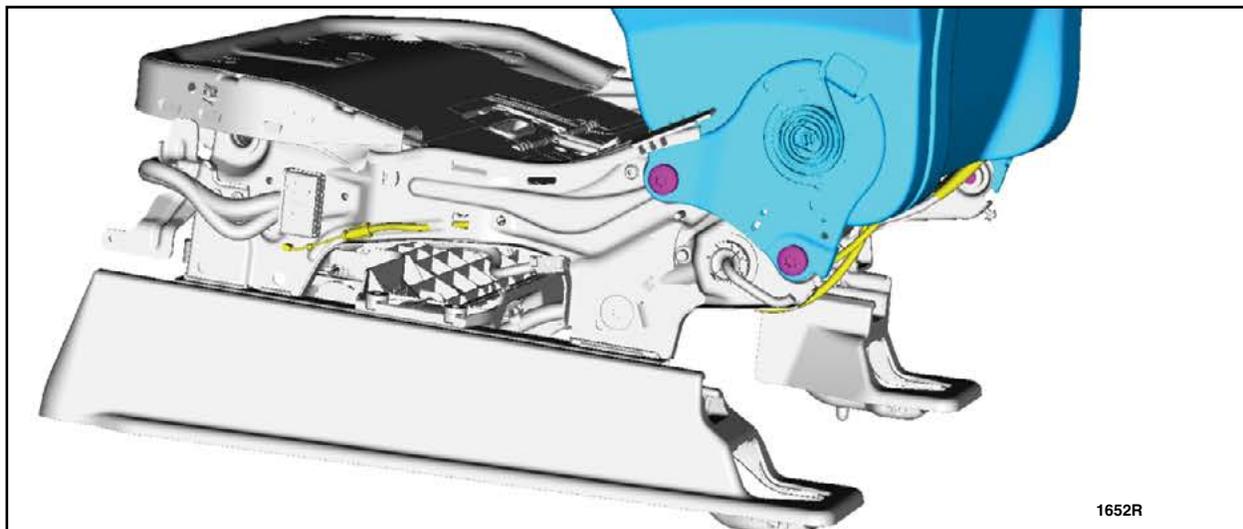
FIGURE 24

9. Remove and discard the four bolts and remove the front seat backrest. See Figure 24.
 - Torque: 33 lb.ft (45 Nm).

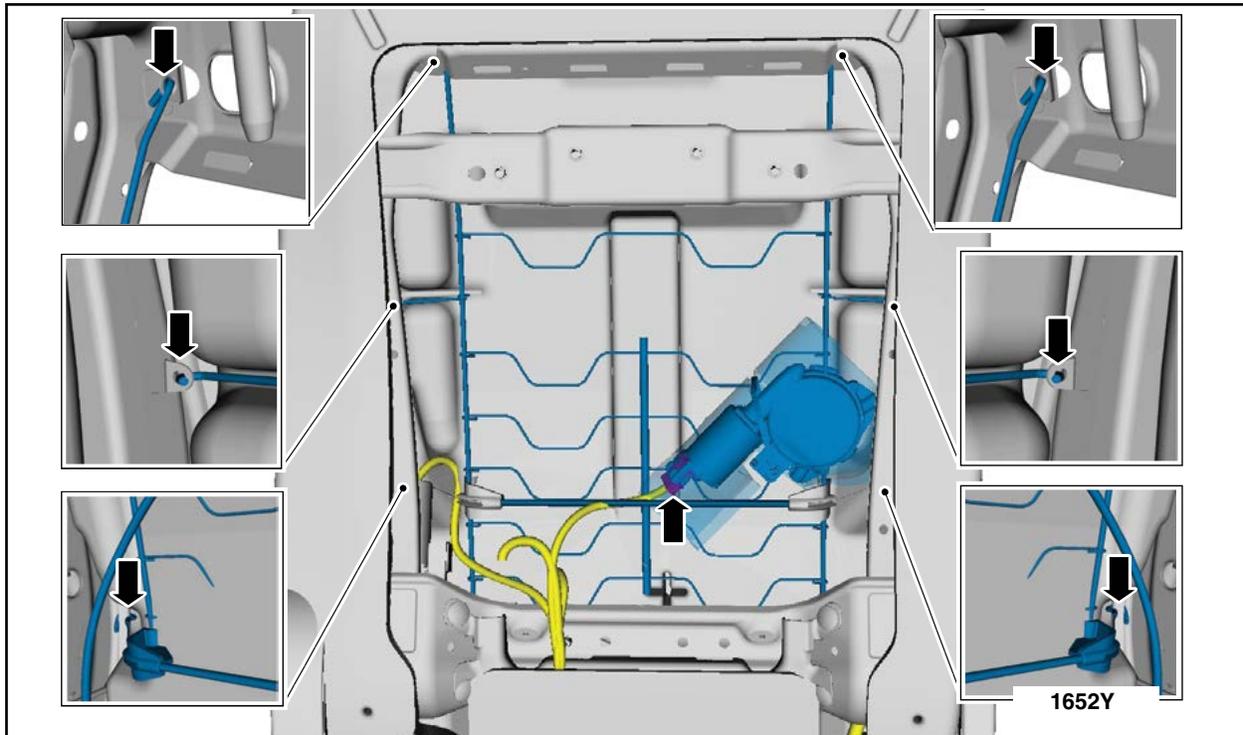
FIGURE 25

10. Disconnect the electrical connector, release the J-hooks, and remove the power lumbar assembly.
See Figure 25.
