Technical BULLETIN

SAFETY RECALL

CERTAIN 2015-2016 YZF-R3F/G MODELS

FACTORY MODIFICATION CAMPAIGN – Clutch Pressure Plate and Oil Pump

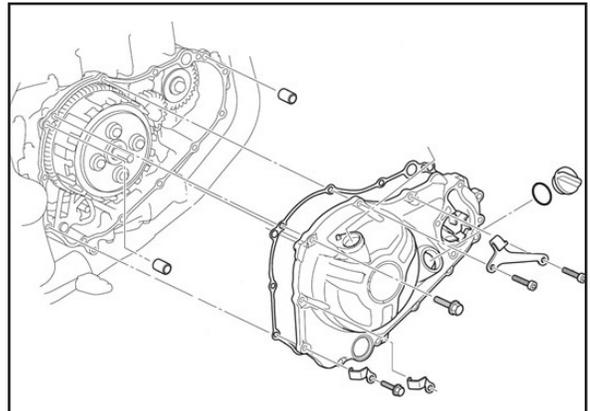
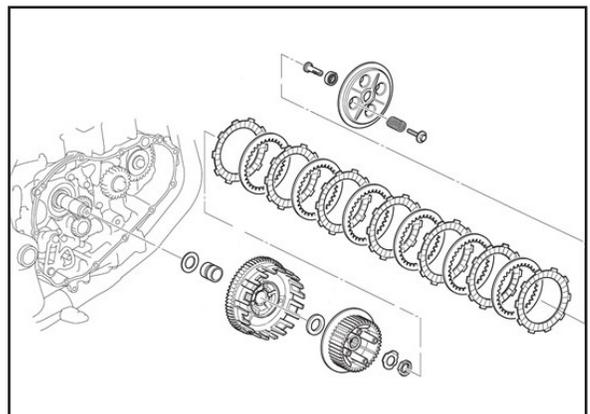
2. Remove the water pump housing from the clutch cover. Disconnect the clutch cable from the clutch pull lever shaft and cable bracket, then remove the clutch cover from the engine.
3. Loosen the 4 bolts securing the clutch springs by loosening in a crisscross pattern and remove the springs. Remove the outer pressure plate and tag and hold it for 90 days from the date you submit your claim.
4. Disassemble the clutch assembly and remove the clutch boss.

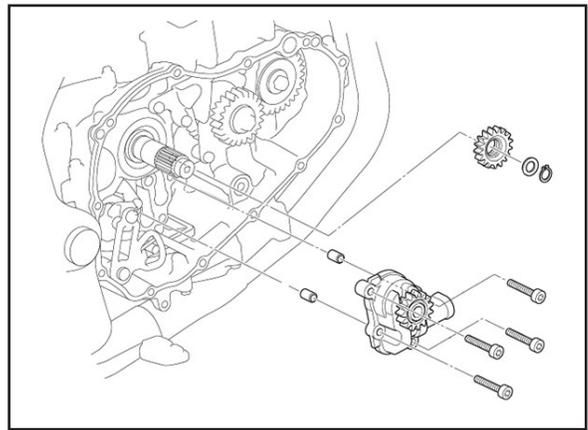
5. Remove the oil pump drive gear and oil pump assembly. Tag and hold the parts for 90 days from the date you submit your claim.
6. Replace the oil pump assembly with the oil pump from the kit.
 - Oil pump bolts: 10m-kgf (7.2ft-lb)
7. Reinstall the clutch assembly using the revised outer clutch pressure plate.
 - Clutch boss nut: 100Nm (10.0 m-kgf, 72ft-lb)
 - Clutch spring retaining bolts: 10Nm (1.0 m-kgf, 7.2ft-lb)
8. Reinstall the clutch cover, install the clutch cable, reinstall the water pump housing, and refill the cooling system. Take care to align the water pump drive gear properly during installation.
 - Clutch cover bolts: (1.0 m-kgf, 7.2ft-lb)
 - Water pump bolts: (1.0 m-kgf, 7.2ft-lb)

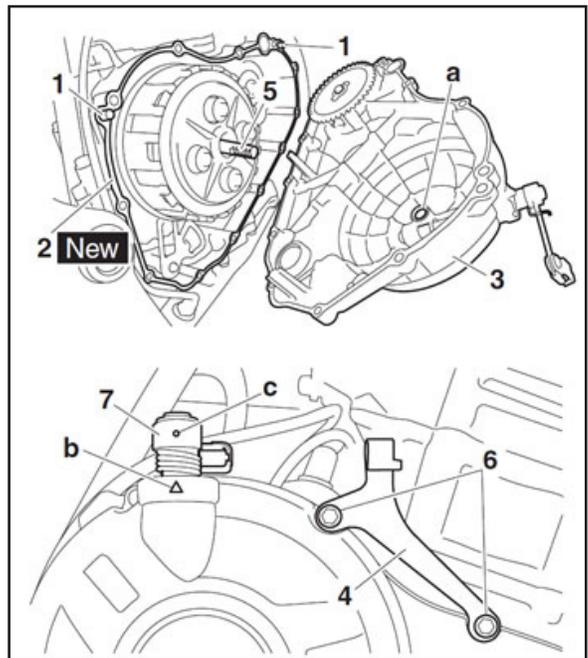
- Face the serrations on the clutch pull rod “5” rearward and align the rod with the hole “a” in the clutch cover.
- Make sure the pull rod teeth and pull lever shaft pinion gear are engaged.
- Apply locking agent (LOCTITE®) to the threads of only the clutch cable holder bolts “6” shown in the adjacent illustration.
- Tighten the bolts in stages and in a crisscross pattern.
- After installing the clutch cover, make sure the alignment mark “b” on the clutch cover is aligned with the punch mark “c” on the pull lever “7.”

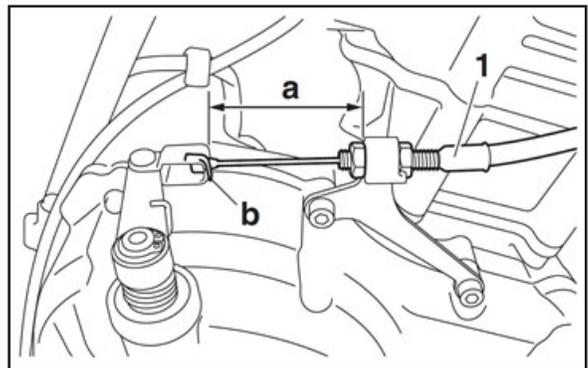
- Install the clutch cable so the clutch cable length “a” is 52.6-64.1 mm (2.07-2.52 in) as shown in the adjacent illustration.
 - After installing the clutch cable, bend the projection “b” on the pull lever as shown in the adjacent illustration.
9. Reinstall the bodywork removed during step 1 and verify the clutch cable free play is within specification.

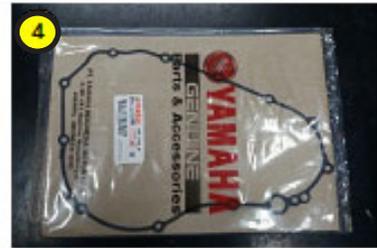
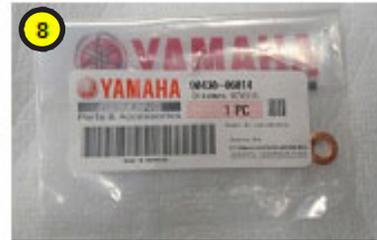
Part Name	Old Part	New Part
Pressure plate assy 2MS	<p>STAMP</p> <p>2MS</p> <p><2MS-E6350-00></p>	<p>STAMP</p> <p>2MS2</p> <p><2MS-E6350-09></p>
Oil pump assy	<p>NO PUNCH MARK</p> <p><1WD-E3300-00></p>	<p>PUNCH MARK ADDED</p> <p><1WD-E3300-09></p>
