GROUP
Safety Recall
Campaign

MODEL
2006~2012MY
Sedona (VQ)

NUMBER
SC100

SUBJECT: FRONT LOWER CONTROL ARM INSPECTION, REPLACEMENT OR APPLICATION OF PREVENTATIVE ANTI-CORROSION MATERIAL (SC100)

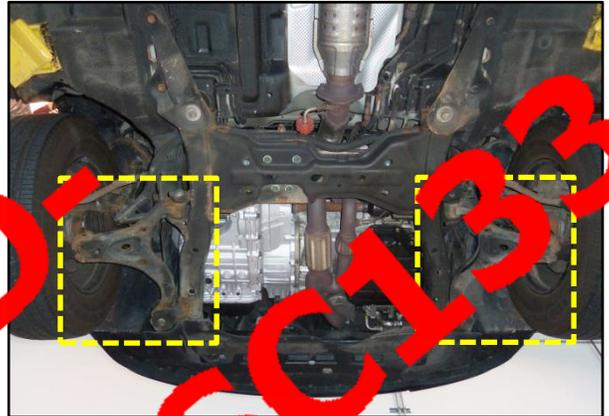
1. Place the vehicle on a lift and inspect the condition of the lower control arms. If any perforations or open cavities are present on either control arm, proceed to the Service Procedure on Page 4. If not, proceed to step 2.

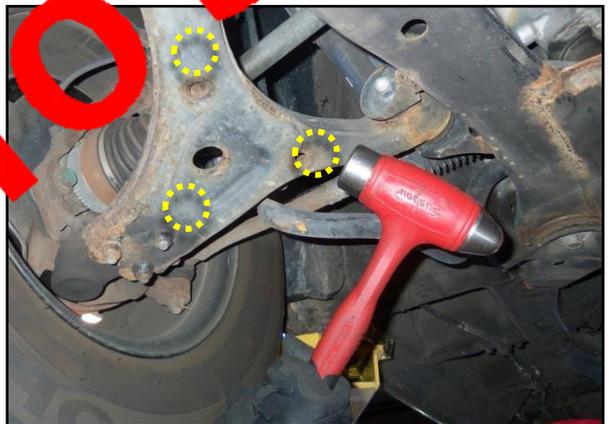
2. Use a hammer to strike the lower control arm at multiple spots. Check for weak spots in the metal and overall integrity of the lower control arm. If the lower control arm fails, proceed to the Service Procedure on Page 4. If overall integrity is confirmed, proceed to step 3.

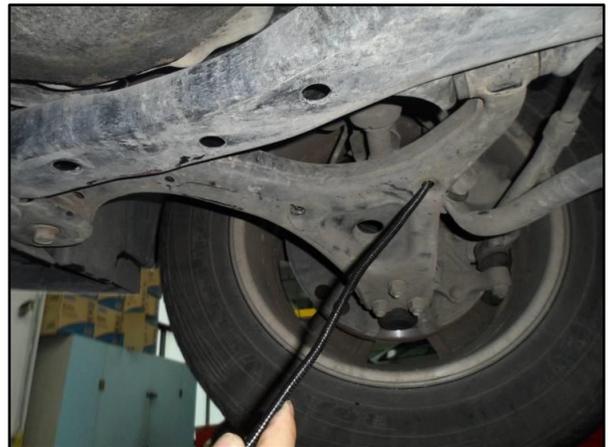
3. Insert a wire wheel pick up tool inside the lower control arm to remove any loose rust flakes.

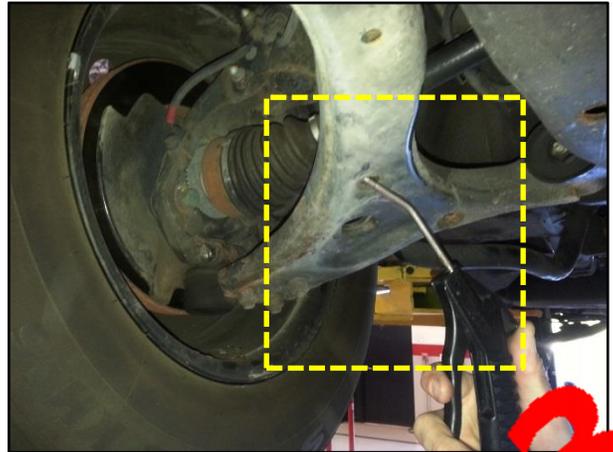
4. Remove any remaining debris from the inside of the lower control arm using an air gun. Make sure to insert the nozzle in multiple holes and rotate it in all directions to completely remove any foreign material or rust flakes.

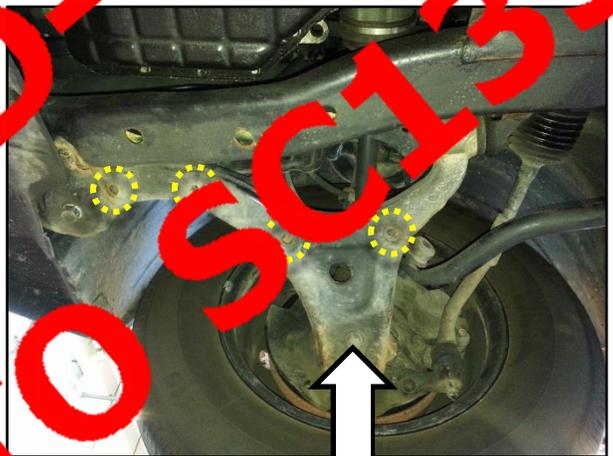
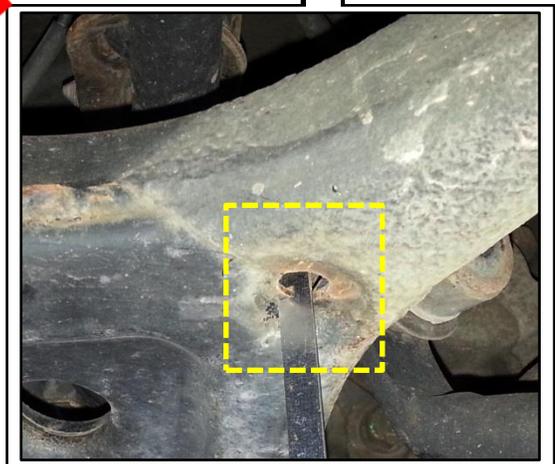
5. After removing all loose rust flakes from inside the lower control arm, use the S gauge (see below) to check the material thickness at all holes in the lower control arm, as shown.

SST P/N: 54500 18GA

6. If the gauge can be inserted over the material's edge, proceed to the Service Procedure on Page 4.
7. If the gauge cannot be inserted over the material's edge, and the lower control arm passed the visual inspection and the hammer strike test, proceed to the Reconditioning Procedure on Page 7.

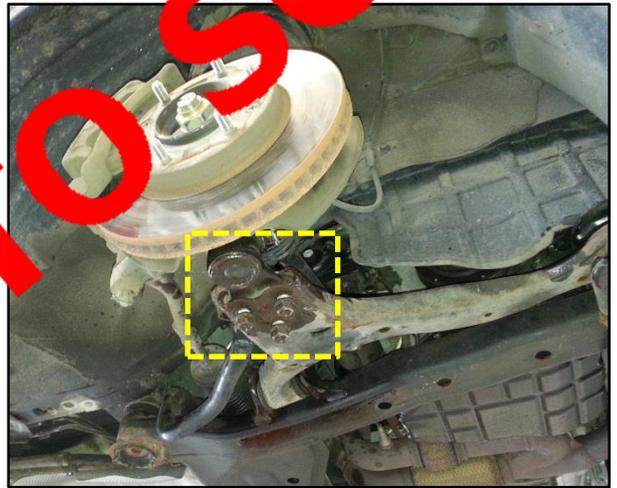
3. Loosen but do not remove the three (3) nuts securing the lower control arm to the ball joint.

Tightening torque:
65.1 ~ 86 lb-ft (9 ~ 120 Nm)

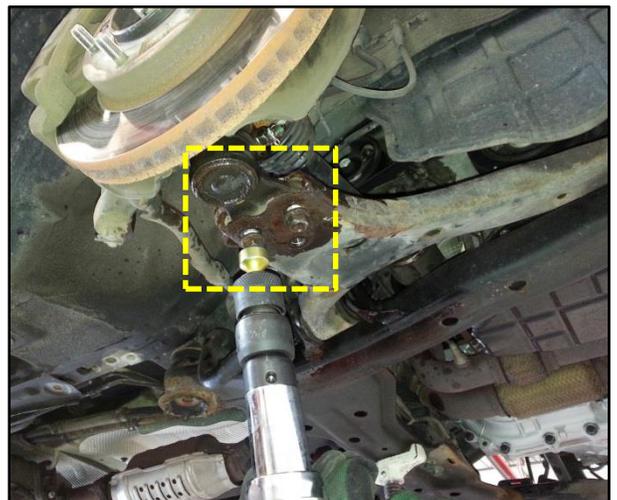
4. Remove the rear bolt and nut and from the lower control arm. Then, use a mallet or air hammer to remove the two (2) front "wheel-stop" type bolts and the nuts.

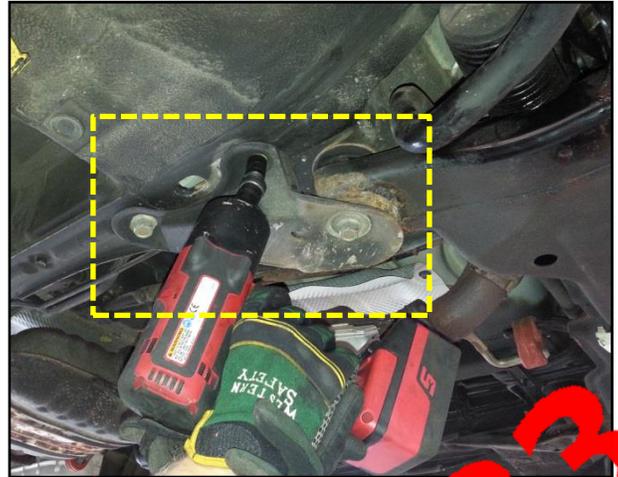
- 5. Remove three (3) bolts securing the sub-frame and the sub-frame bracket.

Tightening torque:
115.7 ~ 130.2 lb-ft (156.9 ~ 176.5 Nm)

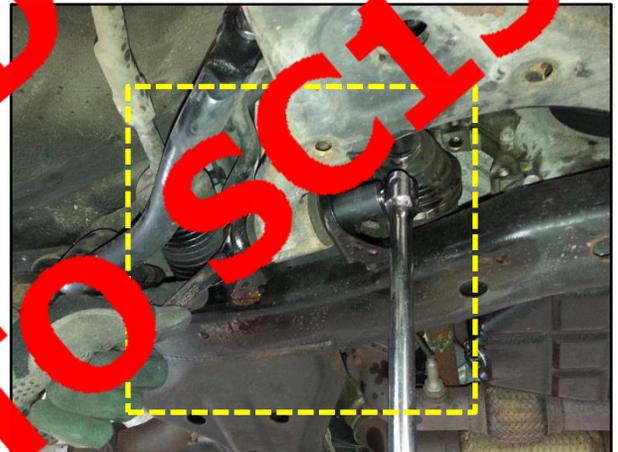
- 6. Remove the bolt and nut securing the rear mounting location for the lower control arm.

Tightening torque:
115.7 ~ 130.2 lb-ft (156.9 ~ 176.5 Nm)

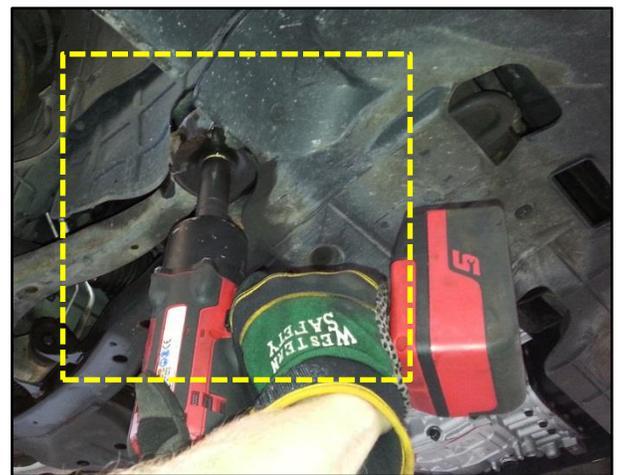
- 7. Remove the bolt securing the front mounting location for the lower control arm.

Tightening torque:
115.7 ~ 130.2 lb-ft (156.9 ~ 176.5 Nm)

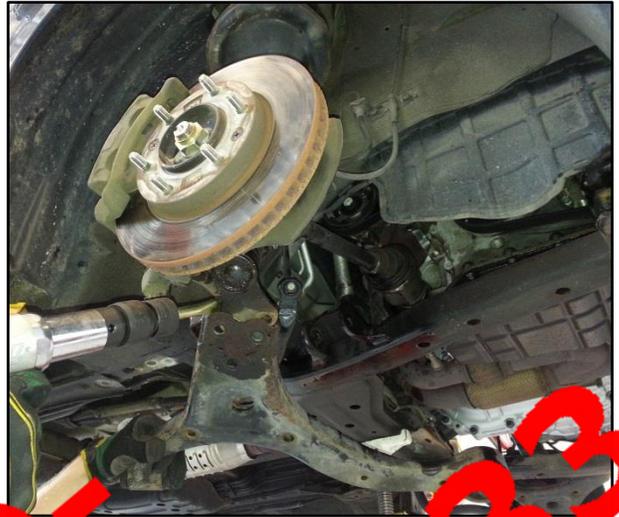
- 8. Use an air hammer with a chisel bit to remove the lower control arm from the ball joint.

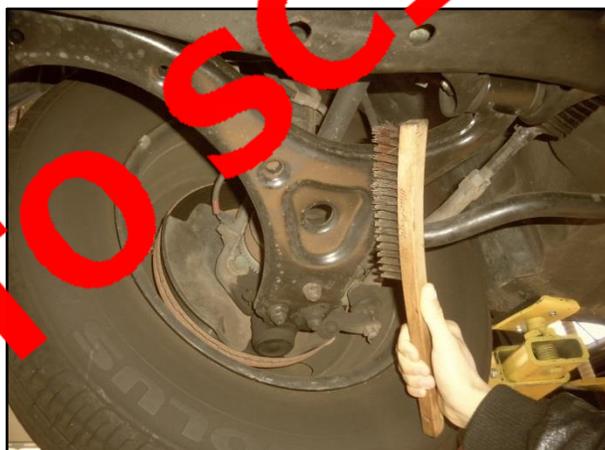
1. Use a metal bristle brush to remove any surface rust from the lower control arms.

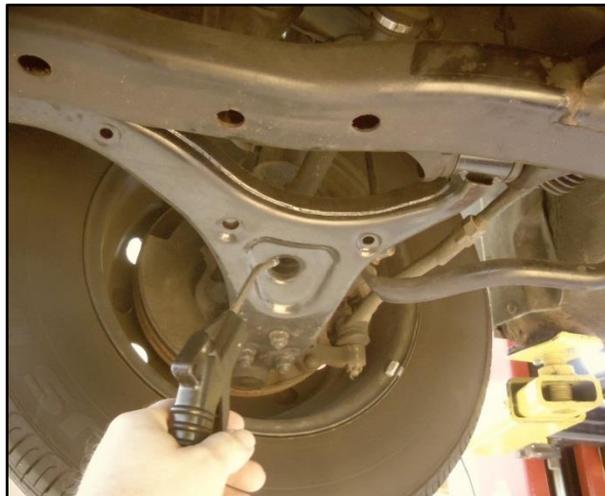
2. Use shop air to remove any loose dust from the lower control arm surfaces.

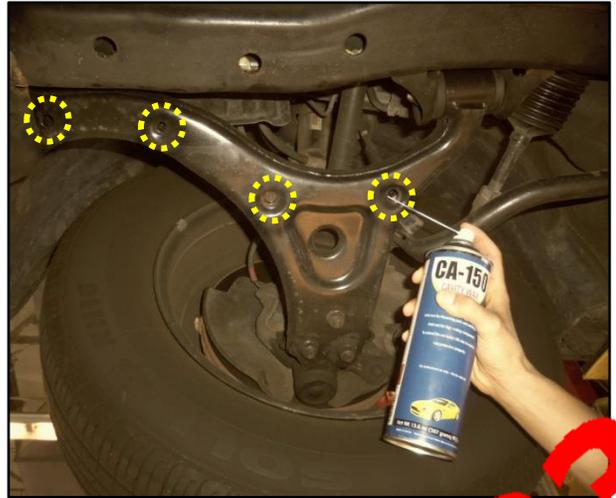
- Spray cavity wax into every hole in the lower control arm, as shown. To evenly apply cavity wax, turn the nozzle in all directions while spraying and make sure to use ONLY half (½) of the contents in each can per lower control arm.

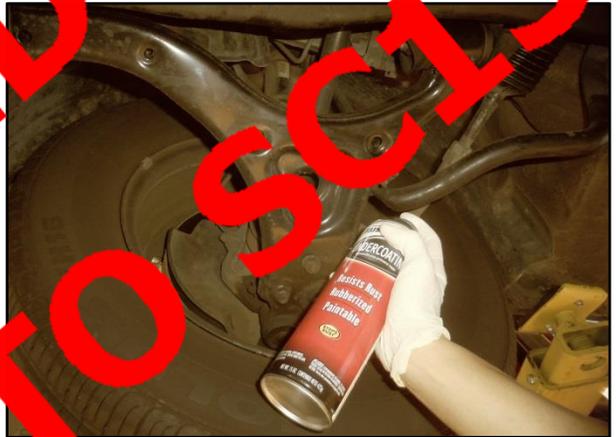
- Spray underbody coating onto the upper and lower surfaces of the lower control arm. Avoid over-spraying other parts of the vehicle.
