# Safety Recall

## Code: 97CB

**Subject: Safety Recall 97CB – Side Marker Lights  
Certain 2015-2017 Model Year Audi Vehicles**

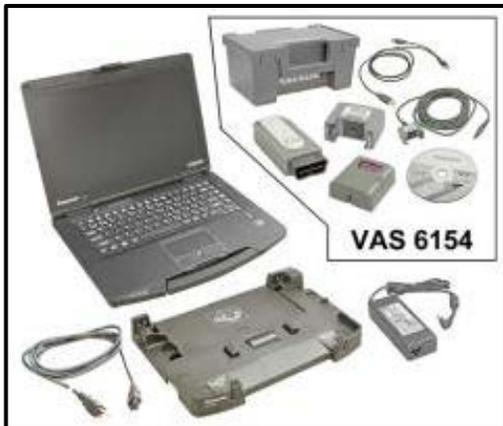
- VAS6150D - Diagnostic Tester (or equivalent)
- VAS6154 - Vehicle Communication Interface (or equivalent)

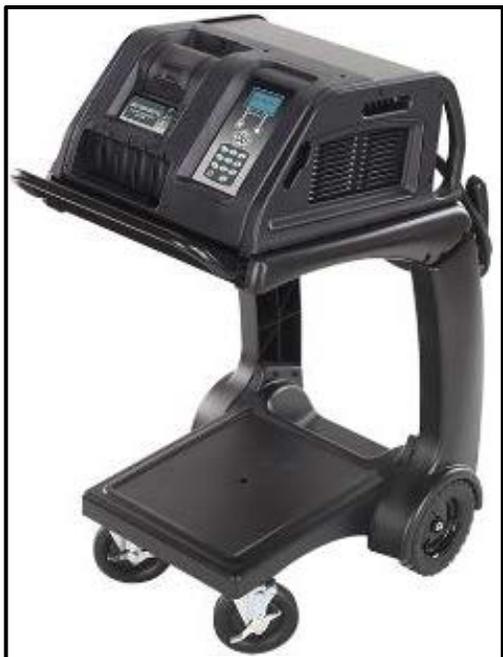
- GRX3000VAS – Battery Tester/Charger (or equivalent)

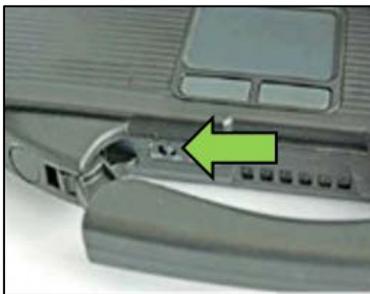
**VAS 6150 & VAS 6150A**  
(Front panel behind handle)

- ✓ **The Bluetooth function of the scan tool is physically switched off <see pictures below>.**

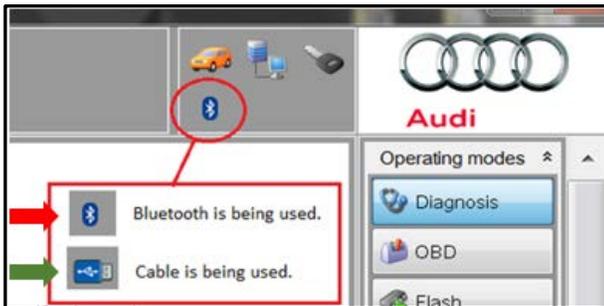
- Open the hood.
- Open the battery cover.
- Attach the GRX3000VAS Tester/Charger (or equivalent) to the vehicle battery.
- Connect the VAS6150D Diagnostic Tester (or equivalent) to the vehicle.
- Start the ODIS program.
- Confirm that scan tool is communicating with the diagnostic head by USB <Green Arrow>.
  - If the Bluetooth symbol is shown <Red Arrow> then disconnect the diagnostic head from the vehicle and reconnect the USB cable to the diagnostic head and then reattach to the vehicle.

- From the home screen of the scan tool select "Flash."
- Follow the on-screen prompts.
- Select "SVM code input."
- Enter SVM code **97CBA378**.
- Follow the on-screen prompts.
- Send flash log online.
- **Proceed to Section C.**
