ITB11-027

VOLUNTARY SAFETY RECALL CAMPAIGN 1997 – 2003 QX4 FRONT STRUT HOUSING CORROSION INSPECTION

CAMPAIGN ID #: R1102
NHTSA #: 11V-244
APPLIED VEHICLES: 1997 – 2003 QX4 (JR50)

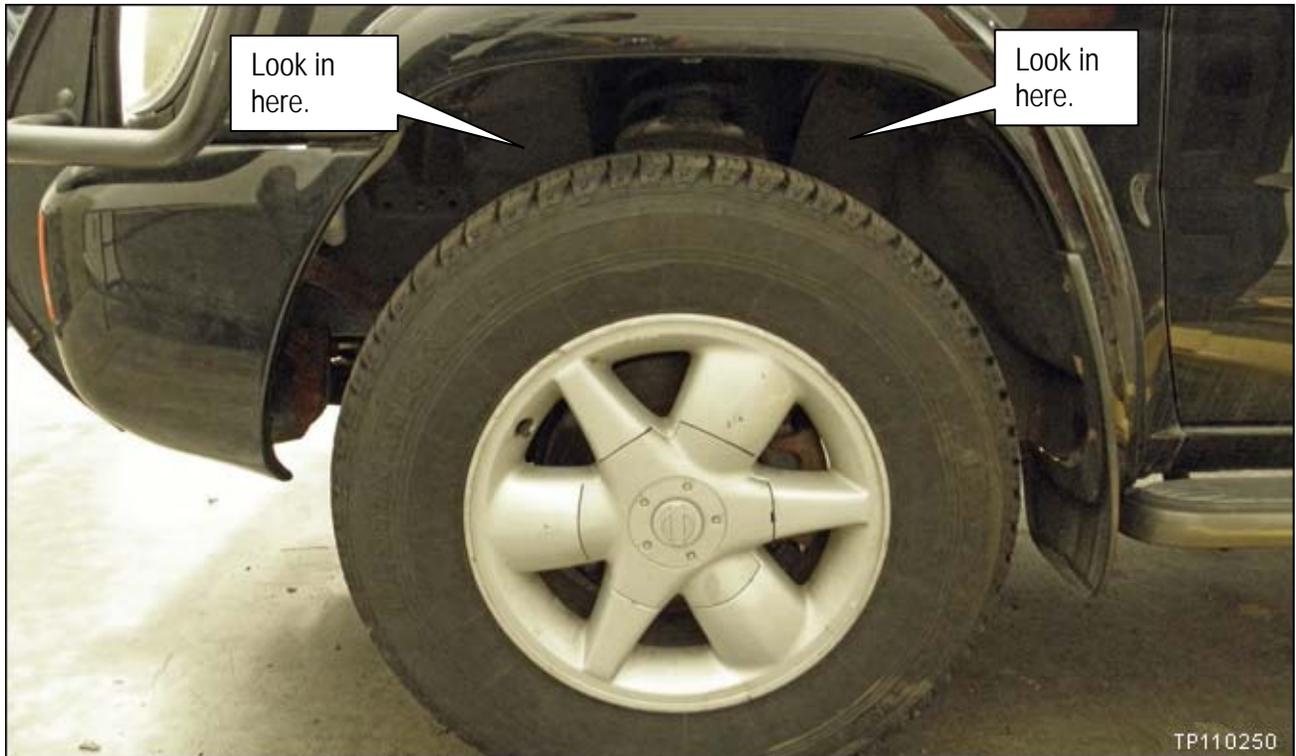
Figure 1

3. Look behind the driver side tire in the two areas shown in Figure 1.

NOTE: Turning the tire left and then right will allow a better view.

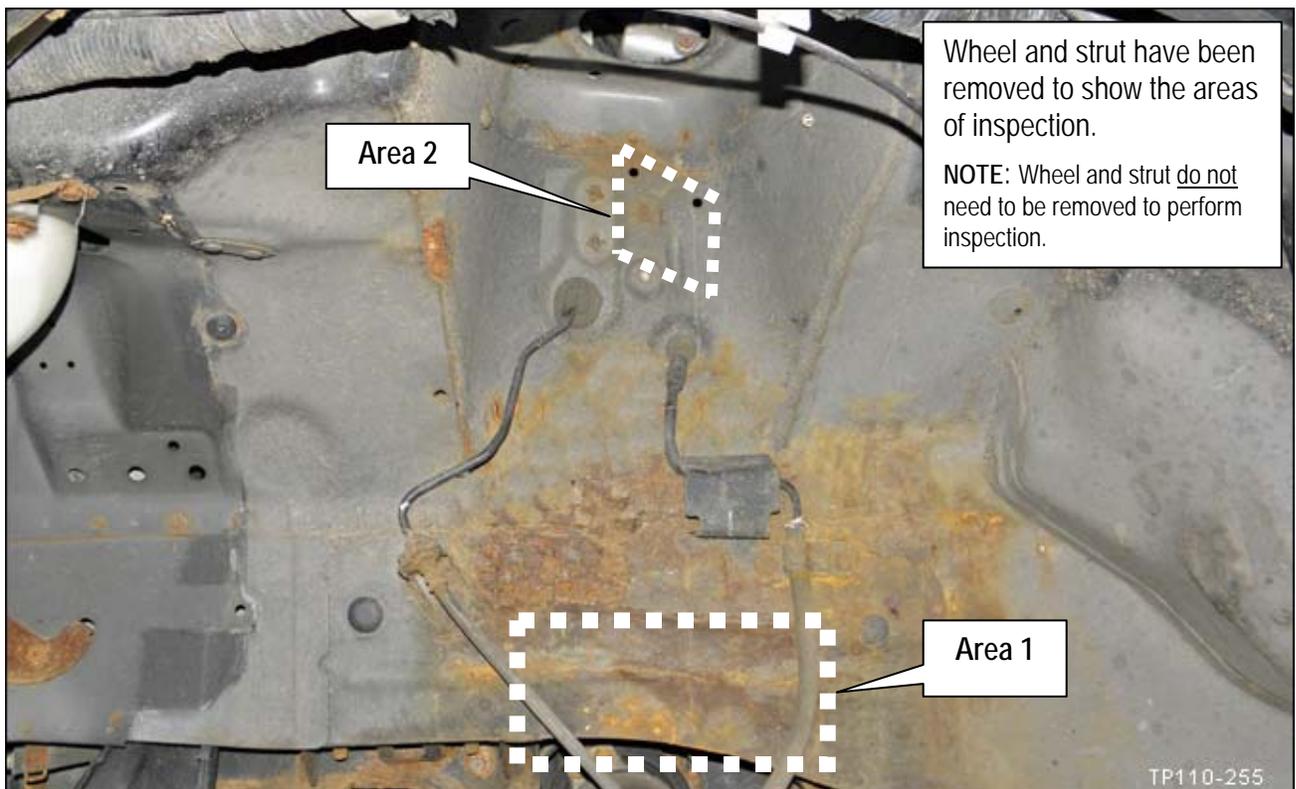
Figure 2

4. Inspect for corrosion in Area 1 and Area 2 (see Figures 2, 3 and 4).

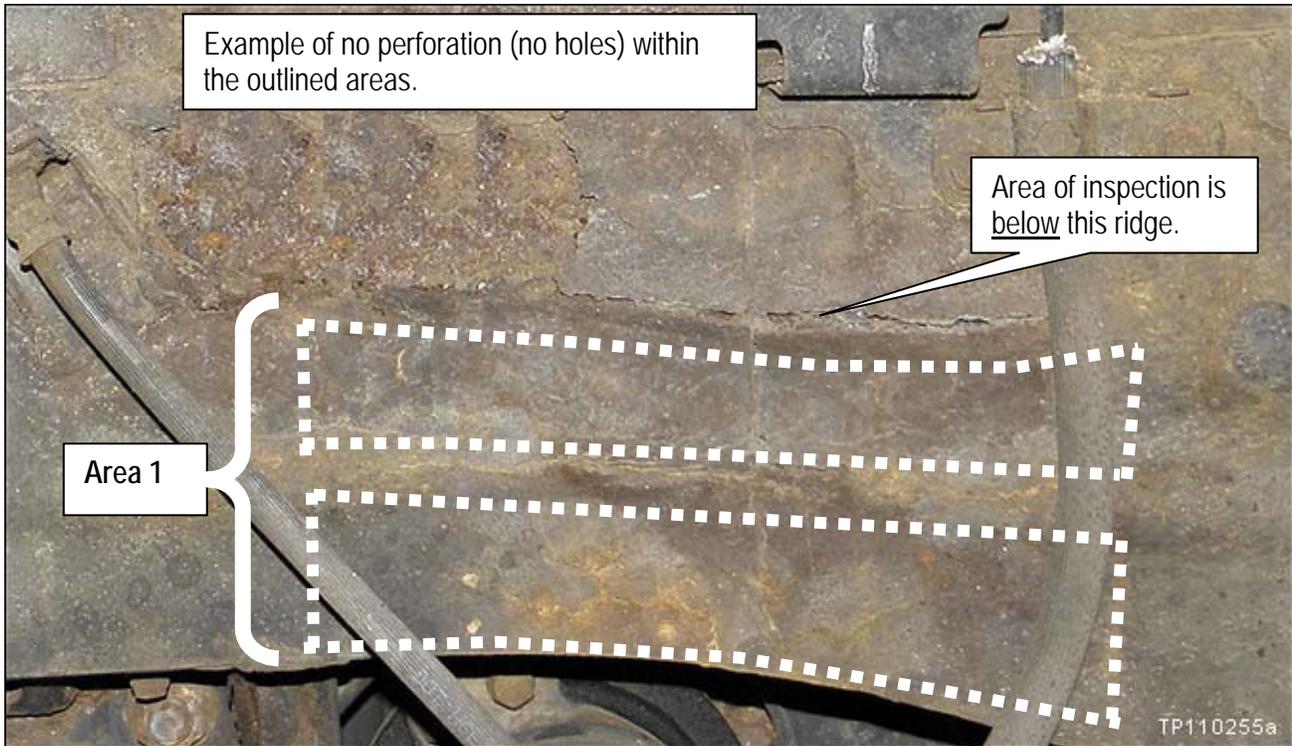
Figure 3

Area 1: Look for perforation (holes) in the metal only in the areas outlined.

If there **is perforation** (holes) in the metal:

- a. Retain the vehicle at the dealer. (The vehicle is not repairable.)
- b. Supply the customer with a rental car.
- c. Fax a completed Non-Repairable Report (see page 11) to your regional office.

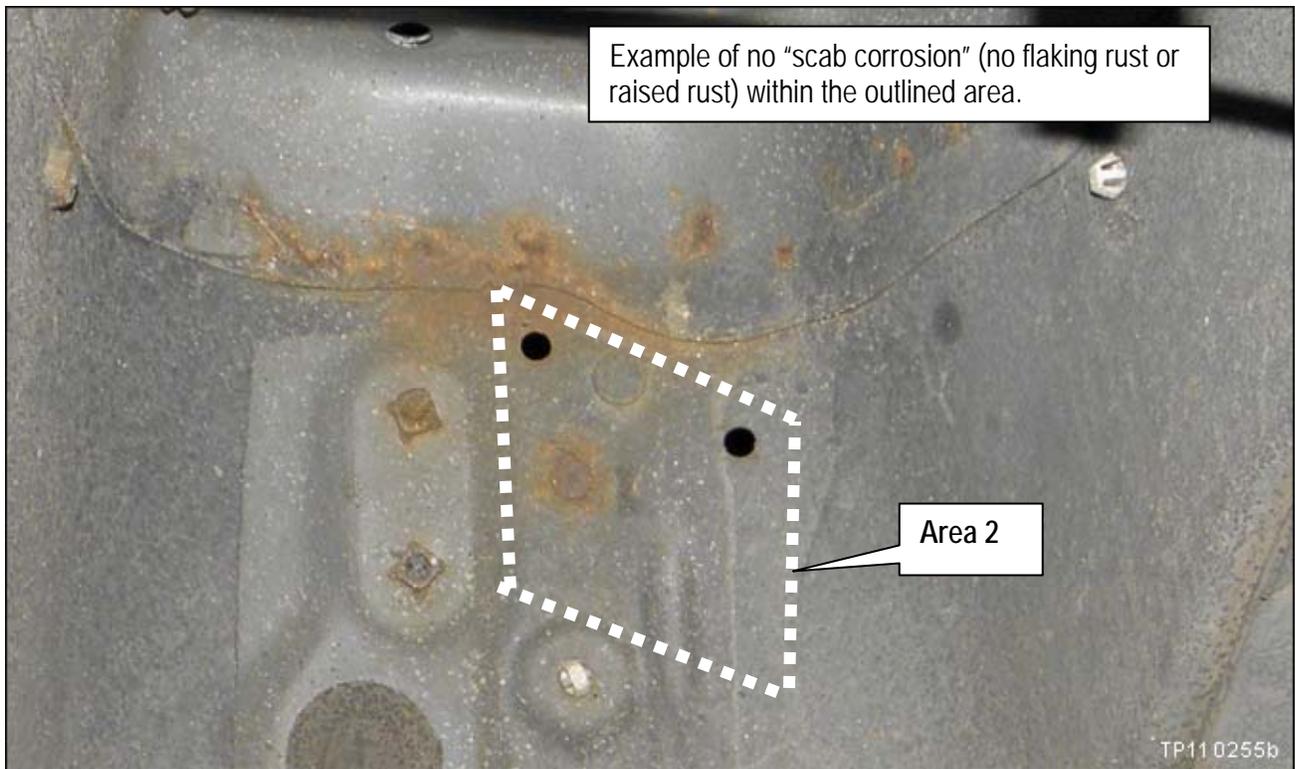
Figure 4

Area 2: Look for "scab corrosion" (flaking rust or raised rust) only in the area outlined.

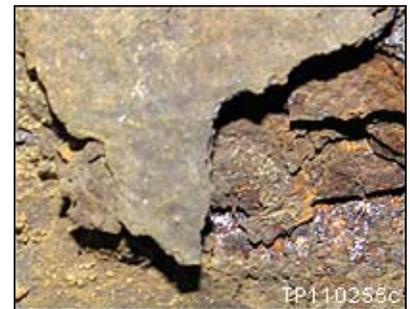
Figure 5 is an example of "scab corrosion" (flaking and raised rust).

If there is scab corrosion (flaking or raised rust):

- a. Retain the vehicle at the dealer. (The vehicle is not repairable.)
- b. Supply the customer with a rental car.
- c. Fax a completed Non-Repairable Report (see page 11) to your regional office.

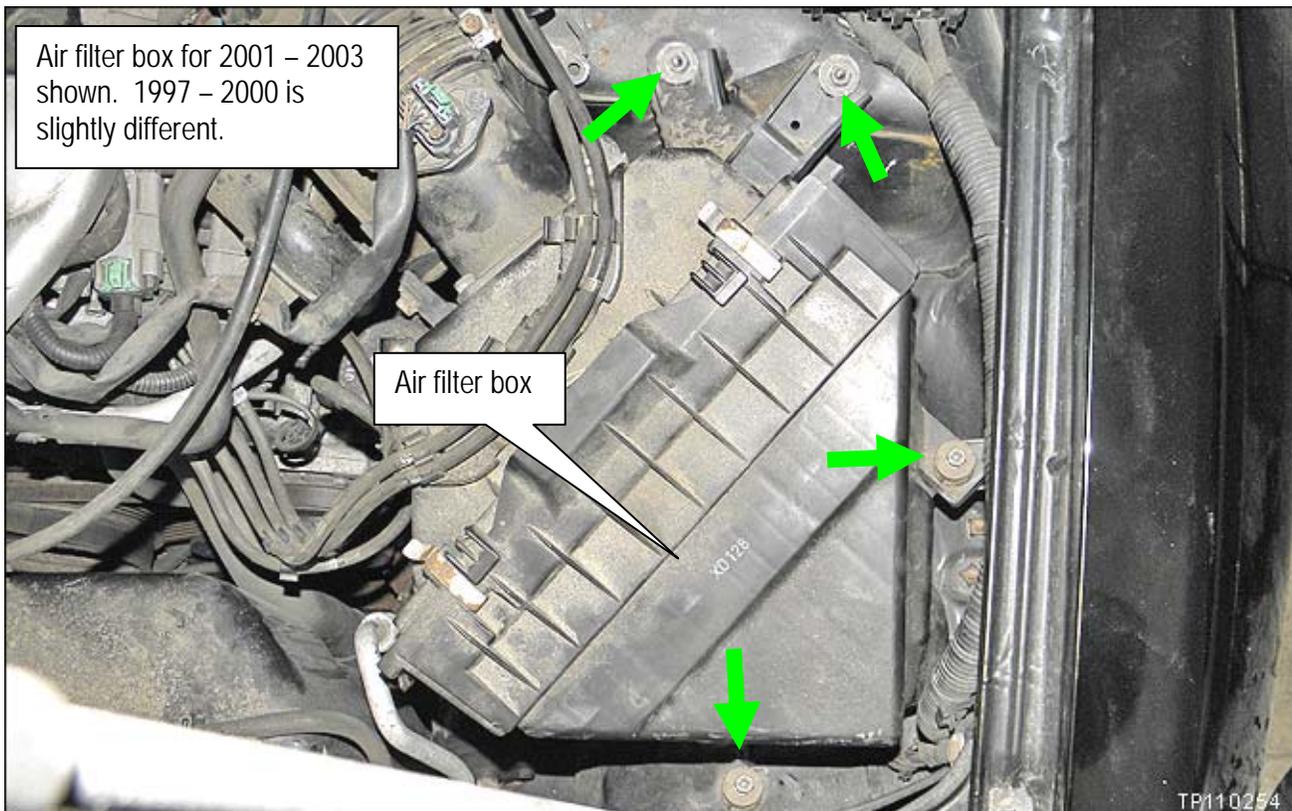
Figure 6

1. **Do not** raise the vehicle. Make sure all vehicle weight is on the wheels/tires.
2. Remove the 4 air filter box mounting bolts/nuts shown in Figure 6.

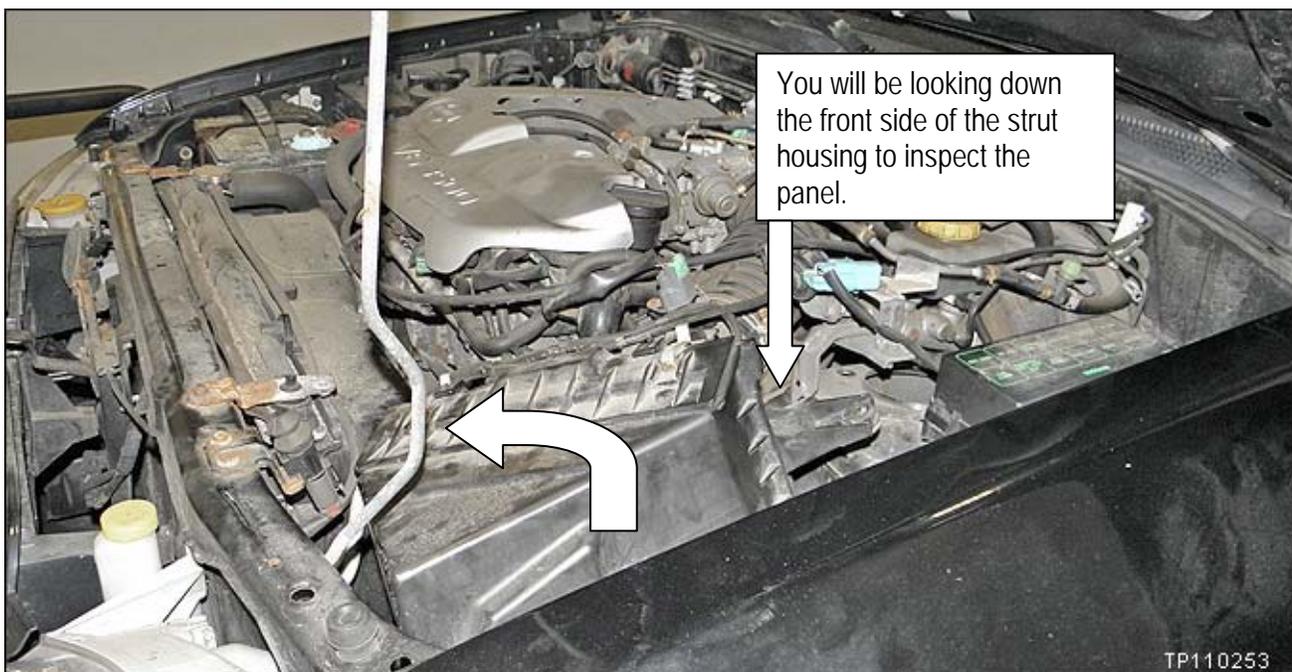
Figure 7

3. Lift the air filter box and move it forward.

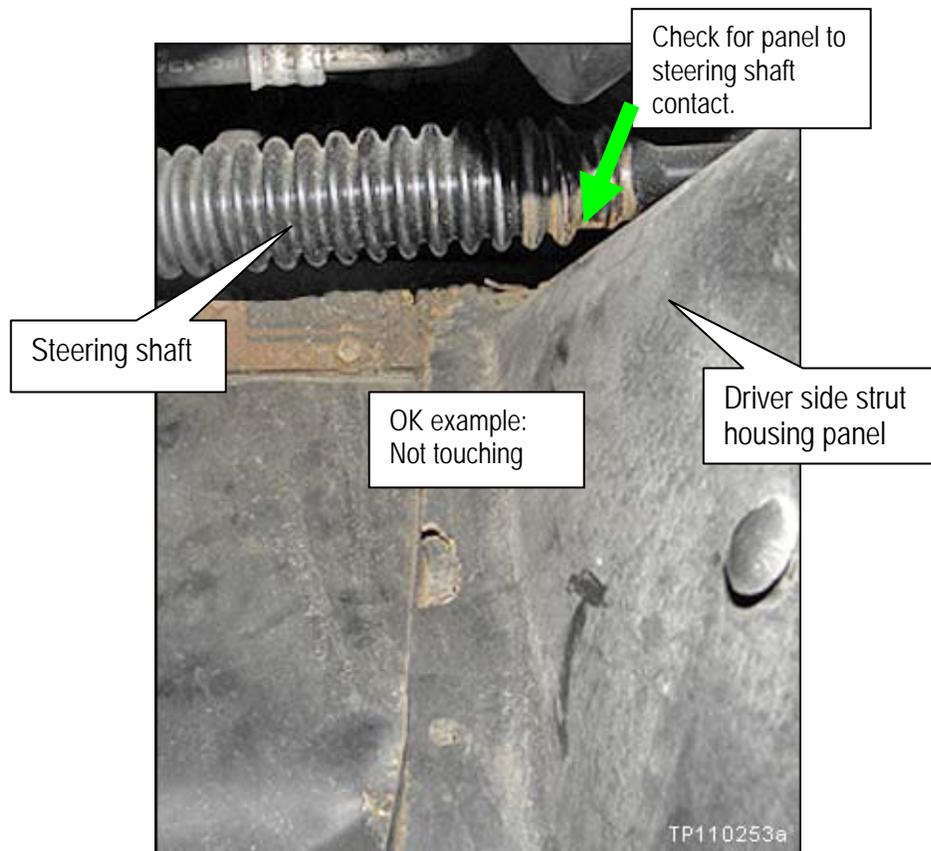
Figure 8

4. Check for driver side strut housing panel to steering shaft contact (see Figure 8).

Panel is touching the steering shaft:

- a. Retain the vehicle at the dealer. (Vehicle is repairable but **cannot** be driven.)
- b. Supply the customer with a rental car until the repair is available.

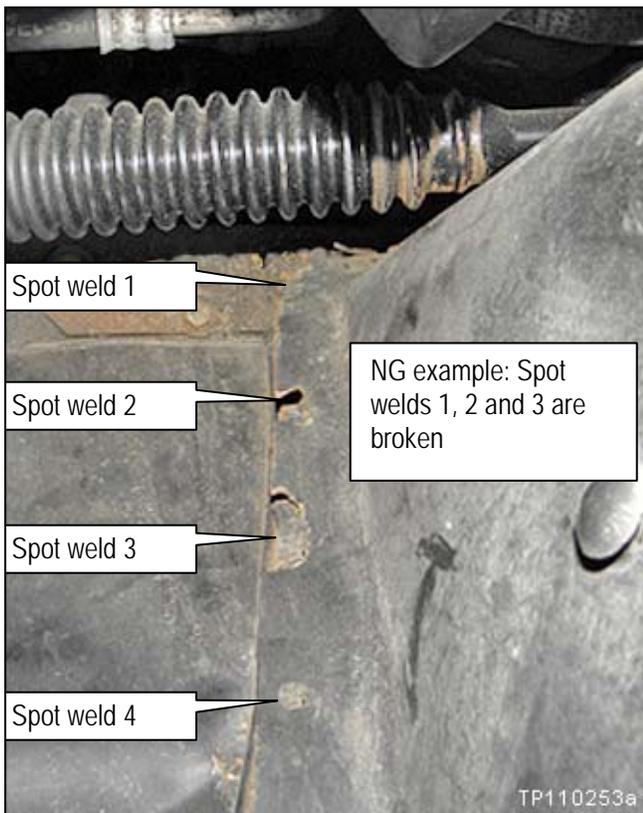
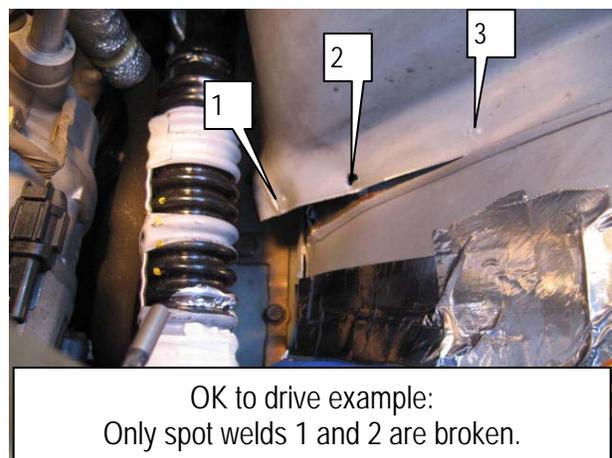
Figure 9

5. Check the spot welds on the front of the driver side strut housing panel (see Figures 9 and 10).

OK to drive:

Not Drivable - Spot weld 3 is broken:

- No spot welds broken
 - Spot weld 1 is broken
 - Spot welds 1 and 2 are broken
- a. Reinstall the 4 air filter box mounting bolts/nuts.
 - b. Release the vehicle to the customer.
 - c. Inform the customer of the following:
 - Infiniti will contact them in the near future with instructions for obtaining additional repairs.
 - If the customer experiences an increased steering effort or difference in the vehicle handling, they should return to the dealer immediately for a repeat inspection.

- a. Retain the vehicle at the dealer. (Vehicle is repairable but **cannot** be driven).
- b. Supply the customer with a rental car until the repair is available.
