RECALL CAMPAIGN BULLETIN

NTB11-064e

VOLUNTARY SAFETY RECALL CAMPAIGN 1996-2004 PATHFINDER IN SALT STATES FRONT STRUT HOUSING CORROSION

CAMPAIGN ID #: R1107
NHTSA #: 11V-244
APPLIED VEHICLES: 1996 – 2004 Pathfinder (R50)

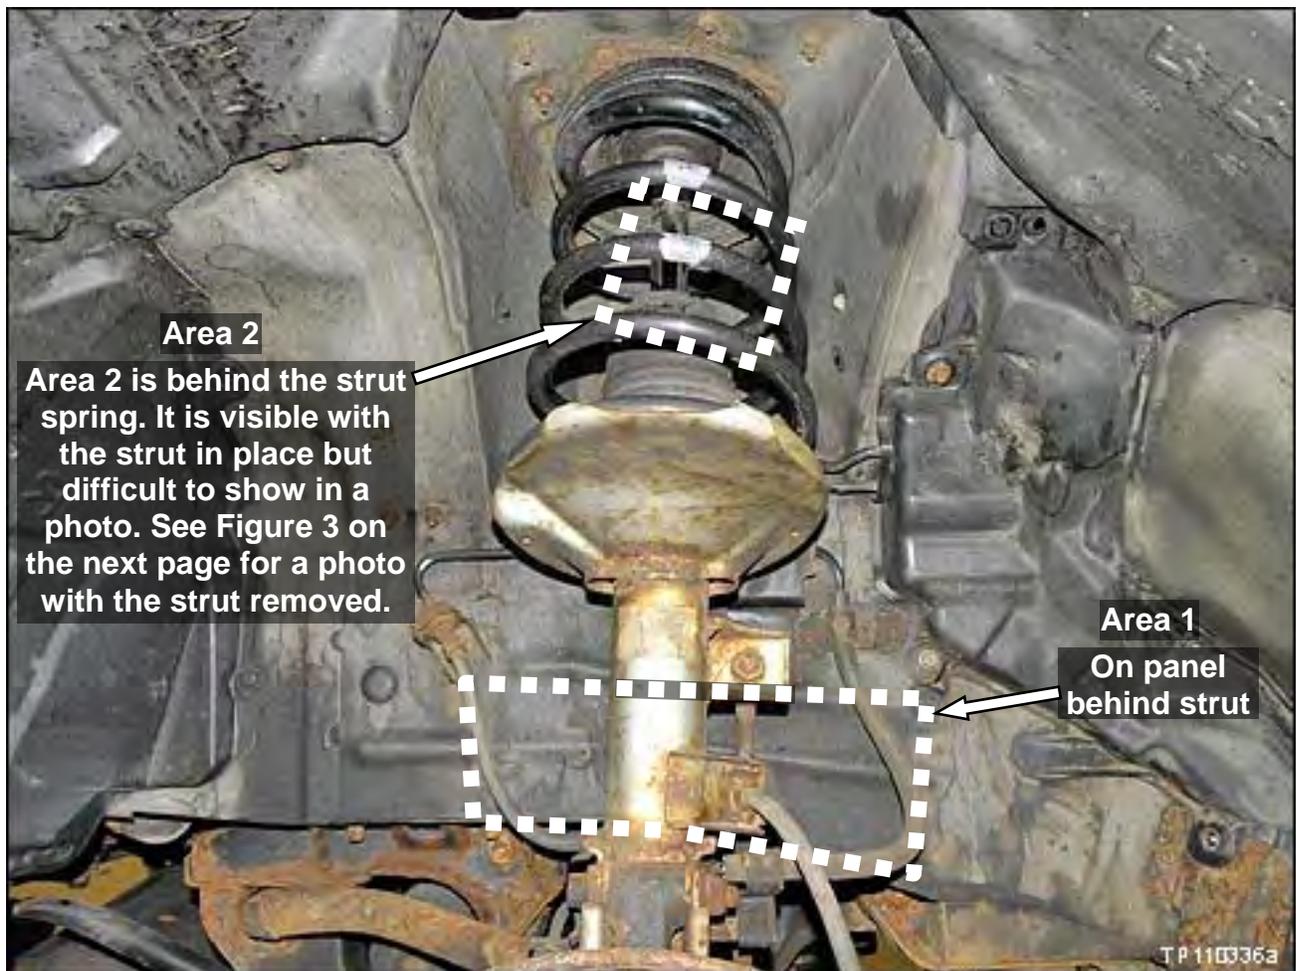
Figure 1

3. Inspect for corrosion on the driver side AND passenger side in the wheel house **Area 1** and strut housing **Area 2** (see Figures 1, 2, 3, and 4).

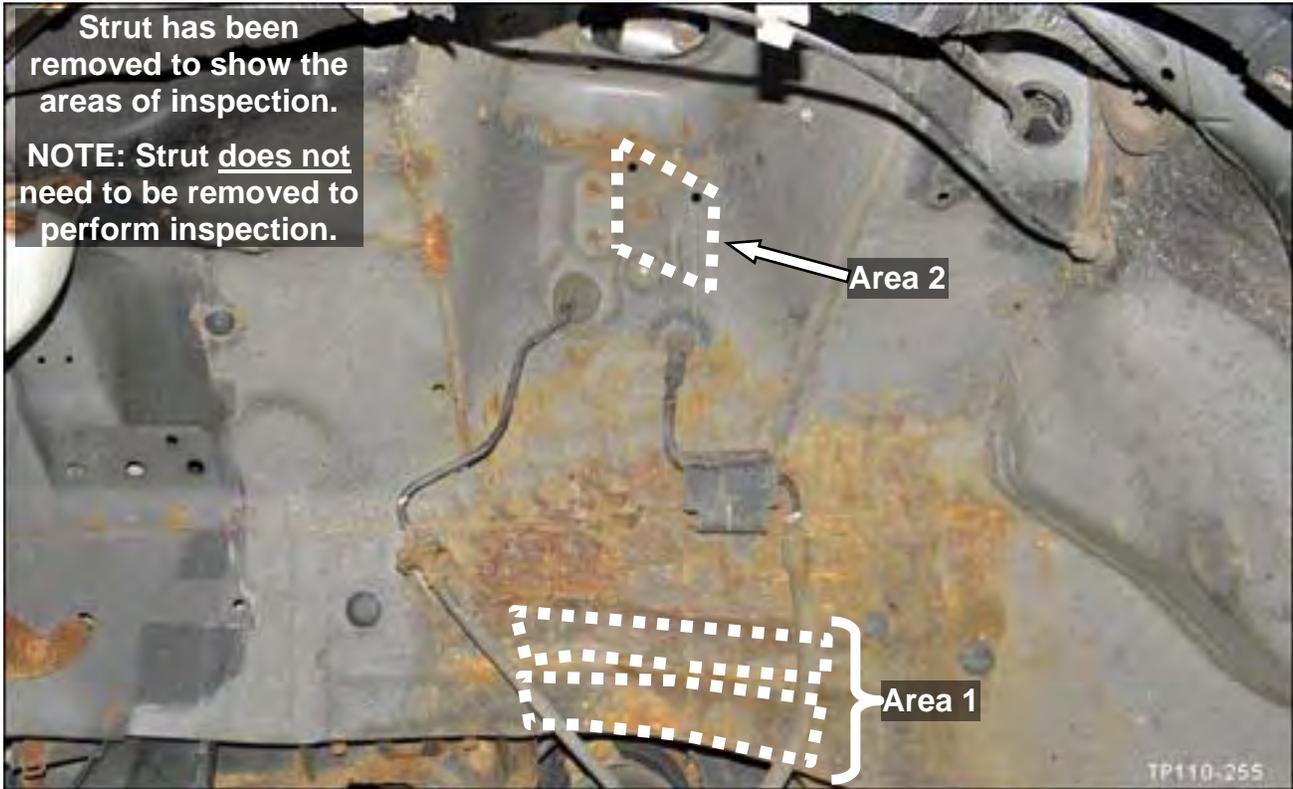
Figure 2

This example photo shows the inspection areas in relation to the repair bracket installation.

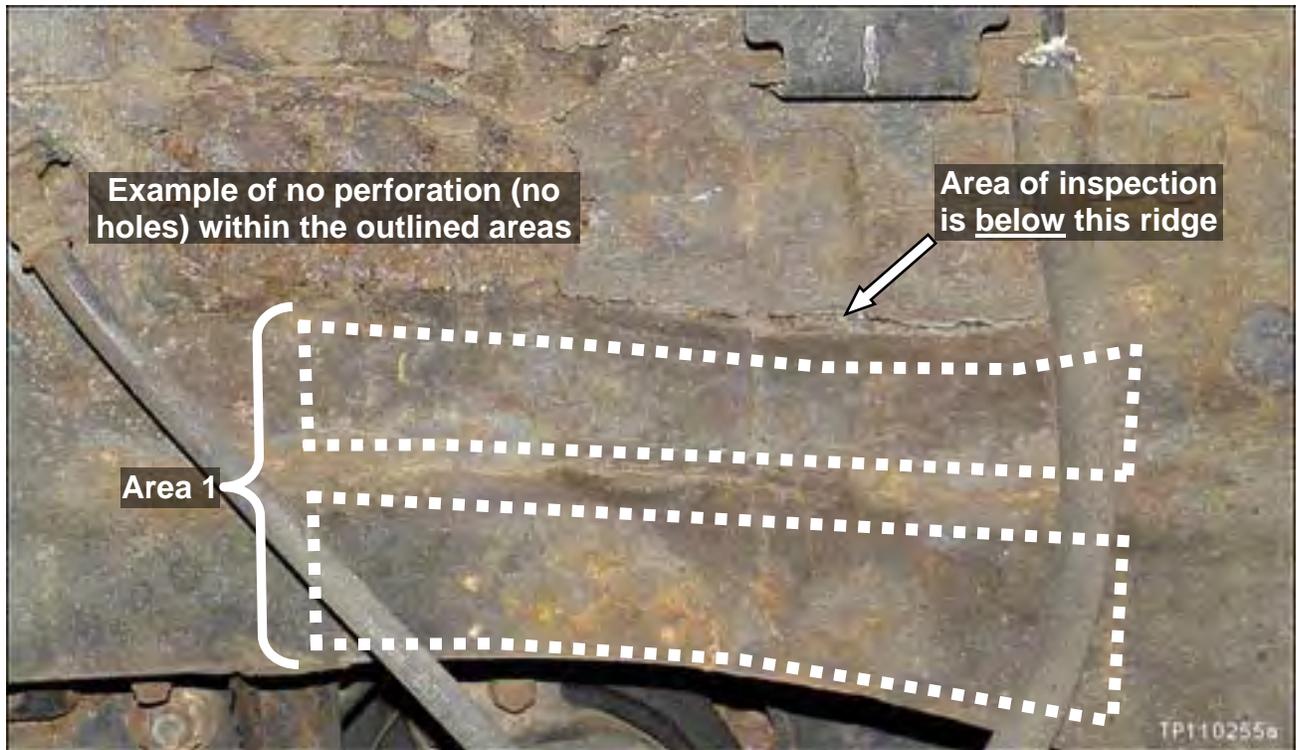
Figure 3

Area 1: Look for perforation (holes) in the metal only in the areas outlined above.

- a. Retain the vehicle at the dealer. (The vehicle is not repairable.)
- b. Supply the customer with a rental car.
- c. Fax a completed Non-Repairable Report to Morley (see page 54).

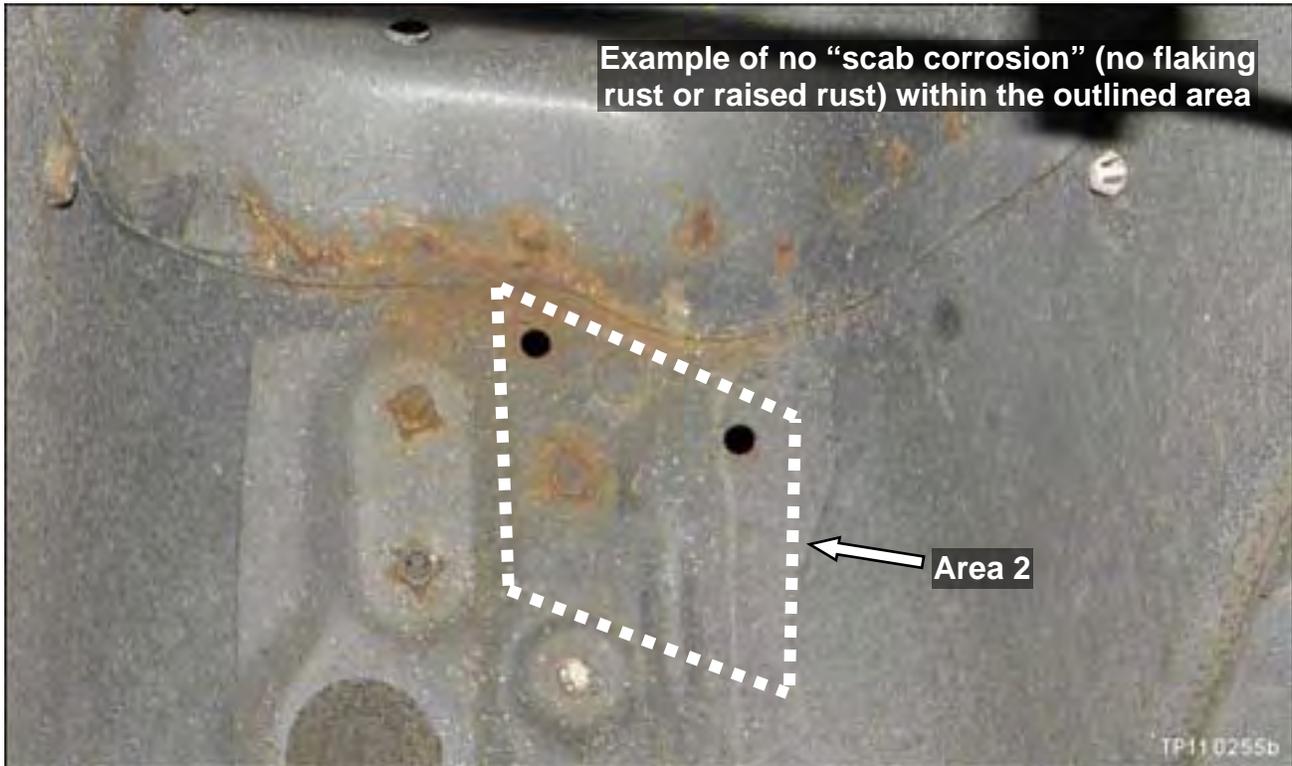
Area 2: Look for “scab corrosion” (flaking rust or raised rust) on driver side **AND** passenger side **only in the area outlined above.**

- The area shown in Figure 4 applies to driver side **AND** passenger side.
- If needed, refer to examples (additional photos) of Area 2 scab corrosion inspection on pages 46 and 47.

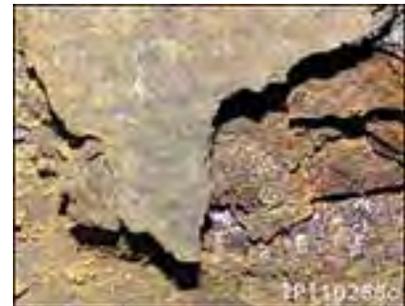
Figure 5 is an example of “scab corrosion” (flaking and raised rust).

If there is **scab corrosion** (flaking or raised rust) in Area 2, driver side **OR** passenger side:

- a. Retain the vehicle at the dealer. (The vehicle is not repairable.)
- b. Supply the customer with a rental car.
- c. Fax a completed Non-Repairable Report to Morley (see page 54).

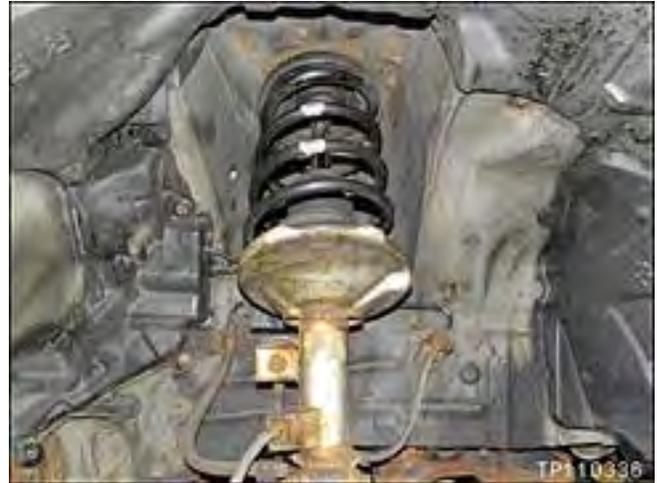
Figure 6

2. Visually inspect for corrosion and rust on the wheel housing panel and the strut housing panel (driver and passenger side).
 - Inspect for corrosion and rust on the panels only.

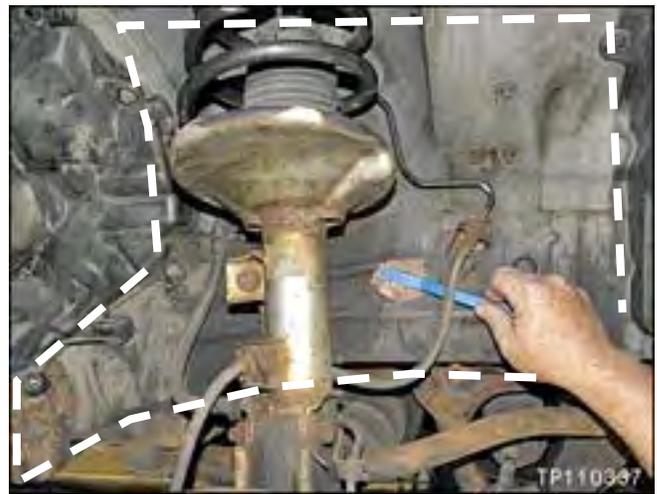
Figure 7

1. Use a wire brush to remove loose rust in the area shown with dashed line.

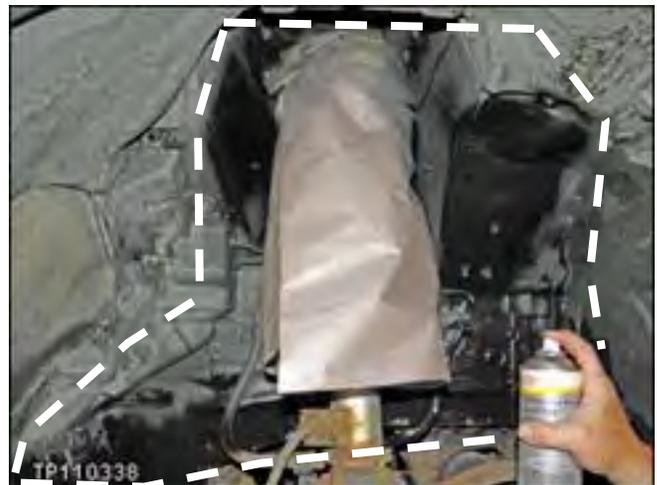
Figure 8

3. Cover the strut so it is protected from overspray.

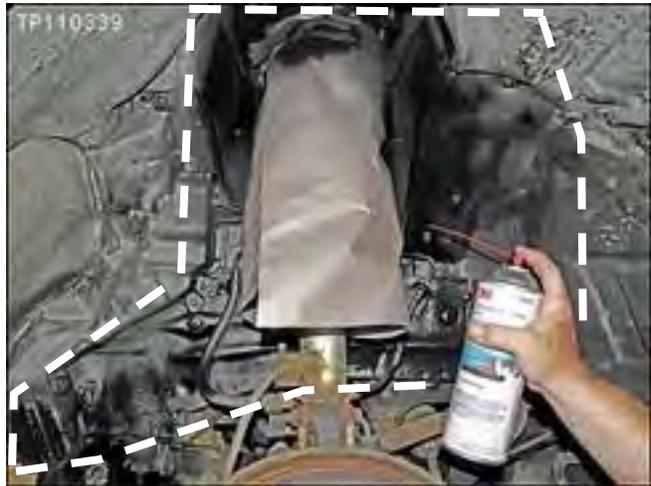
Figure 9

- Use 3M™ Rubberized Undercoating (P/N 051135 – 08883) or equivalent.
- Follow all product instructions.
- Coat all of the exposed metal areas on the strut housing and wheel house panels.
- Use a spray nozzle to spray the areas behind the strut and other hard to reach areas.

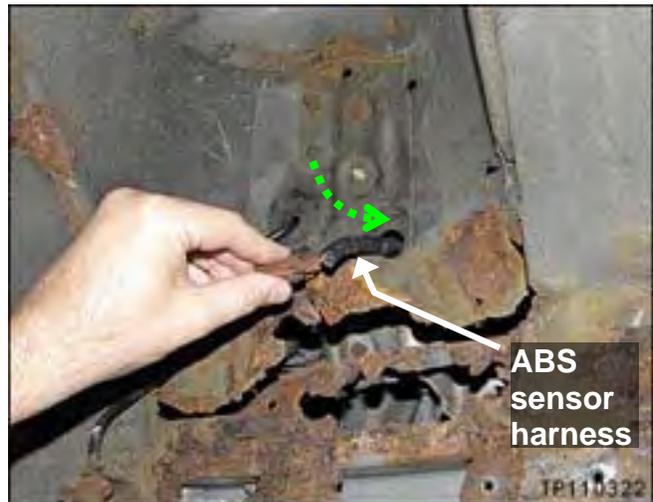
Figure RB1

1. Inspect the ABS sensor harness for damage. If damaged, repair as necessary.
2. Push the ABS harness and connector through the panel.
 - The harness/connector will now be out of the working area.

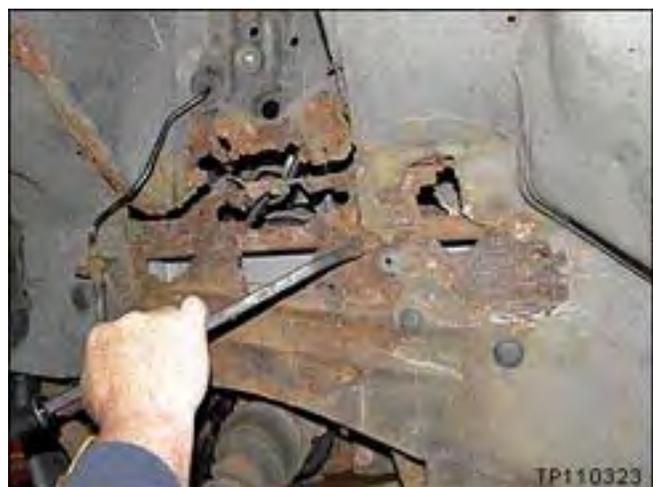
Figure RB2

3. Use a scraper bar to scrape off loose flaking rust and corrosion.

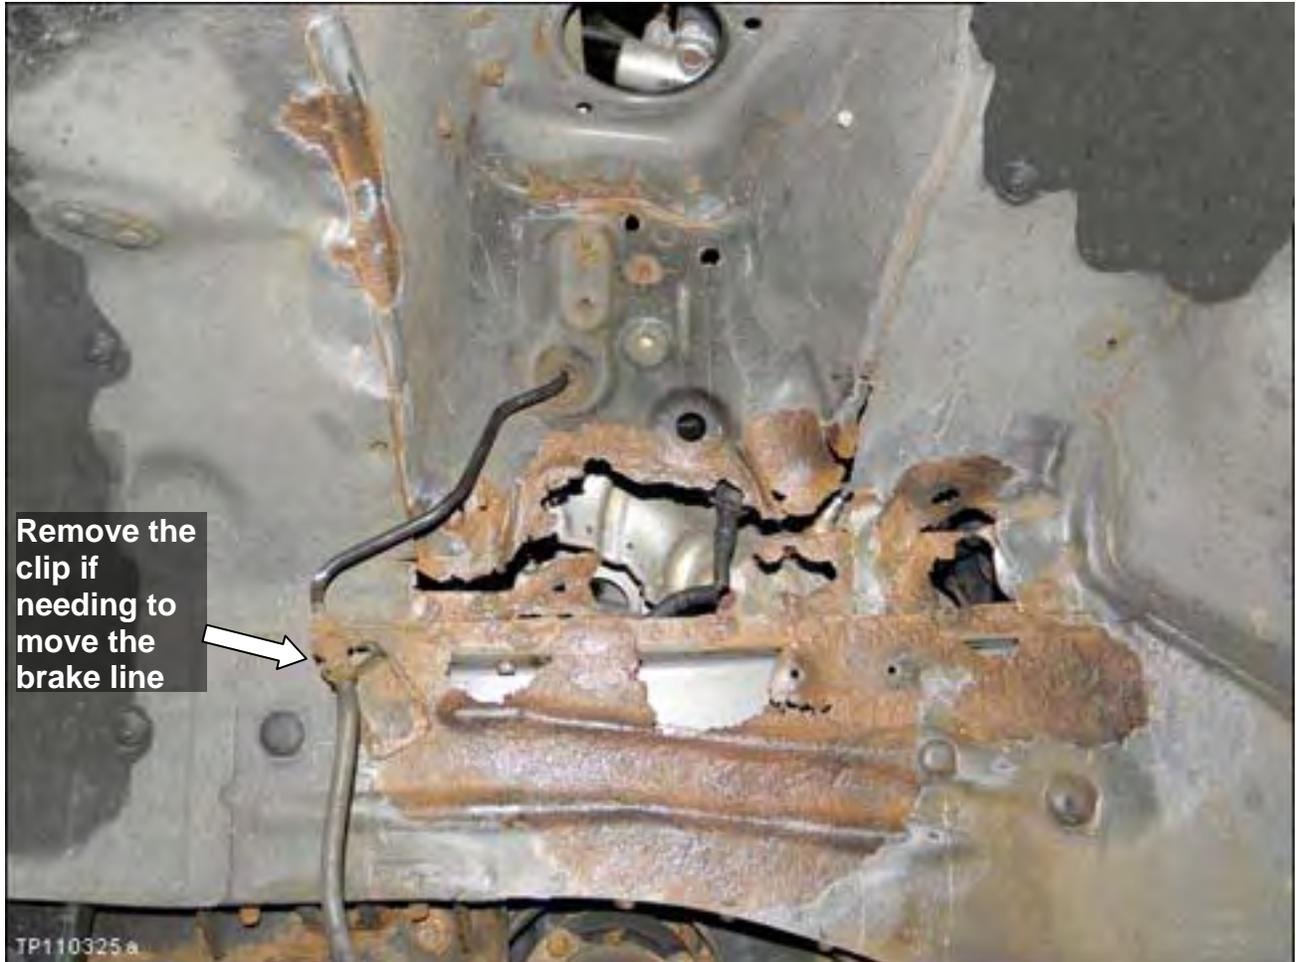
Figure RB3

4. Clean all the loose rust from the strut housing and wheel house areas (see Figure RB3).

NOTE: If the brake line is in the way of an area that needs cleaning, move it out of the way by first removing the clip from the mount.

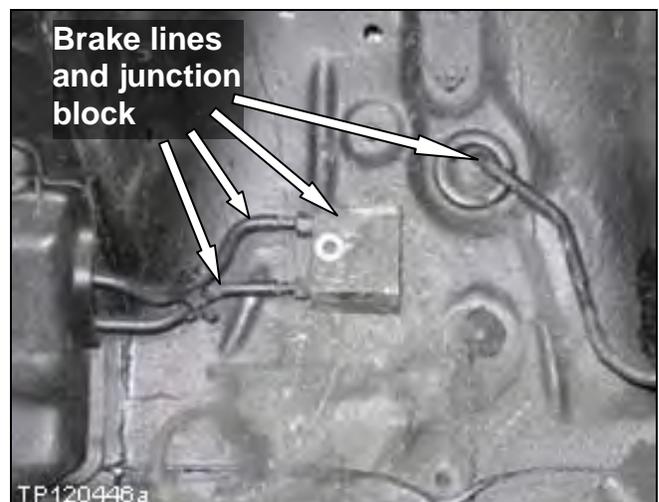
Figure RB4

4a. Passenger side: work around the 2 brake lines and junction block best as possible (see Figure RB4).

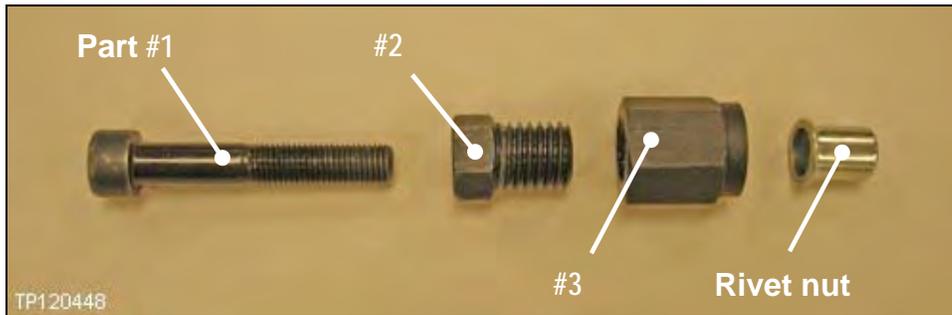
RB13 – Rivet Tool

NOTE: Rivet Tool J-50835 comes with extreme pressure lubricant. Apply to the threads and contact points of part #2 and part #3 for approximately every 60 rivet nuts installed (enough for 15 brackets).

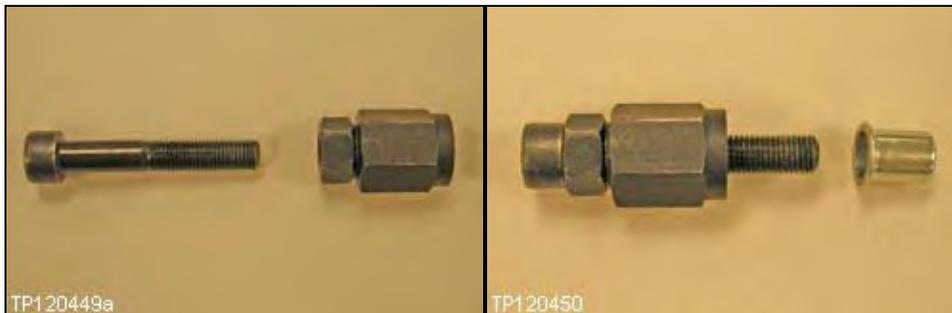
Figure RB14

1. Thread no more than finger tight part #2 into part #3 until it bottoms out (see Figure RB14).
 - This is a left handed thread.
2. Insert part #1 through part #2 and part #3 (see Figure RB15).

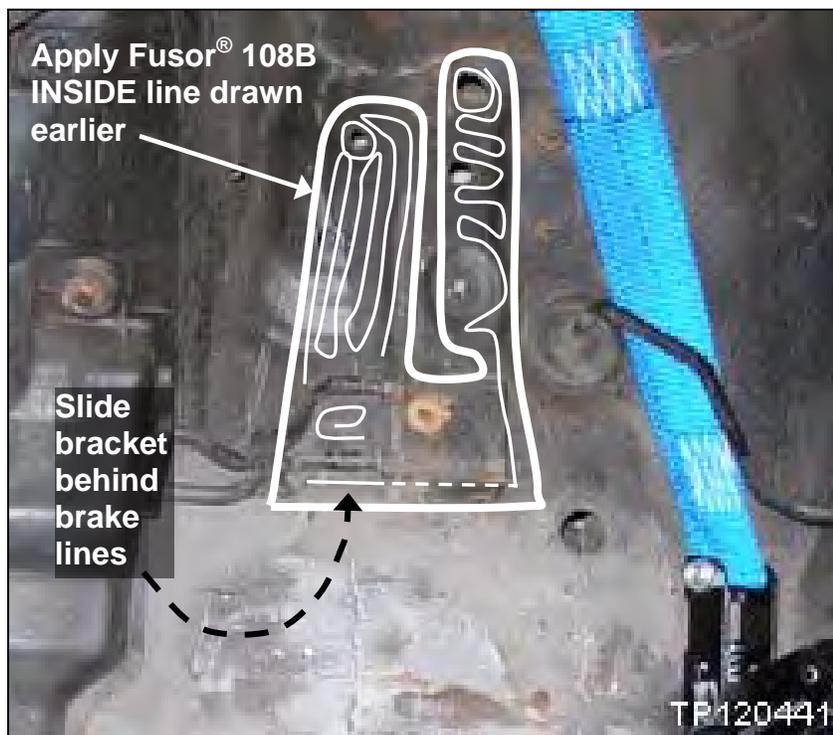
RB24 – Passenger side

27. Passenger side: Liberally apply Fusor[®] 108B on the strut housing area within the white line drawn earlier (see page 24, step 20, and Figure RB24 below).

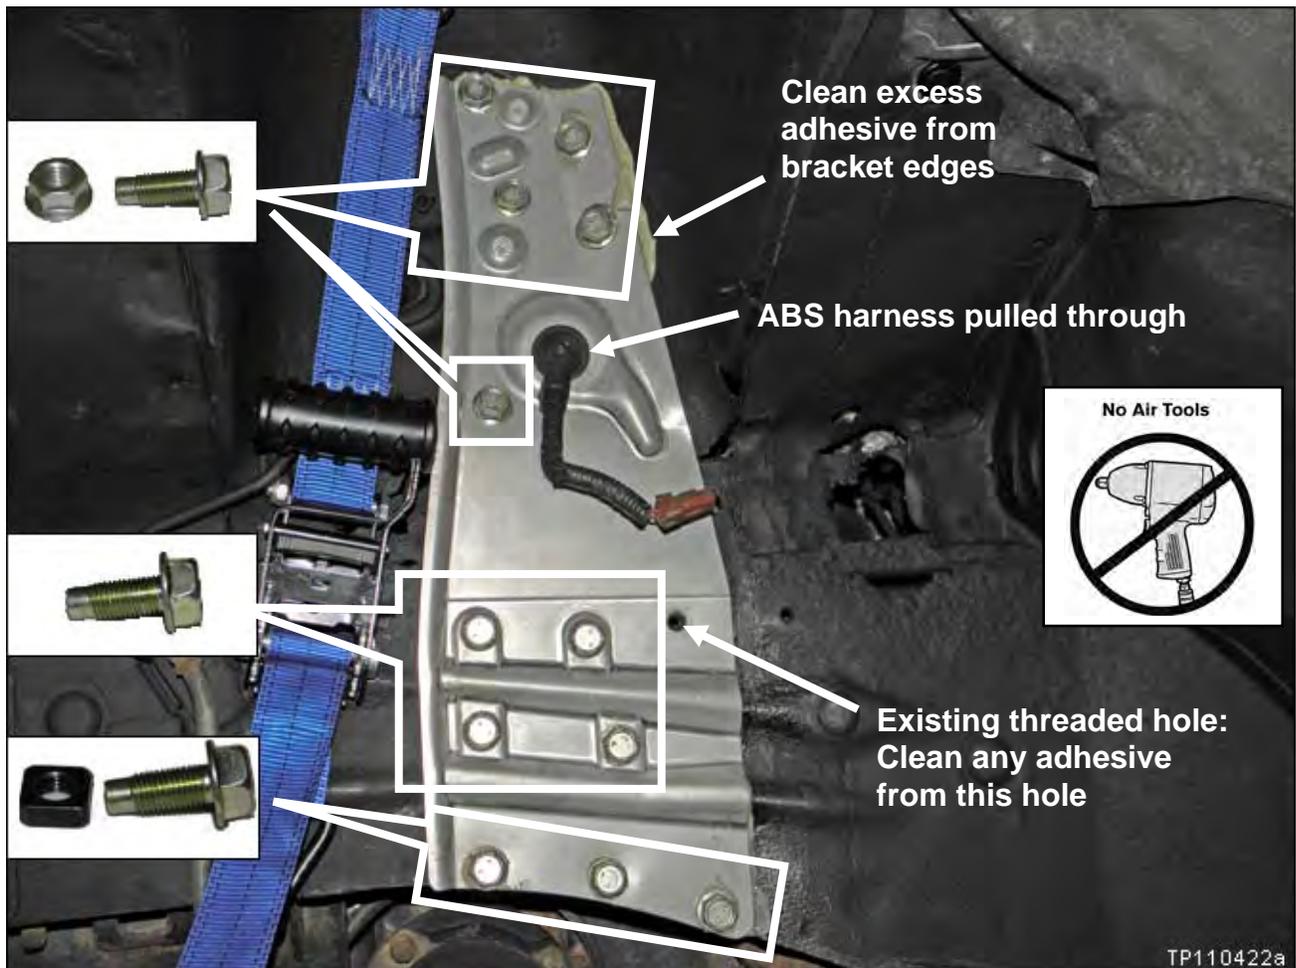
Figure RB25 – Driver side

- Driver side: make sure the ABS harness is pulled through its hole in the repair bracket.
- Use the correct nuts (see Figure RB25, or RB26 on next page, as it applies).
- **Do not use air tools to tighten the bolts.**
- Torque all new bolts/nuts to 50 N•m (5.1 kg-m, **37 ft-lb**).
- Secure all existing bolts.

NOTE: See additional repair bracket bolt installation information on page 33.

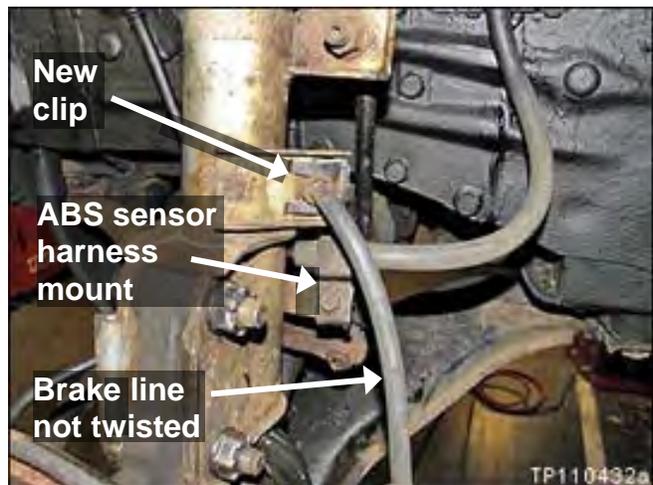
Figure RB37

- Use a new clip for the brake line mount (P/N 46206 – 2J00A).
- Confirm the ABS sensor harness is mounted correctly as shown in Figure RB37.
- Make sure the brake line is not twisted.

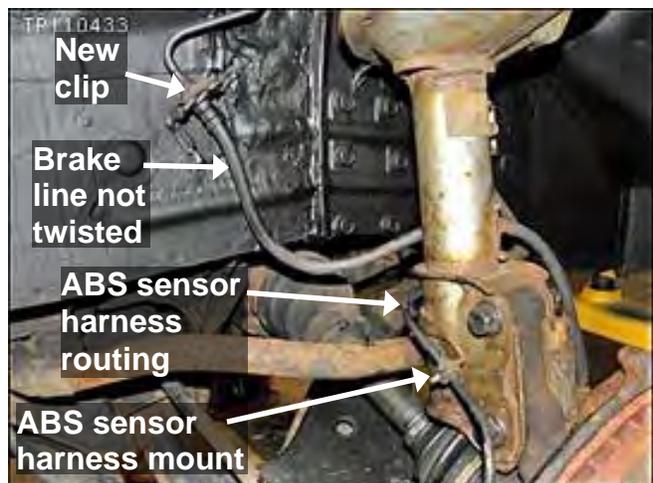
Figure RB38

- Use a new clip for the brake line mount (P/N 46206 – 2J00A).
- Make sure the brake line is not twisted.
- Confirm the ABS sensor harness is routed correctly behind the strut.
- Make sure the ABS sensor harness is mounted correctly as shown in Figure RB38.

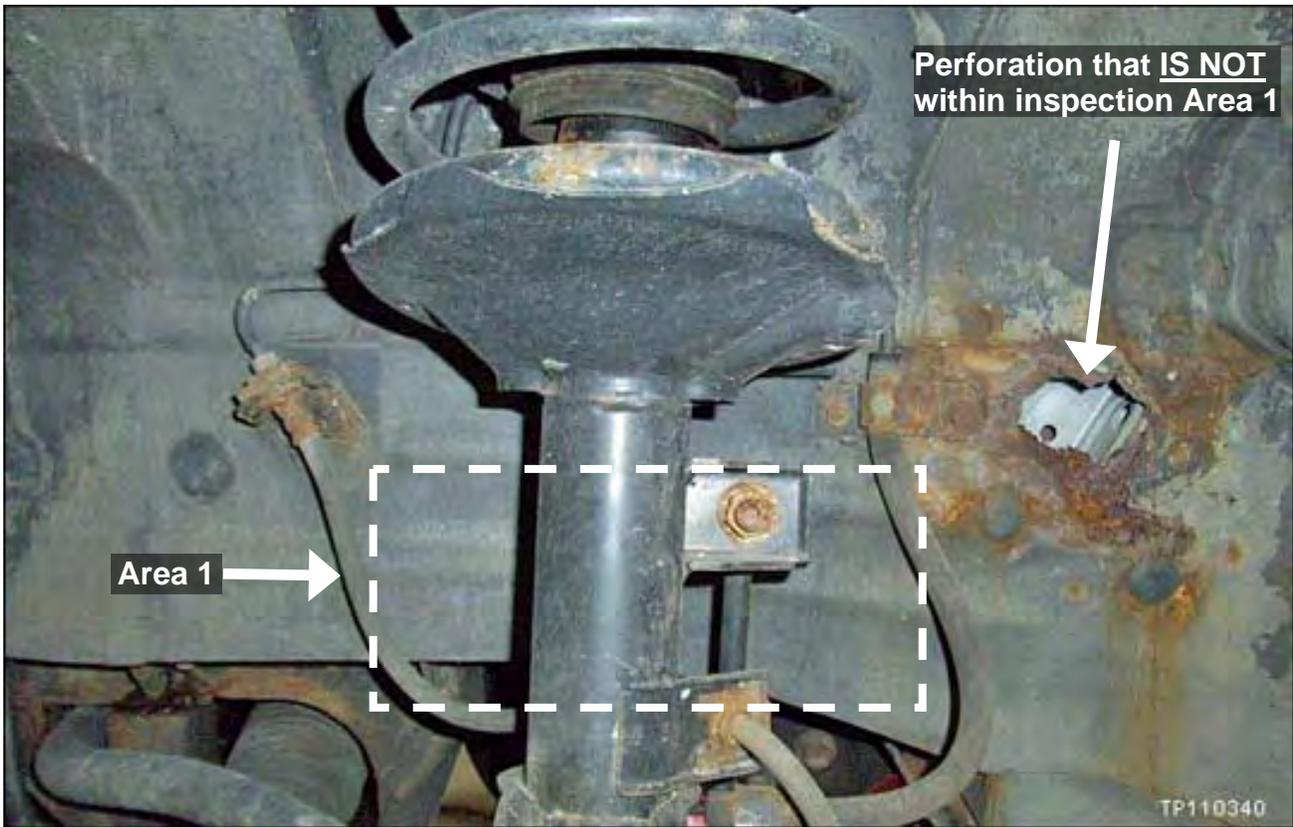
Examples (Additional Photos) of Area 1 Perforation Inspection

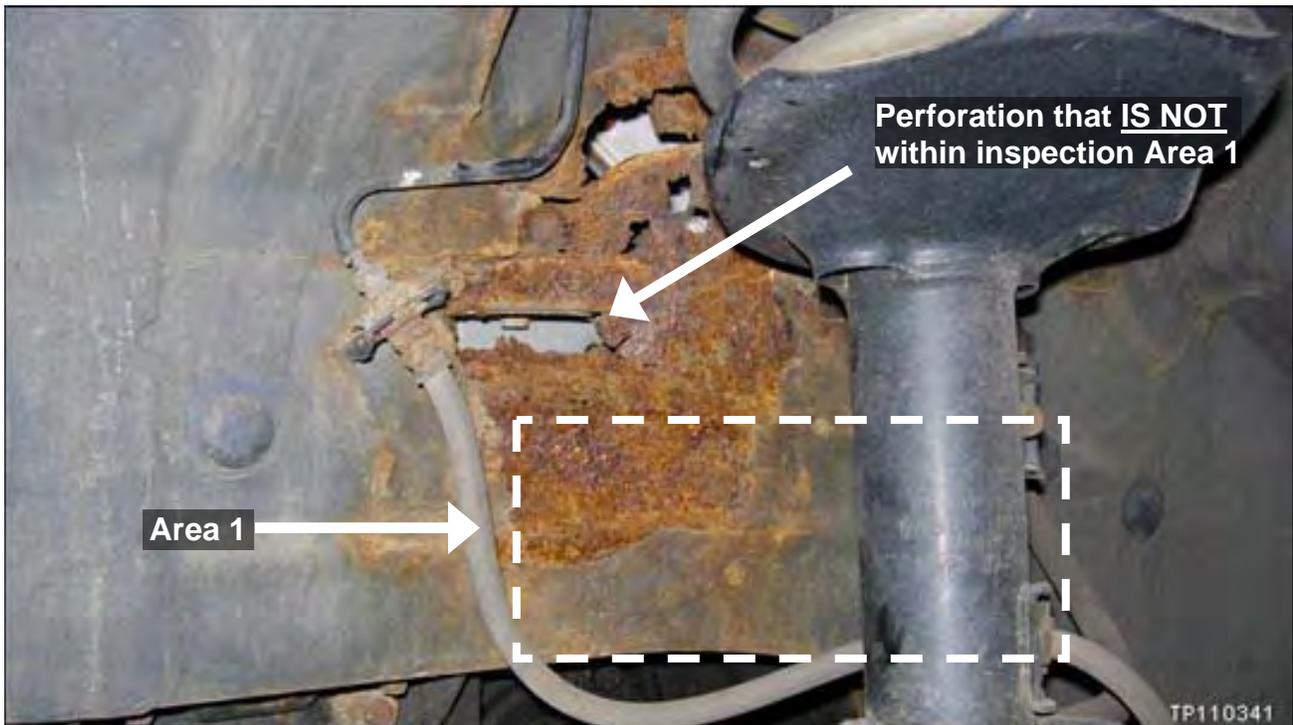
Example (Additional Photo) of Area 1 Perforation Inspection

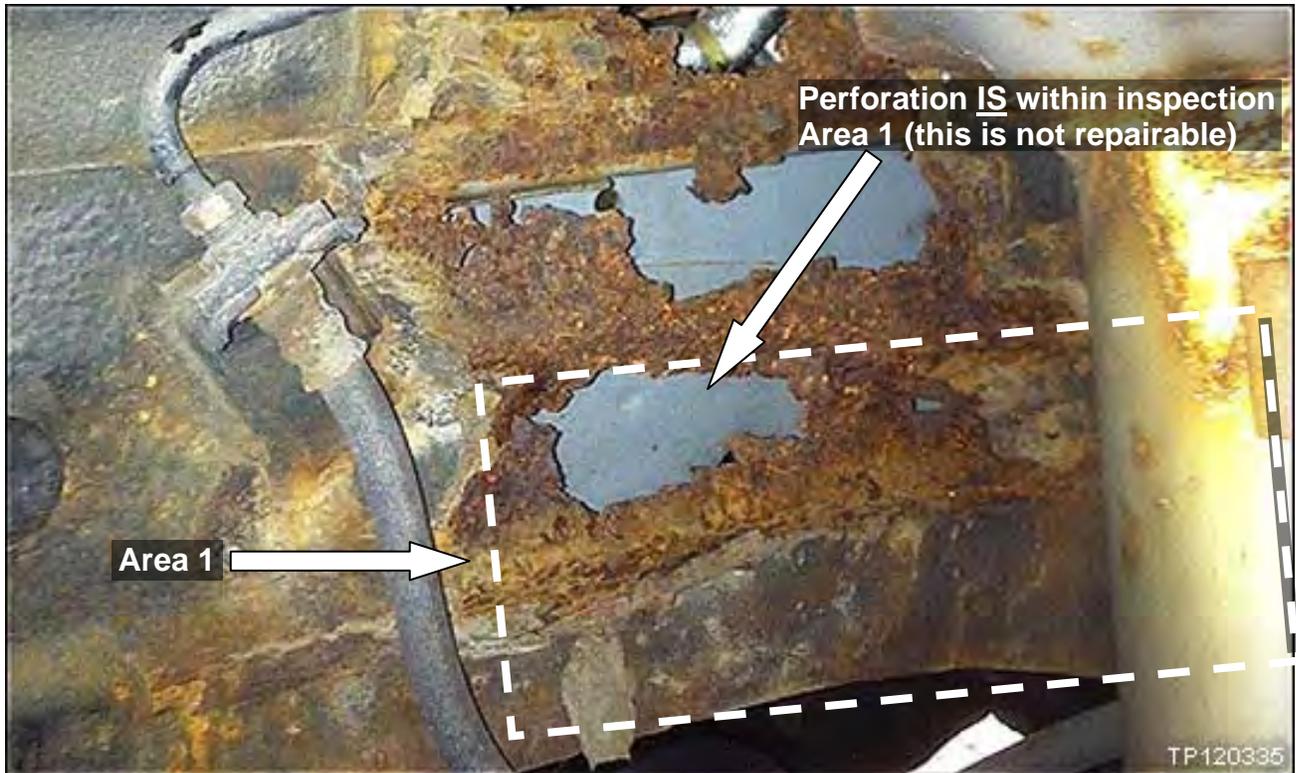
Example (Additional Photo) of Area 1 Perforation Inspection

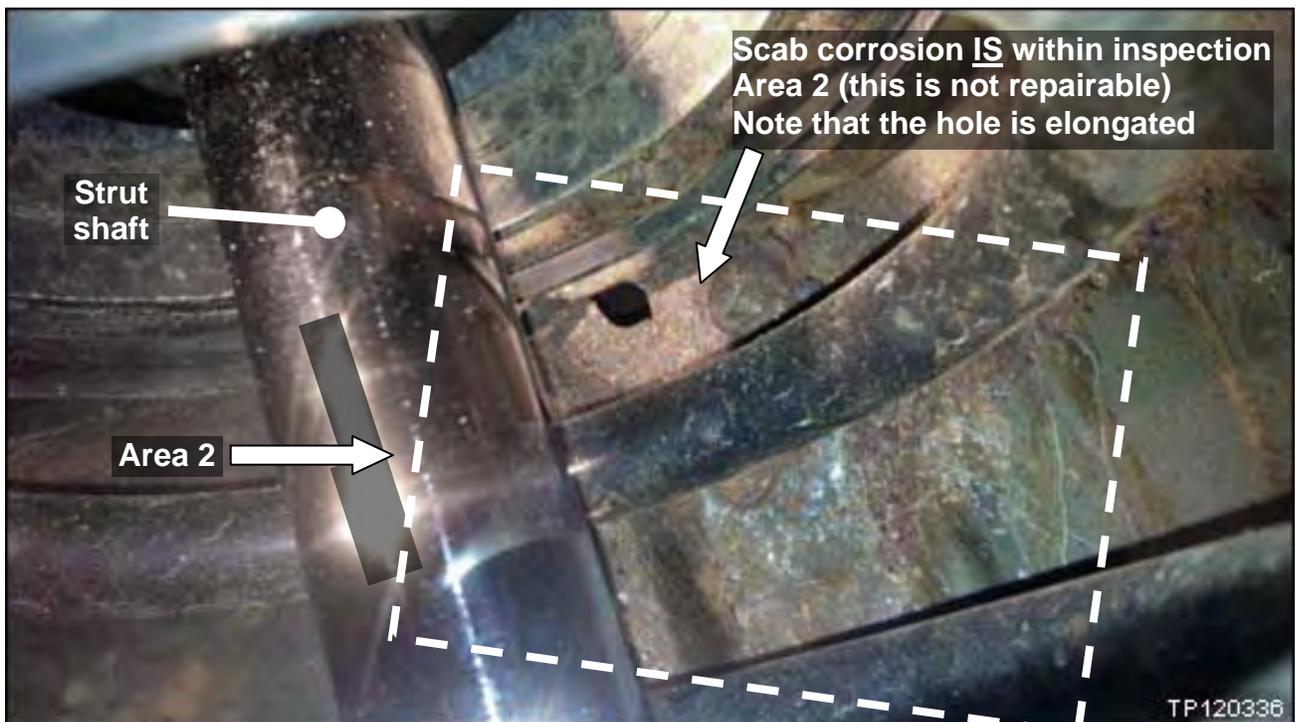
Example (Additional Photo) of Area 2 Scab Corrosion Inspection
